Source Water Assessment

A Hydrogeologic Susceptibility and Vulnerability Assessment for USFS Trail River Sprucewoods Drinking Water System, Crown Point, Alaska PWSID # 240383.001

DRINKING WATER PROTECTION PROGRAM REPORT # 356 Alaska Department of Environmental Conservation

By URS Corporation

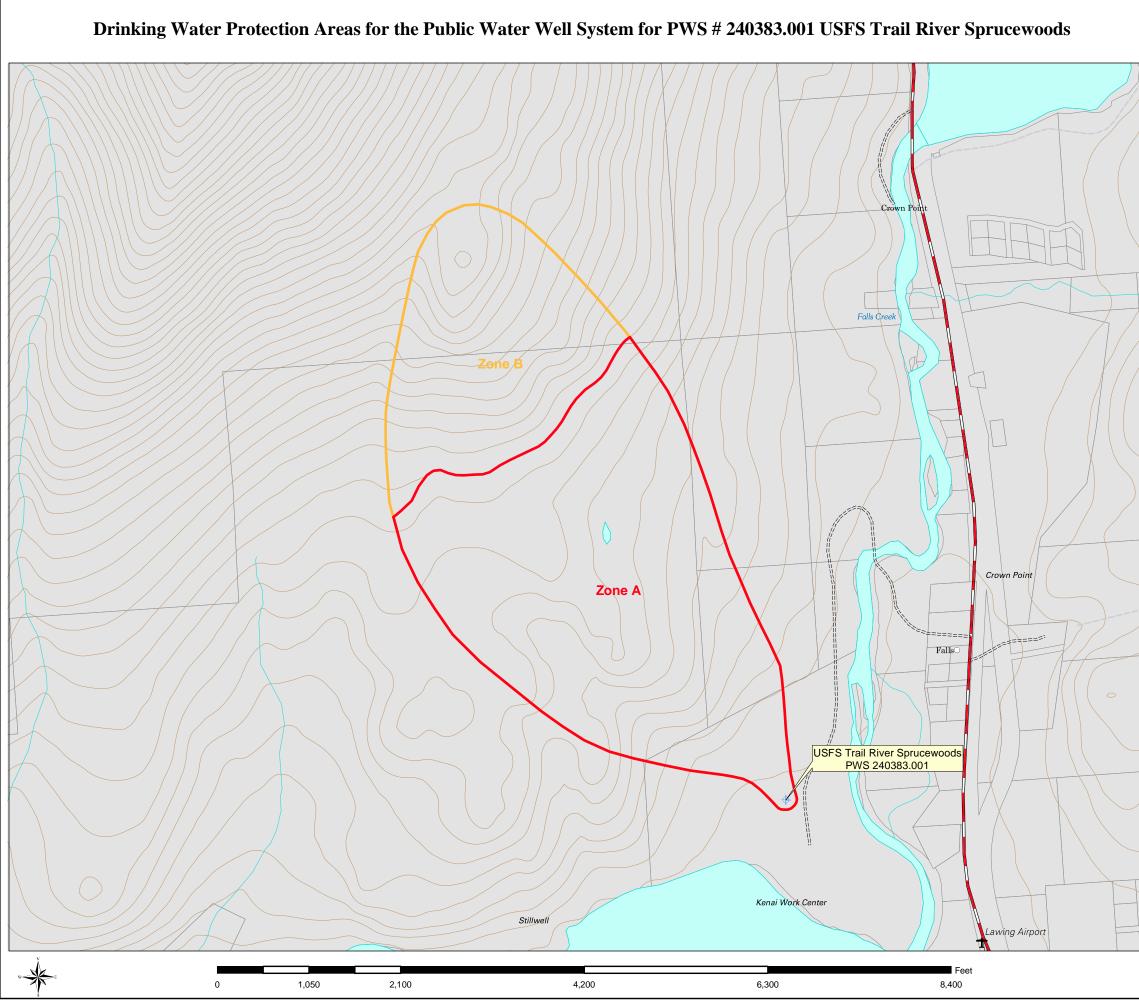
USFS Trail River Sprucewoods Drinking Water Protection Area (Map 1)

The most probable area for contamination to reach the drinking water well is the area that contributes water to the well, the groundwater recharge area. This area is designated as the Drinking Water Protection Area (DWPA). Because a release of contaminants within the DWPA are most likely to impact the drinking water well, this area will serve as the focus for voluntary protection efforts.

An analytical calculation was used to determine the size and shape of the DWPA. The input parameters describing the attributes of the aquifer in this calculation were adopted from the U.S. Geological Survey (*Patrick, Brabets, and Glass, 1989*), and State of Alaska Department of Water Resources (*Jokela et. al., 1991*). Additional methods were also used to take into account any uncertainties in groundwater flow and aquifer characteristics to arrive at a meaningful DWPA (Please refer to the Guidance Manual for Class Bs for additional information).

The DWPAs established for wells by the ADEC are usually separated into four zones, limited by the watershed. These zones correspond to differences in the time-of-travel (TOT) of the water moving through the aquifer to the well. An analytical calculation was used to determine the size and shape of the DWPA. The input parameters describing the attributes of the aquifer in this calculation were adopted from the U.S. Geological Survey (Patrick, Brabets, and Glass, 1989), and State of Alaska Department of Water Resources (Jokela et. al., 1991).

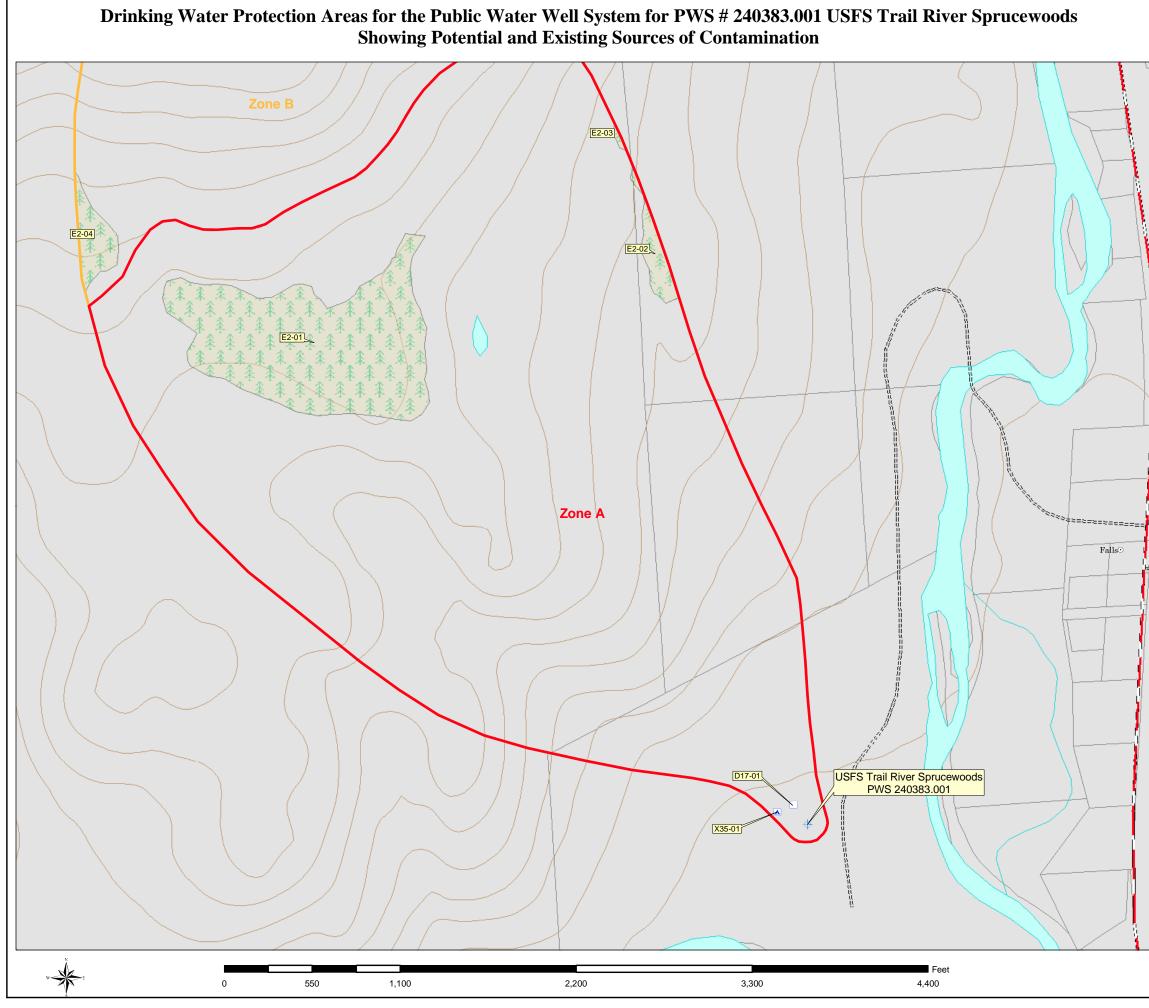
USFS Trail River Sprucewoods Drinking Water Protection Area and Potential and Existing Contaminant Sources (Map 2)

Inventoried potential sources of contamination within Zones A and B are associated with residential and light

industrial type activities. The sources are summarized in the tables in Appendix B.

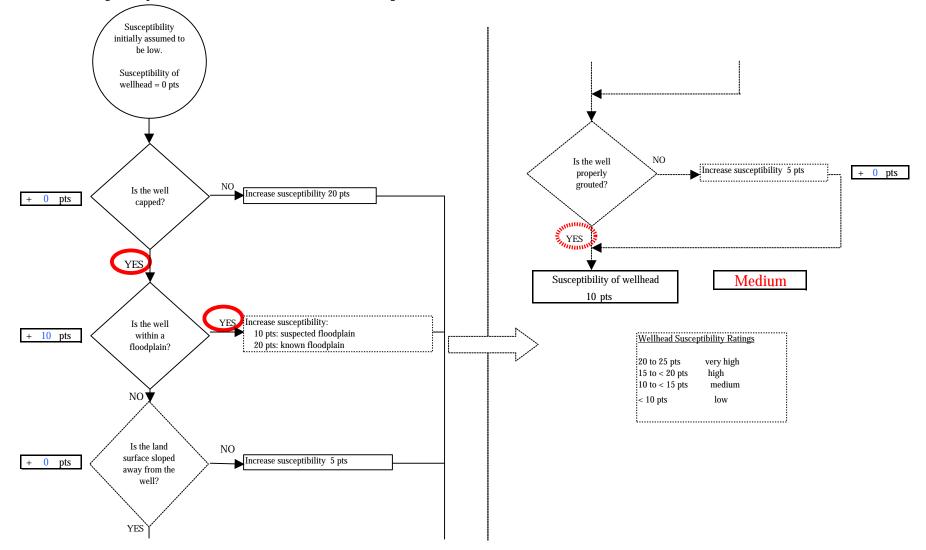
Chart 1. Susceptibility of the wellhead - USFS Trail River Sprucewoods (240383.001)

Appendix D contains eight charts, which together form the 'Vulnerability Analysis' for a source water assessment for a public drinking water source. Chart 1 analyzes the 'Susceptibility of the Wellhead' to contamination by looking at the construction of the well and its surrounding area. Chart 2 analyzes the 'Susceptibility of the Aquifer' to contamination by looking at the naturally occurring attributes of the water source and influences on the groundwater system that might lead to contamination. Chart 3 analyzes 'Contaminant Risks' for the drinking water source with respect to bacteria and viruses. The 'Contaminant Risks' portion of the analysis considers potential sources of contaminants as well as a review of contamination that has or may have occurred, but has not arrived or been detected at the well. Lastly, Chart 4 contains the 'Vulnerability Analysis for Bacteria and Viruses'. Charts 5 through 8 contain the Contaminant

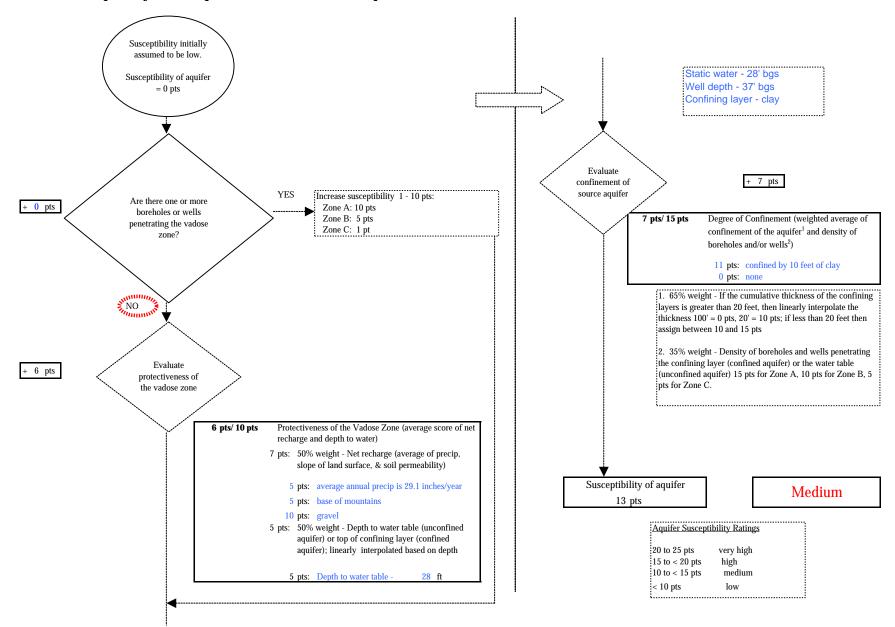
Chart 2. Susceptibility of the aquifer - USFS Trail River Sprucewoods (240383.001)

The well for USFS Trail River Sprucewoods is completed in an unconfined aquifer setting. Because an unconfined aquifer is recharged by surface water and precipitation that migrates downward from the surface, contaminants at the surface have the potential to adversely impact this aquifer. Table 2 shows the Overall Susceptibility score and rating for USFS Trail River Sprucewoods.

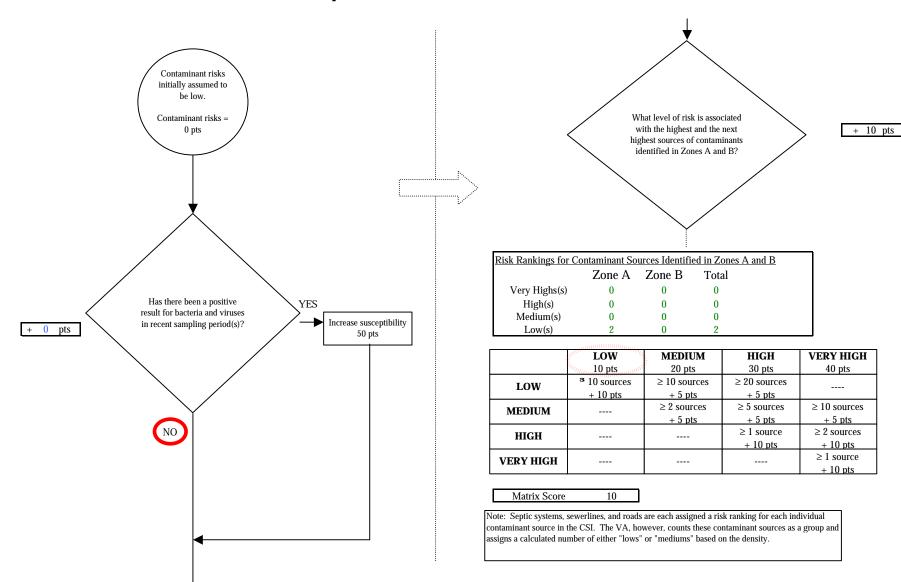
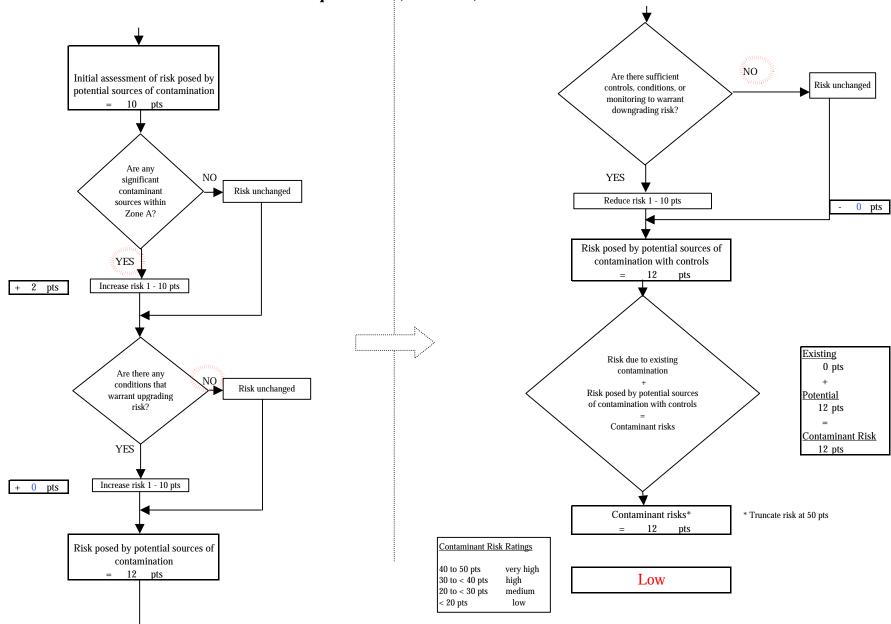
Chart 3. Contaminant risks for USFS Trail River Sprucewoods (240383.001) - Bacteria & Viruses

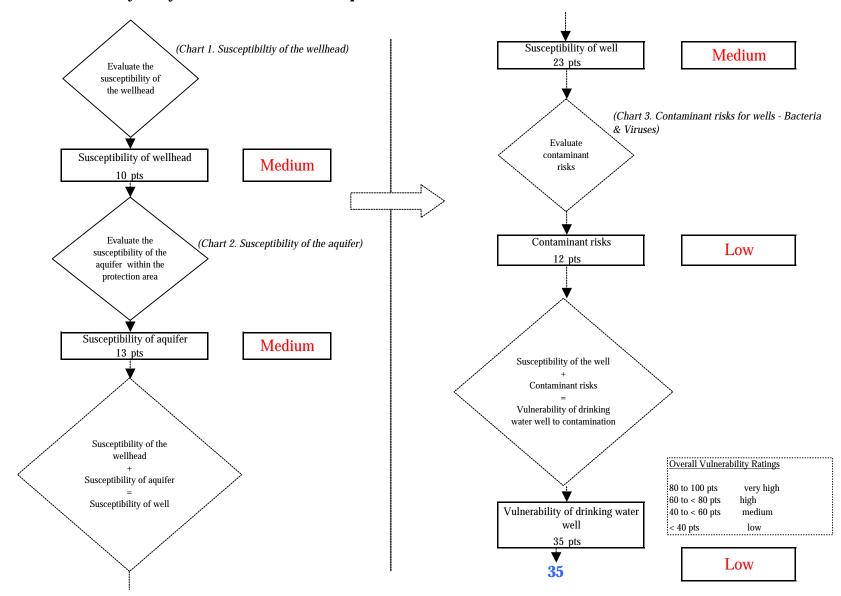
Chart 4. Vulnerability analysis for USFS Trail River Sprucewoods (240383.001) - Bacteria & Viruses

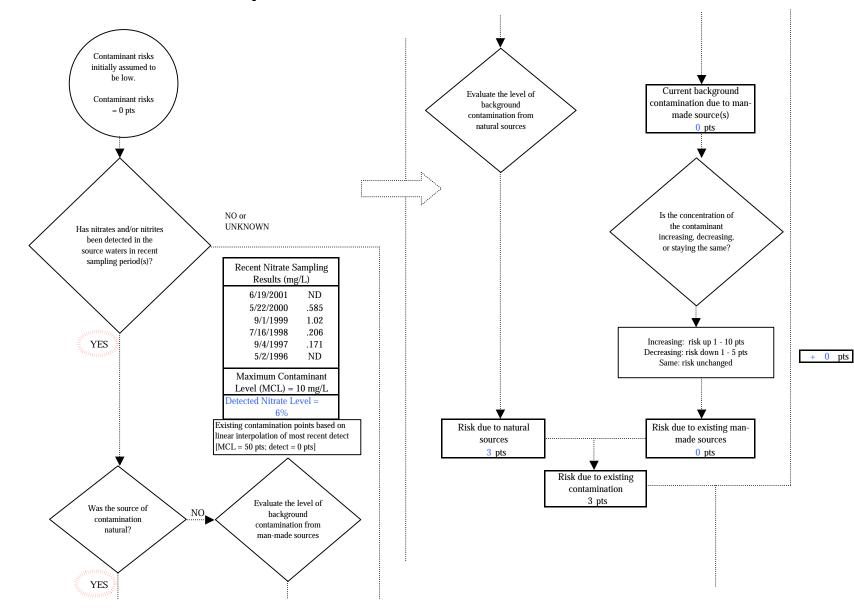
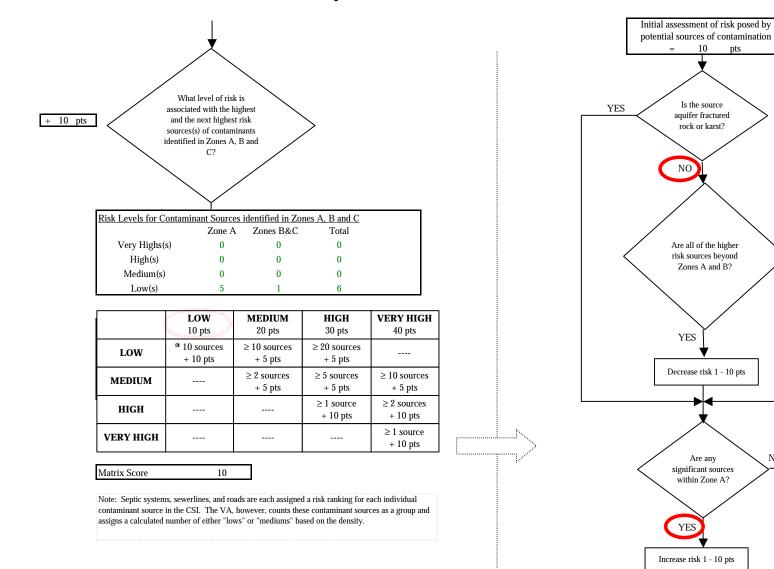
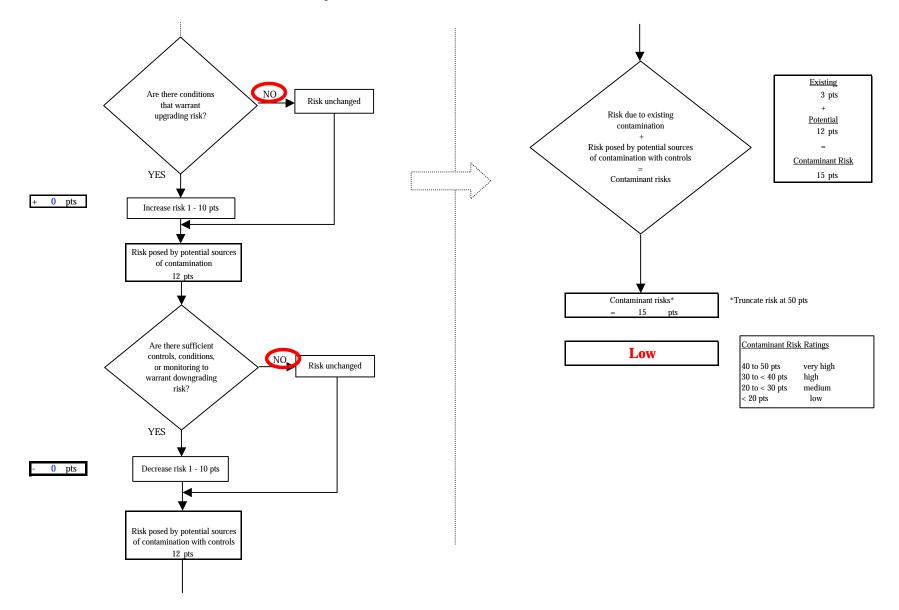
Chart 5. Contaminant risks for USFS Trail River Sprucewoods (240383.001) - Nitrates and Nitrites

Sampling history for USFS Trail River Sprucewoods well indicates that low concentrations of nitrate have been detected (See Chart 5 - Contaminant Risks for Nitrates and/or Nitrites in Appendix D). Existing nitrate concentration is approximately 0.6 mg/L or 6 % of the Maximum Contaminant Level (MCL) of 10mg/L. The MCL is the maximum level of contaminant that is allowed to exist in drinking water and still be consumed by humans without harmful health effects. Due to the high solubility and weak retention by soil, nitrates are very mobile, moving at approximately the same rate as water. Though existing nitrate contamination was detected at the site, concentrations remain at very safe levels with respect to human health.

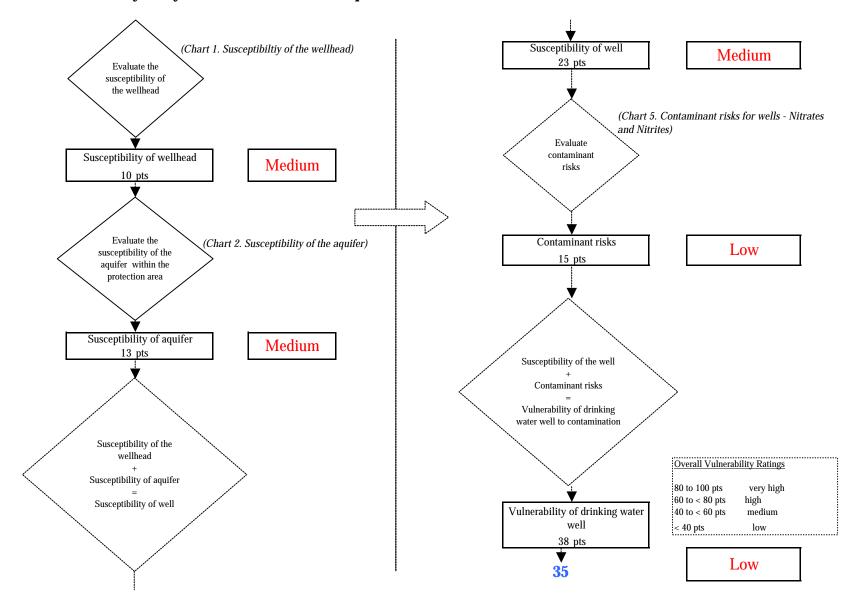
Chart 6. Vulnerability analysis for USFS Trail River Sprucewoods (240383.001) - Nitrates and Nitrites

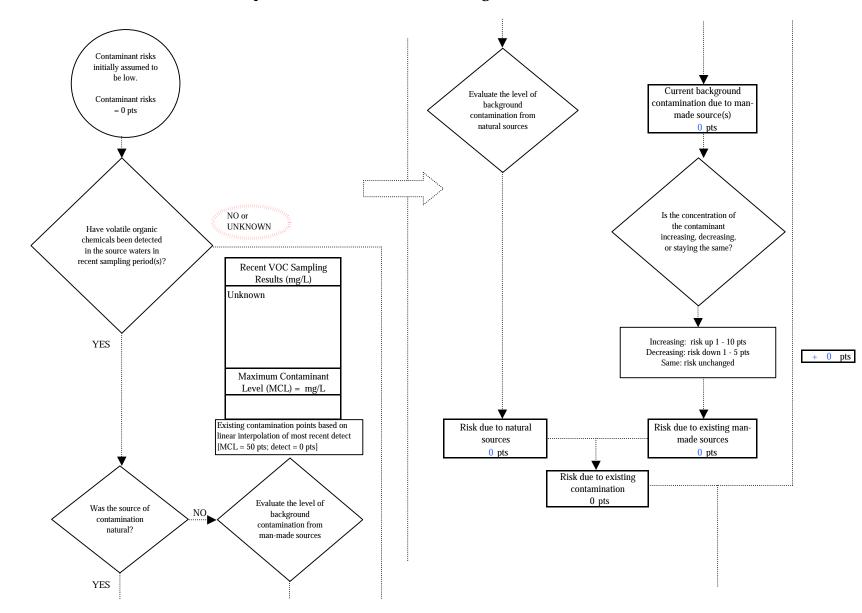
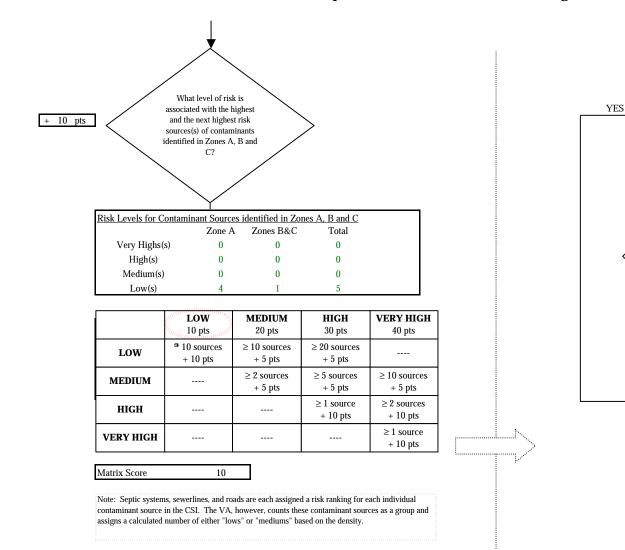
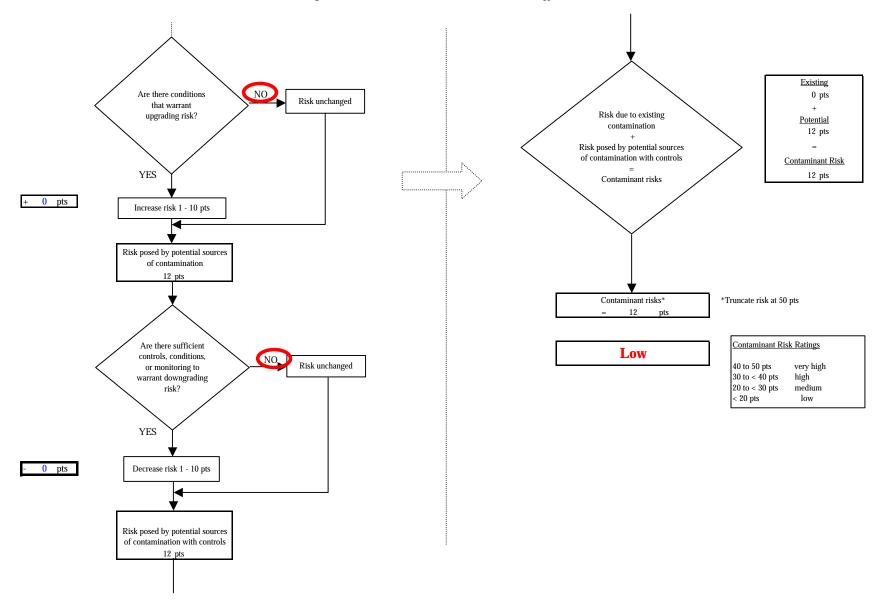
Chart 7. Contaminant risks for USFS Trail River Sprucewoods (240383.001) - Volatile Organic Chemicals

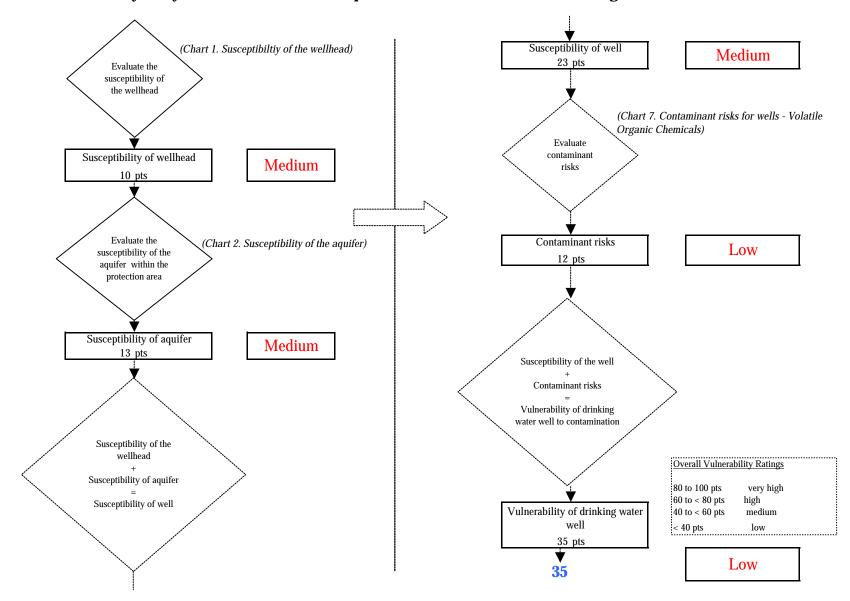
Chart 8. Vulnerability analysis for USFS Trail River Sprucewoods (240383.001) - Volatile Organic Chemicals
