Source Water Assessment

A Hydrogeologic Susceptibility and Vulnerability
Assessment for
Eagle's Ridge / Church Bldg.
Drinking Water System,
Delta Junction area, Alaska
PWSID # 372279

DRINKING WATER PROTECTION PROGRAM REPORT #974

November 2003

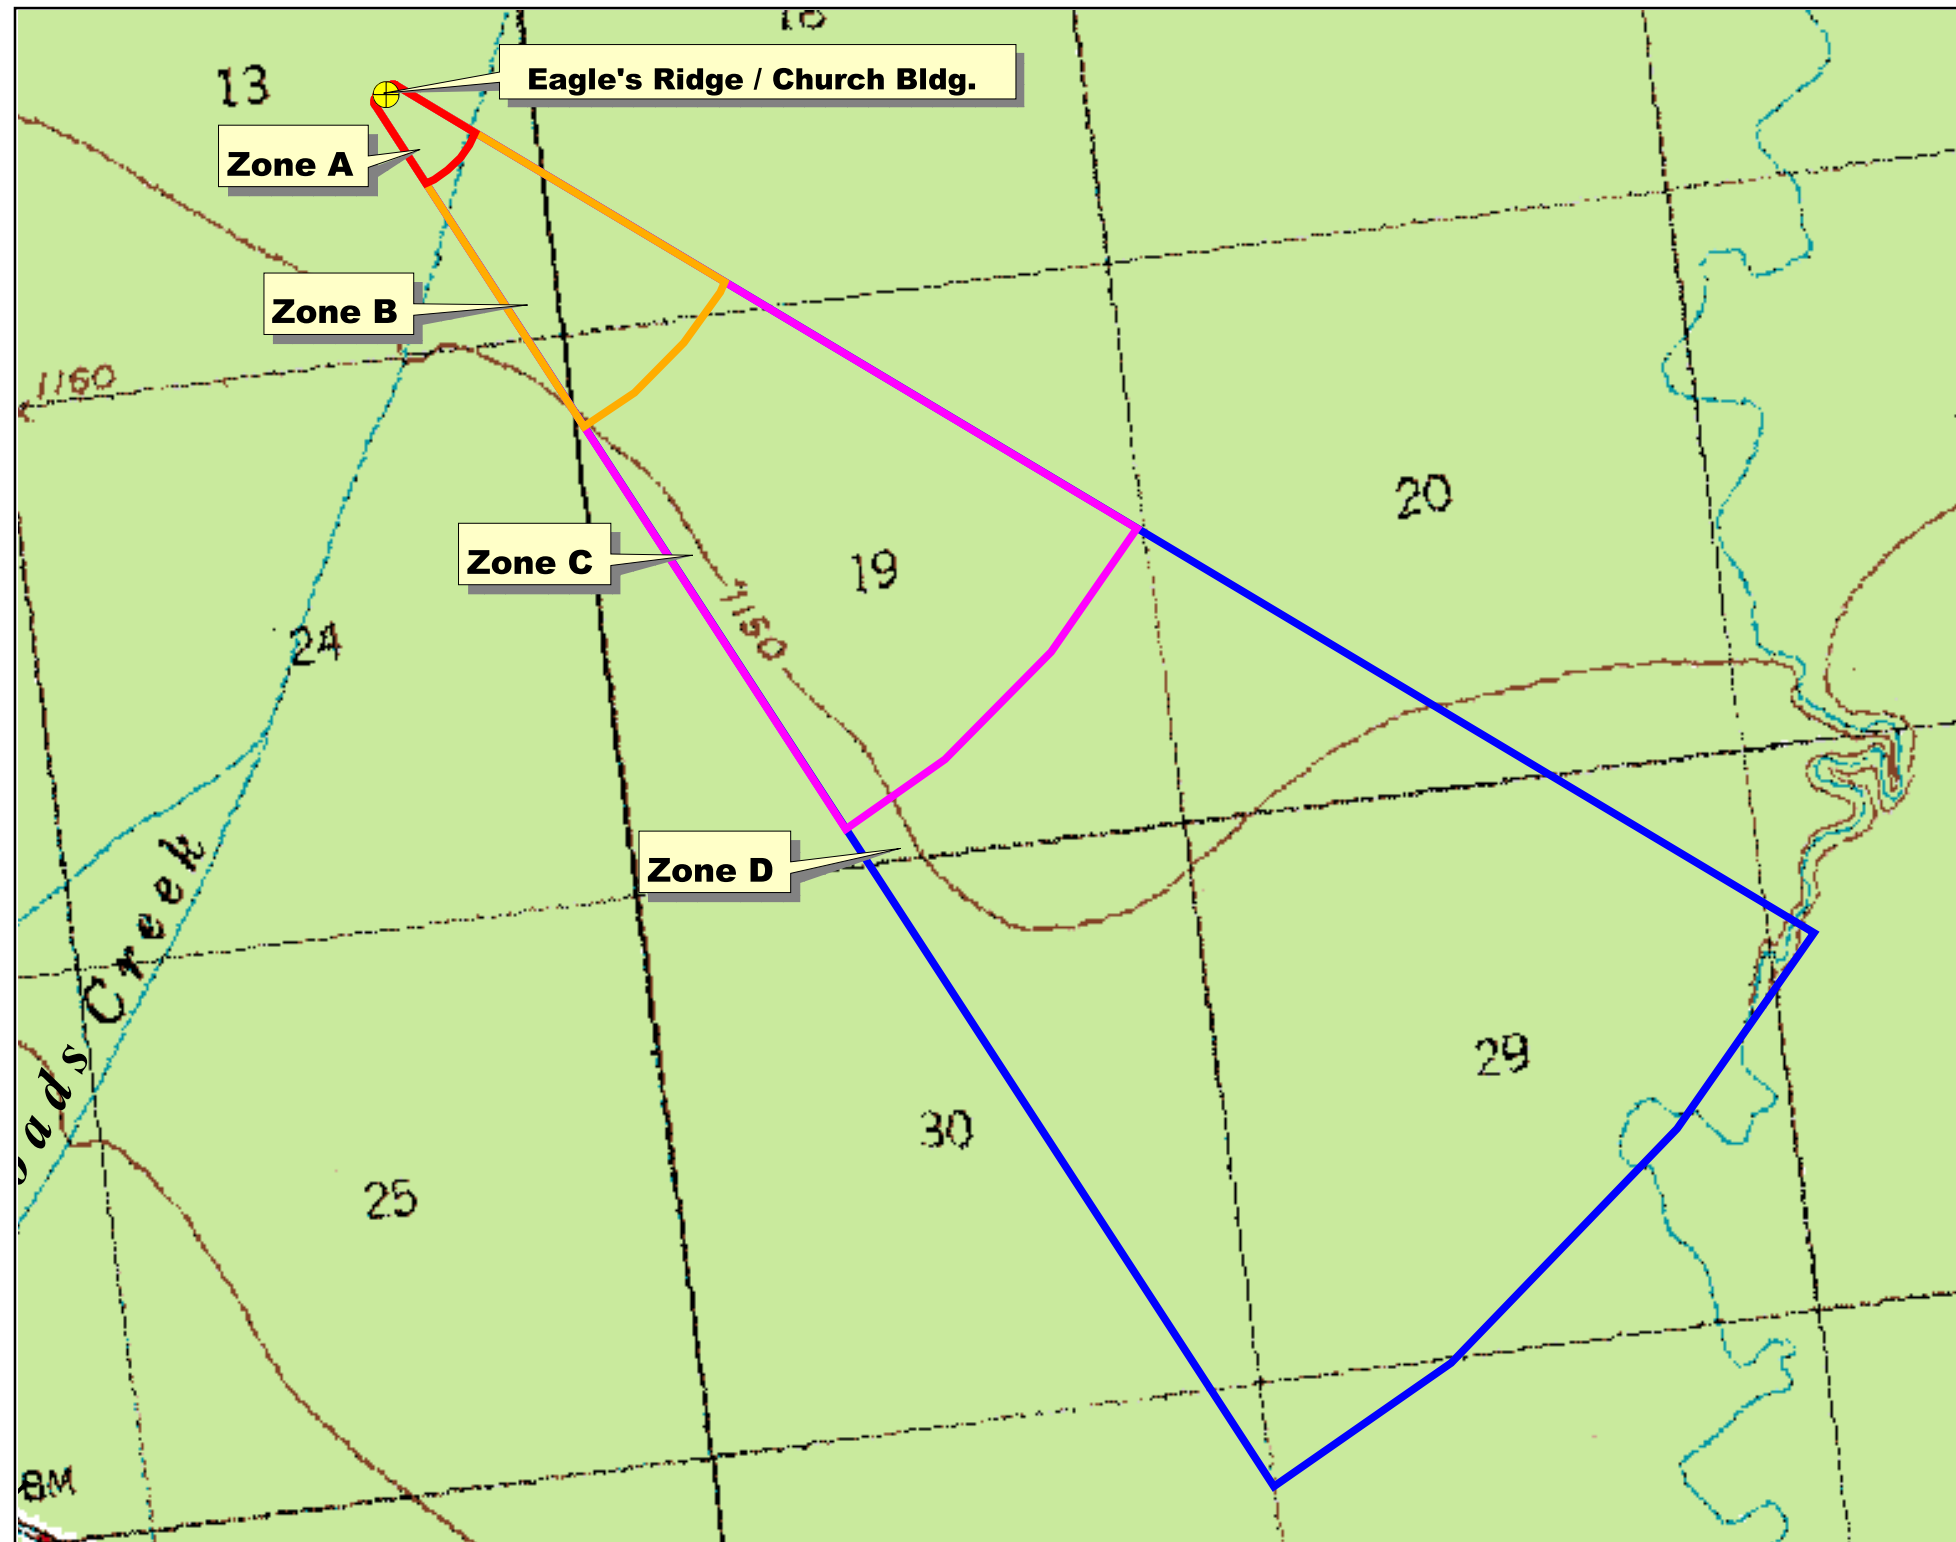
The DWPA may be limited by its immediate watershed and therefore may not include all four zones (See Map 1 of Appendix A).

Drinking Water Protection Area for Eagle's Ridge Church Building Well

Eagle's Ridge / Church Bldg. public water system is a Class B (transient/non-community) water system. The system consists of one well located near Delta Junction off the Alaska Highway at 1300 Barley Way (see Map 1 of Appendix A). Delta Junction is located at the junction of the Richardson and Alaska Highways, approximately 95 miles southeast of Fairbanks (see the inset of Map 1 in Appendix A for location). It is a second-class city with an estimated population of 856 residents (ADCED 2003).

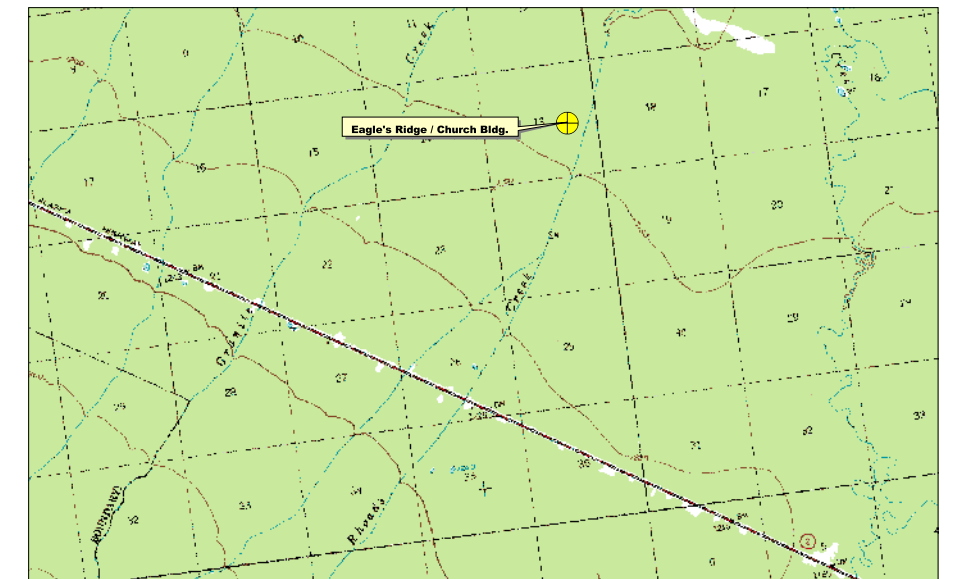
PWSID 372279.001

- ⊕ Eagle's Ridge/Church Building Well
- ▭ Zone A (Few Months Travel Time)
- ▭ Zone B (Less Than 2 Years Travel Time)
- ▭ Zone C (Less Than 5 Years Travel Time)
- ▭ Zone D (Less Than 10 Years Travel Time)

The protection areas established for wells by the ADEC are usually separated into four zones, limited by the watershed. These zones correspond to differences in the time-of-travel (TOT) of the water moving through the aquifer to the well. An analytical calculation was used to determine the size and shape of the protection area. The input parameters describing the attributes of the aquifer in this calculation were derived from Freeze and Cherry (1979), Wilcox (1980), and from a review of well logs in the area found in the Alaska Department of Natural Resources and United States Geological Survey databases. Additional methods were considered to take into account any uncertainties in groundwater flow and aquifer characteristics to arrive at a meaningful protection area. (Please refer to the Guidance Manual for Class B Public Water Systems for additional information).

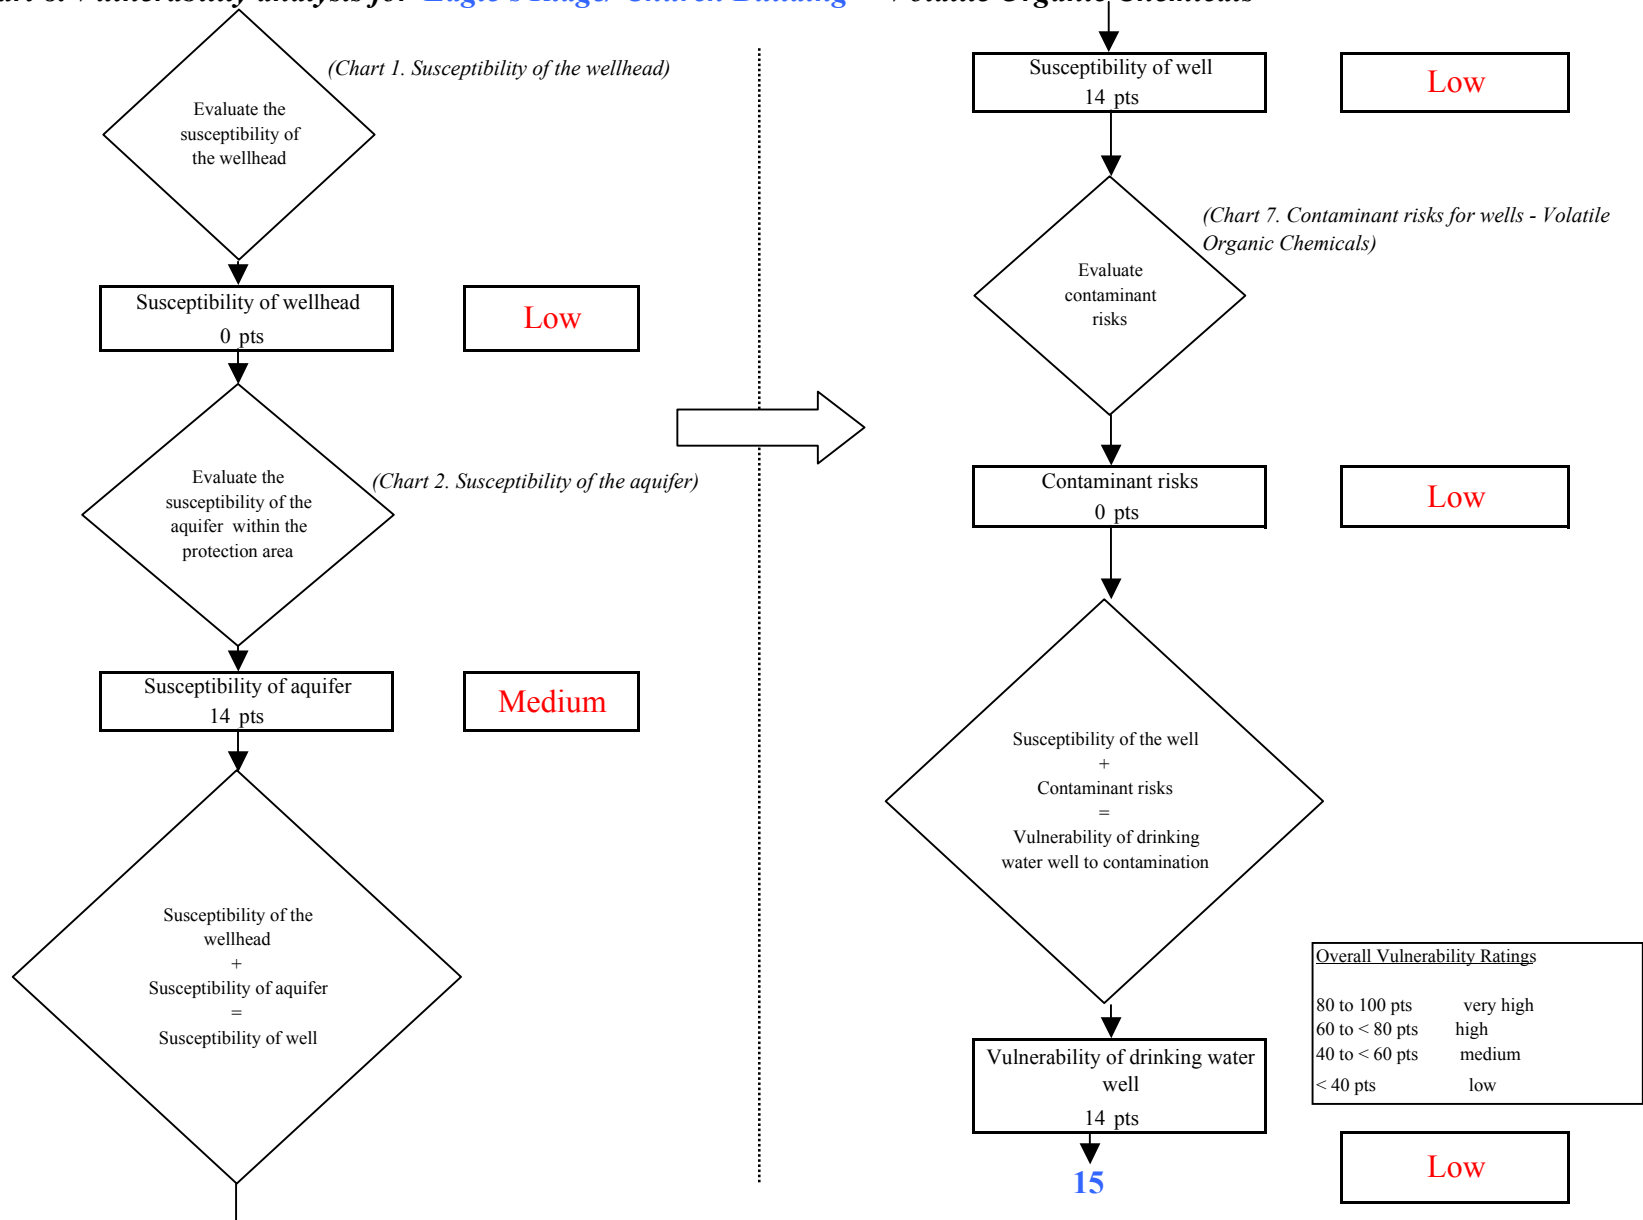
Chart 8. Vulnerability analysis for Eagle's Ridge/ Church Building - Volatile Organic Chemicals

potential contaminant risk for volatile organic chemicals with the natural susceptibility of the well, the overall vulnerability of the well to contamination by volatile organic chemicals is Low.
