A Hydrogeologic Susceptibility and Vulnerability Assessment for Bristol Bay Lodge, Inc. Drinking Water System, Dillingham, Alaska

PWSID # 261630.001 March 2004

DRINKING WATER PROTECTION PROGRAM REPORT 1188 Alaska Department of Environmental Conservation

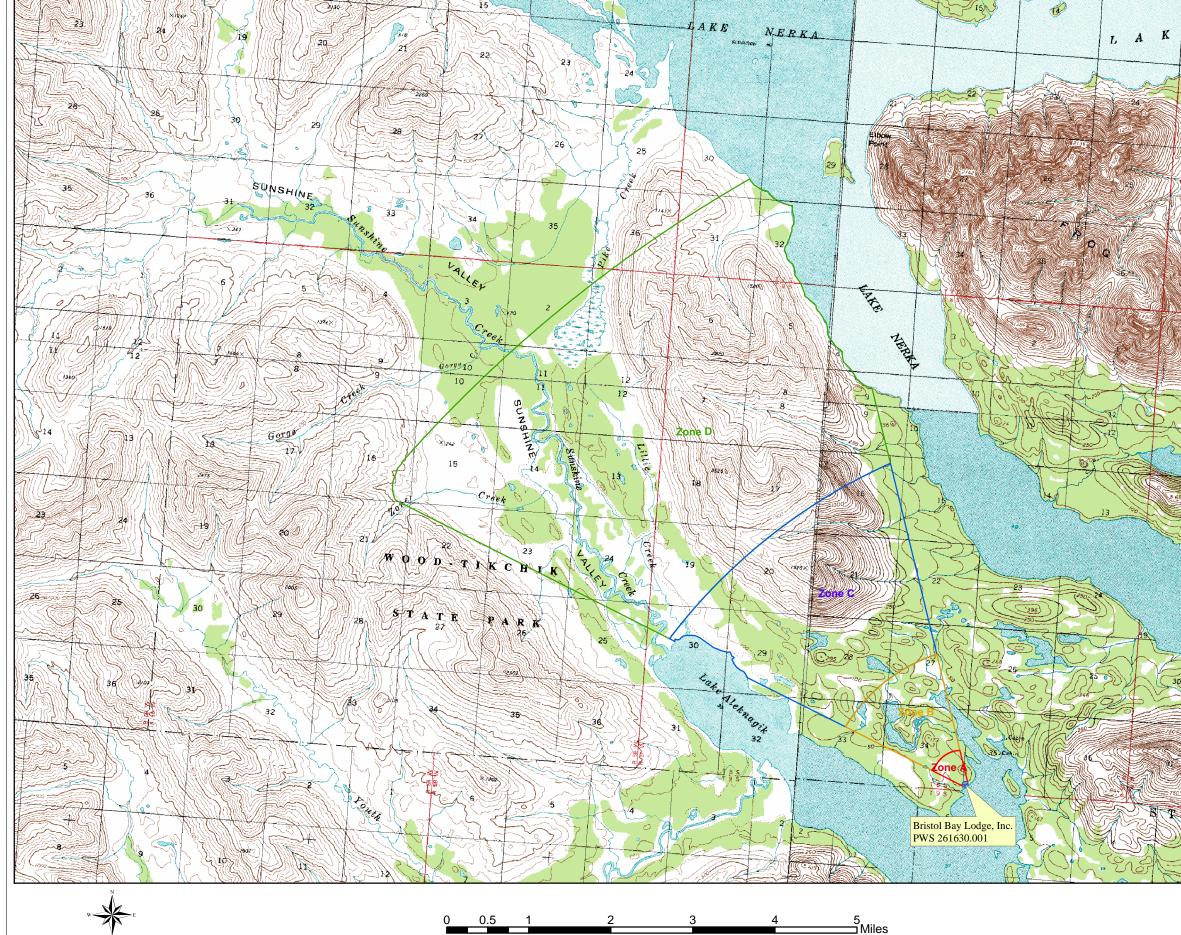
Appendix A Map A

Public Water Well System for PWS #261630.001 Bristol Bay Lodge, Inc.

The DWPA for the Bristol Bay Lodge, Inc. PWS was determined using an analytical calculation and includes Zone A, B, C and D (See Map A of Appendix A).
