Source Water Assessment

A Hydrogeologic Susceptibility and
Vulnerability Assessment for
Lion's Club of Eagle River
Drinking Water System,
Eagle River, Alaska

Lion's Club of Eagle River # 218544

DRINKING WATER PROTECTION PROGRAM REPORT # 223
Alaska Department of Environmental Conservation

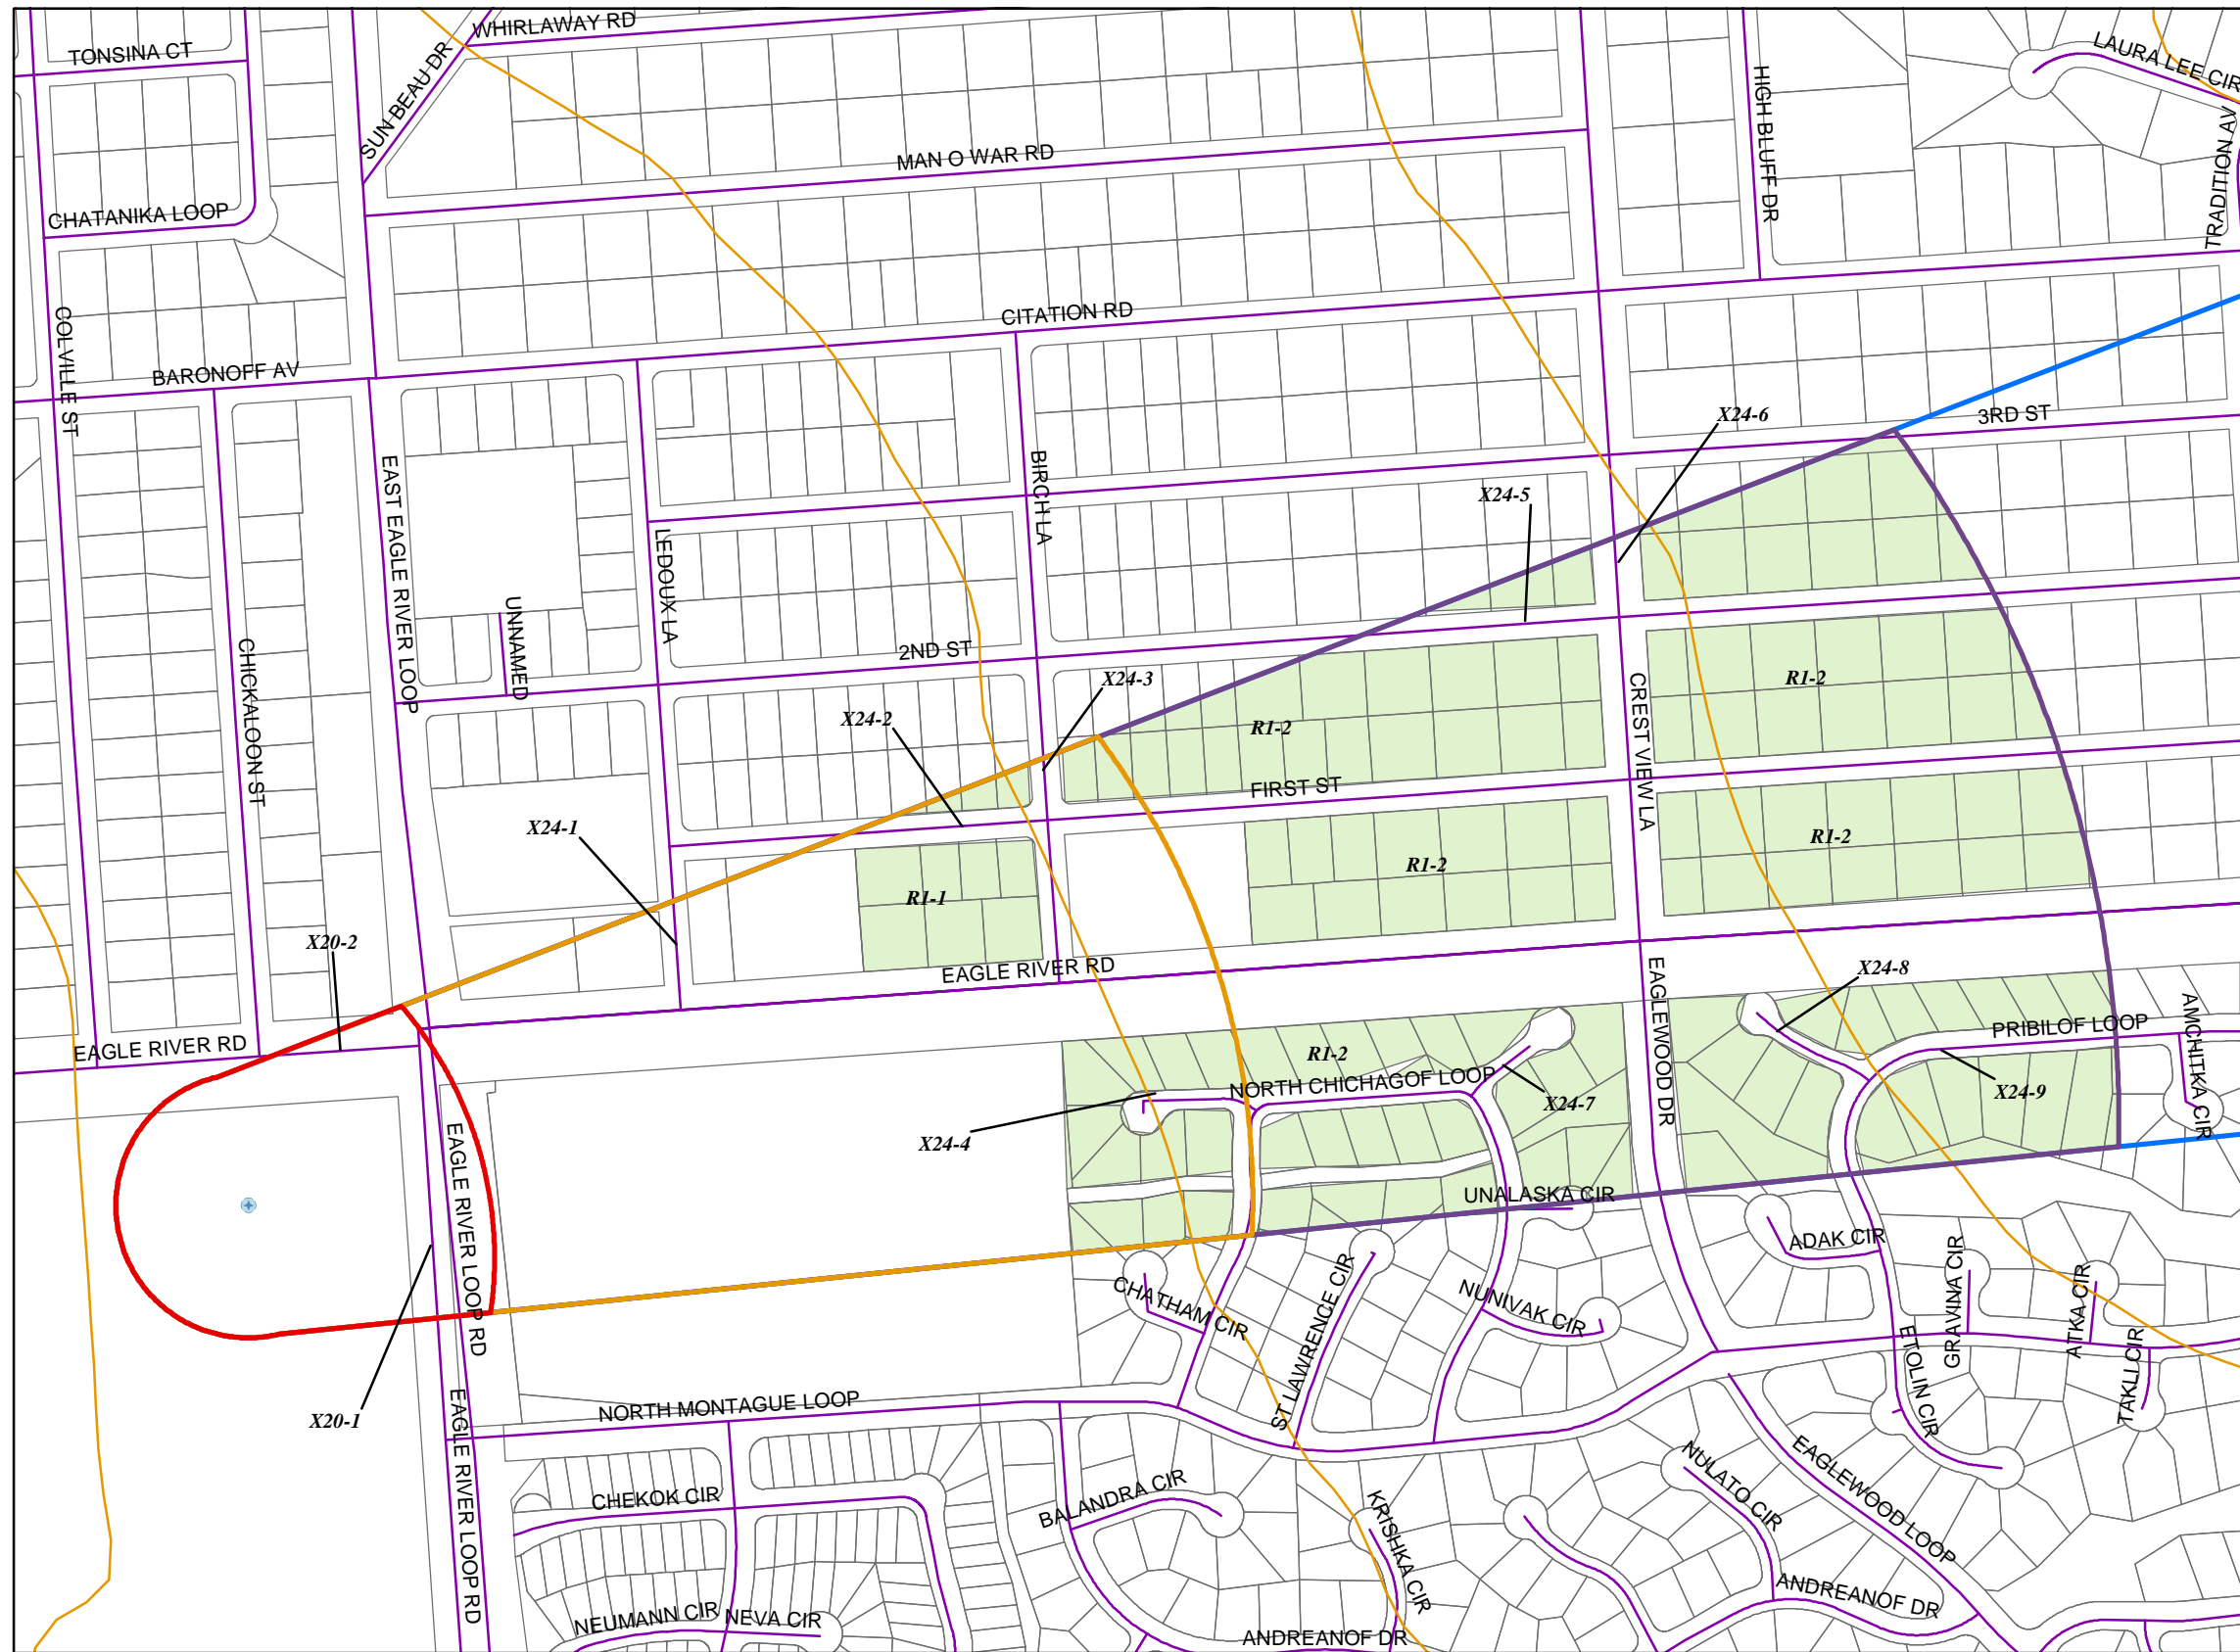
Drinking Water Protection Areas for Lion's Club of Eagle River and Potential and Existing Sources of Contamination

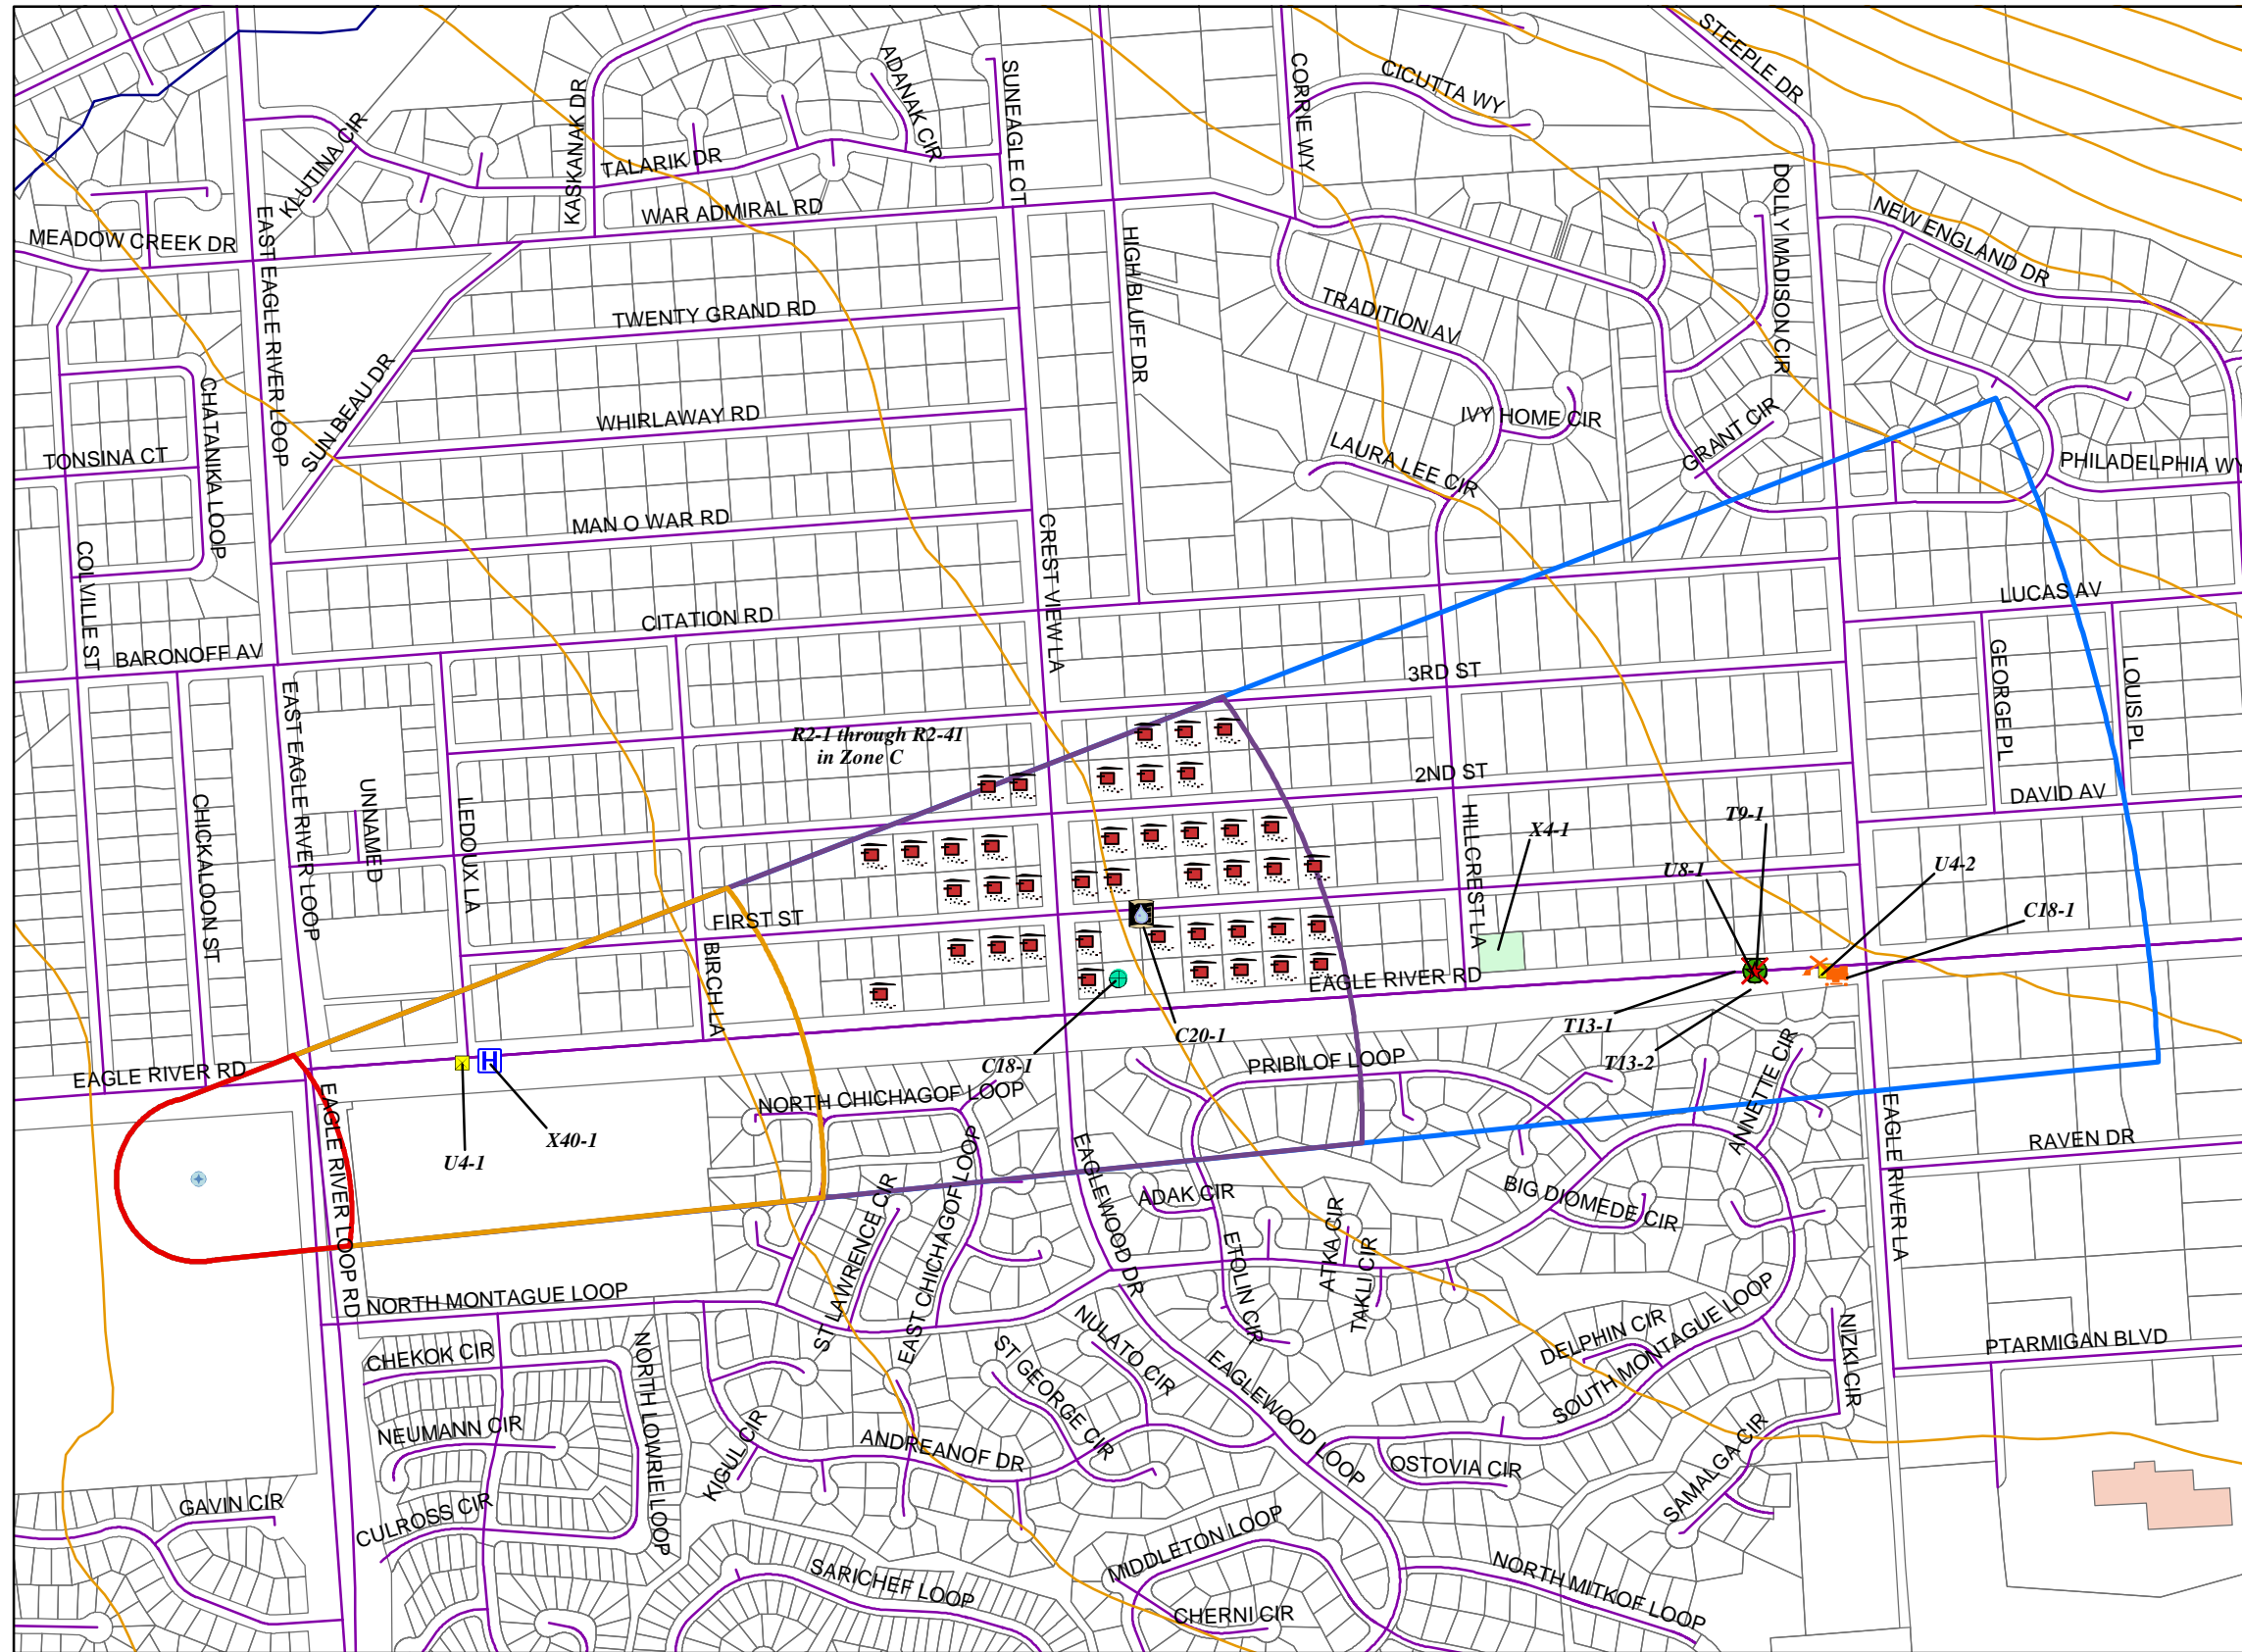
Map 3

Drinking Water Protection Areas for Lion's Club of Eagle River and Potential and Existing Sources of Contamination

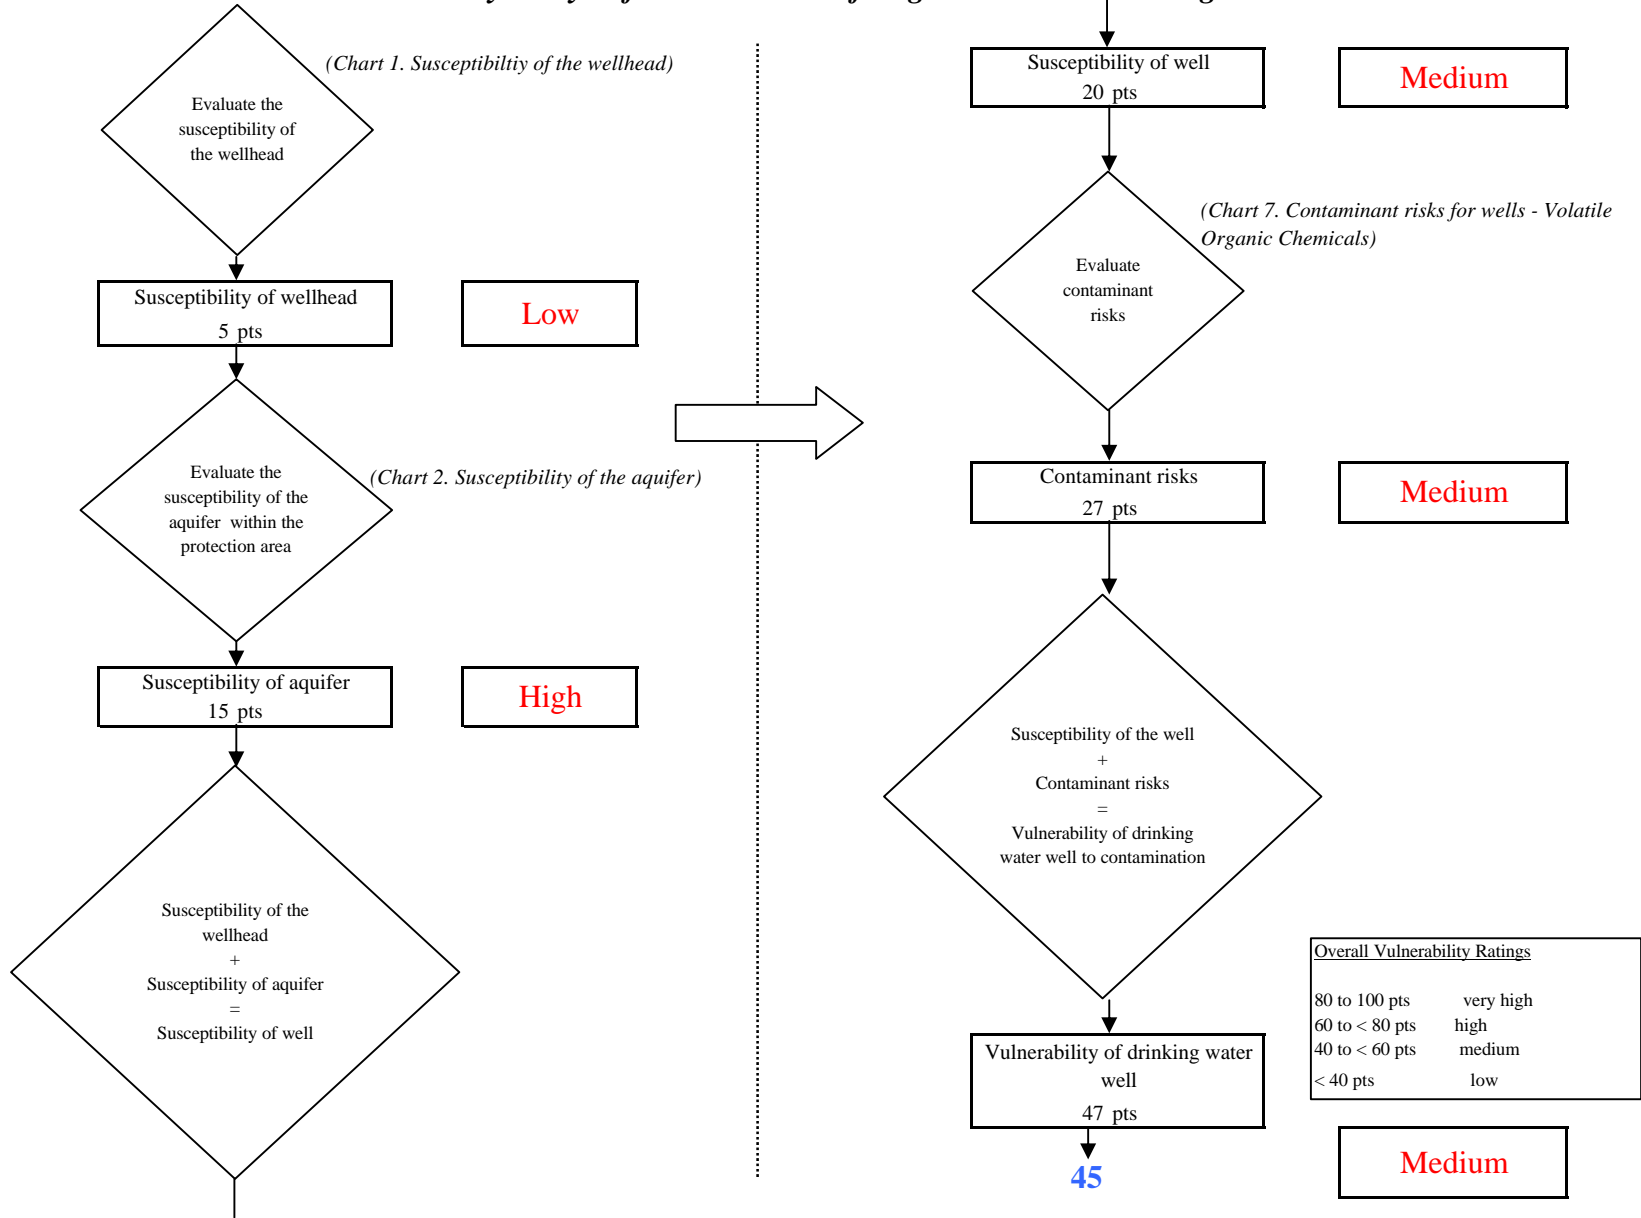
Chart 8. Vulnerability analysis for Lion's Club of Eagle River - Volatile Organic Chemicals
