# **Source Water Assessment**

# A Hydrogeologic Susceptibility and Vulnerability Assessment for Eagle River Missionary Baptist Church Drinking Water System, Eagle River, Alaska Eagle River Missionary Baptist Church # 218585

DRINKING WATER PROTECTION PROGRAM REPORT # 225 Alaska Department of Environmental Conservation

AUGUST 2002

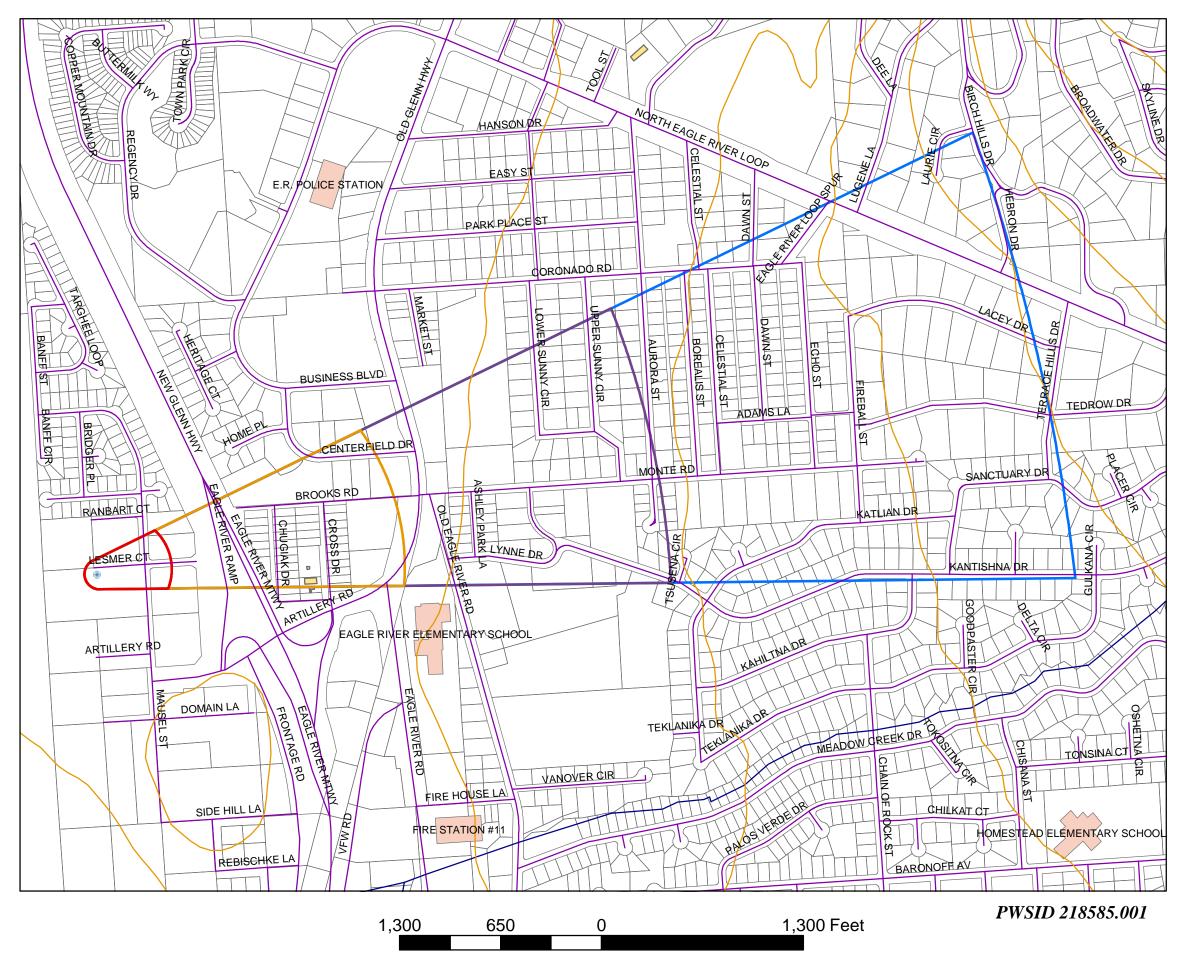
Eagle River Missionary Baptist Church Drinking Water Protection Area (Map 1)

# Drinking Water Protection Areas for Eagle River Missionary Baptist

The most probable area for contamination to reach the drinking water well is the area that contributes water to the well, the groundwater recharge area. This area is designated as the Drinking Water Protection Area (DWPA). Because a release of contaminants within the DWPA are most likely to impact the drinking water well, this area will serve as the focus for voluntary protection efforts.

An analytical calculation was used to determine the size and shape of the DWPA. The input parameters describing the attributes of the aquifer in this calculation were adopted from the U.S. Geological Survey (*Patrick, Brabets, and Glass, 1989*), and State of Alaska Department of Water Resources. Additional methods were also used to take into account any uncertainties in groundwater flow and aquifer characteristics to arrive at a meaningful DWPA (Please refer to the Guidance Manual for Class B Public Water Systems for additional information).

The DWPAs established for wells by the ADEC are separated into four zones. These zones correspond to differences in the time-of-travel (TOT) of the water moving through the aquifer to the well. The TOT for contaminants within the water varies and is dependent on the physical and chemical characteristics of each contaminant. The following is a summary of the four DWPA zones and the calculated TOT for each:

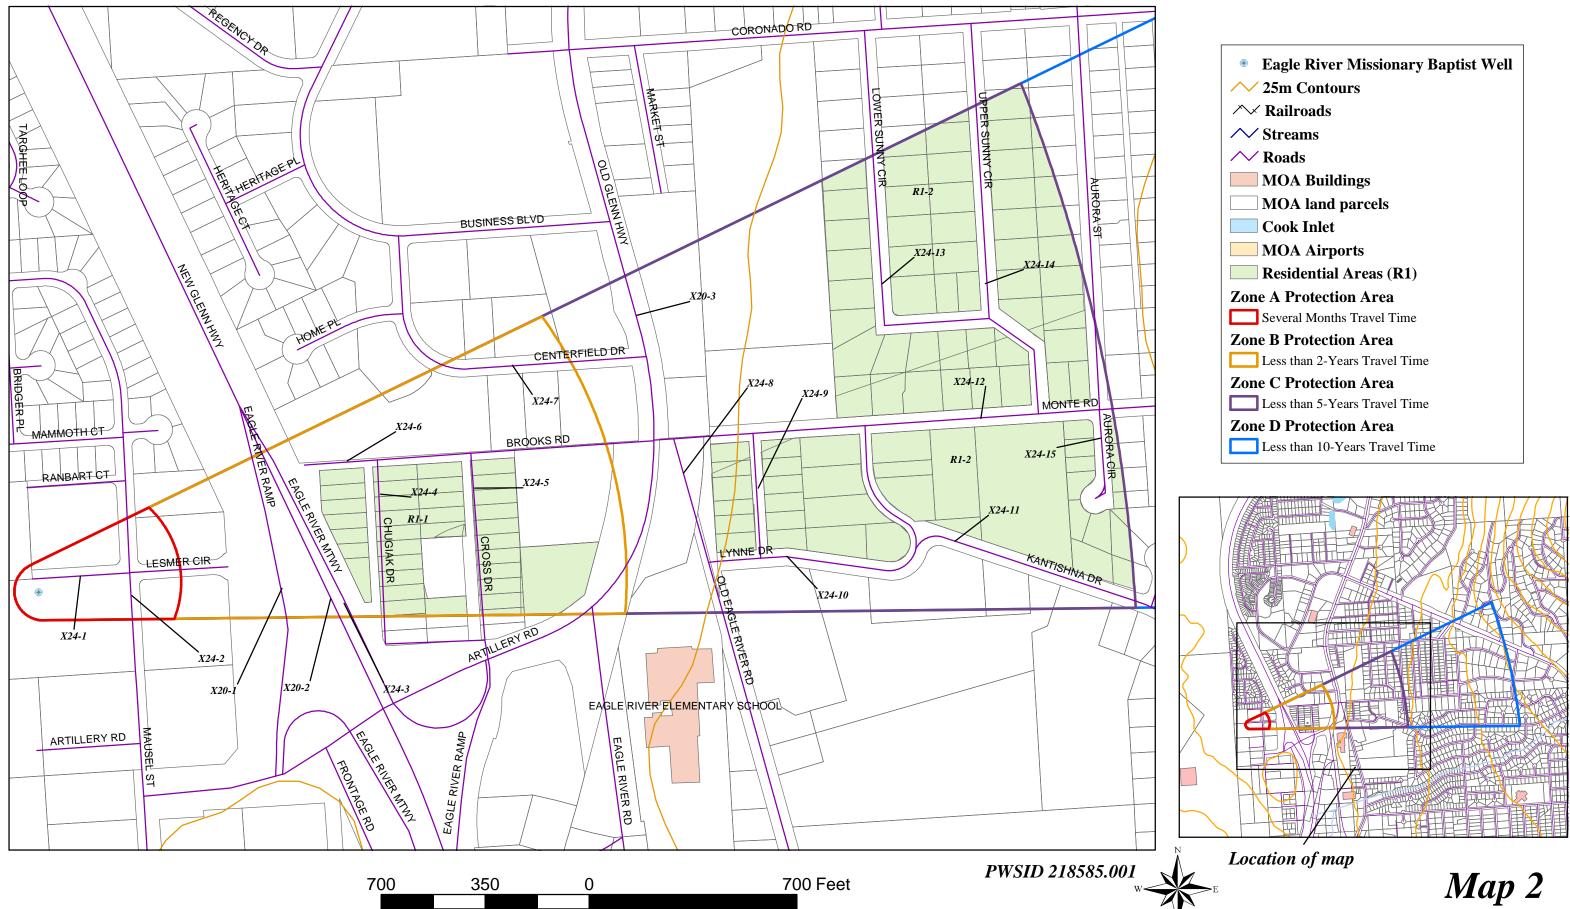
Eagle River Missionary Baptist Church Drinking Water Protection Area and Potential and Existing Contaminant Sources (Maps 2-3)

# Drinking Water Protection Areas for Eagle River Missionary Baptist and **Potential and Existing Sources of Contamination**

Inventoried potential sources of contamination within Zones A through Zone D were associated with residential and light industrial type activities. The sources are summarized in the tables in Appendix B.

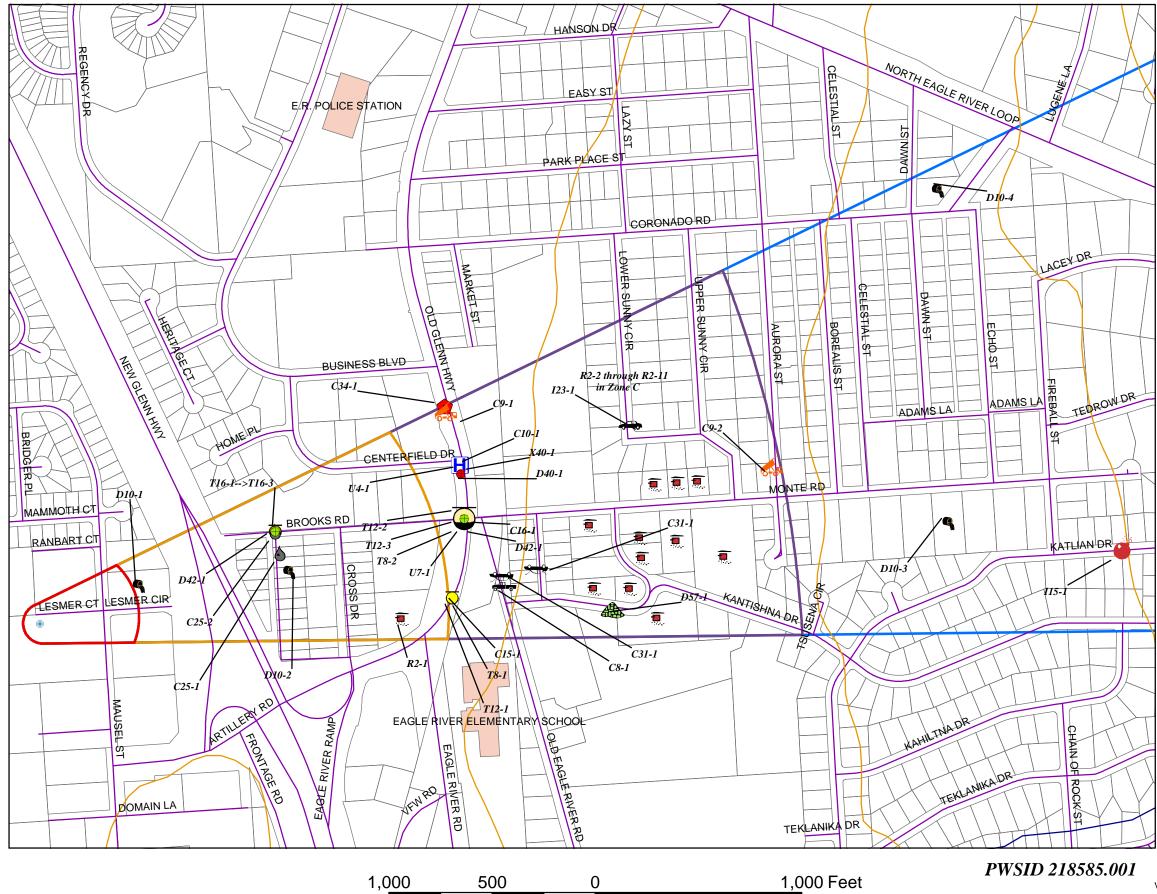
# Drinking Water Protection Areas for Eagle River Missionary Baptist and Potential and Existing Sources of Contamination
