Source Water Assessment

A Hydrogeologic Susceptibility and
Vulnerability Assessment for
Badger Road Baptist Church
Public Drinking Water System,
Fairbanks, Alaska
PWSID # 315146.001

DRINKING WATER PROTECTION REPORT 1795

January, 2009

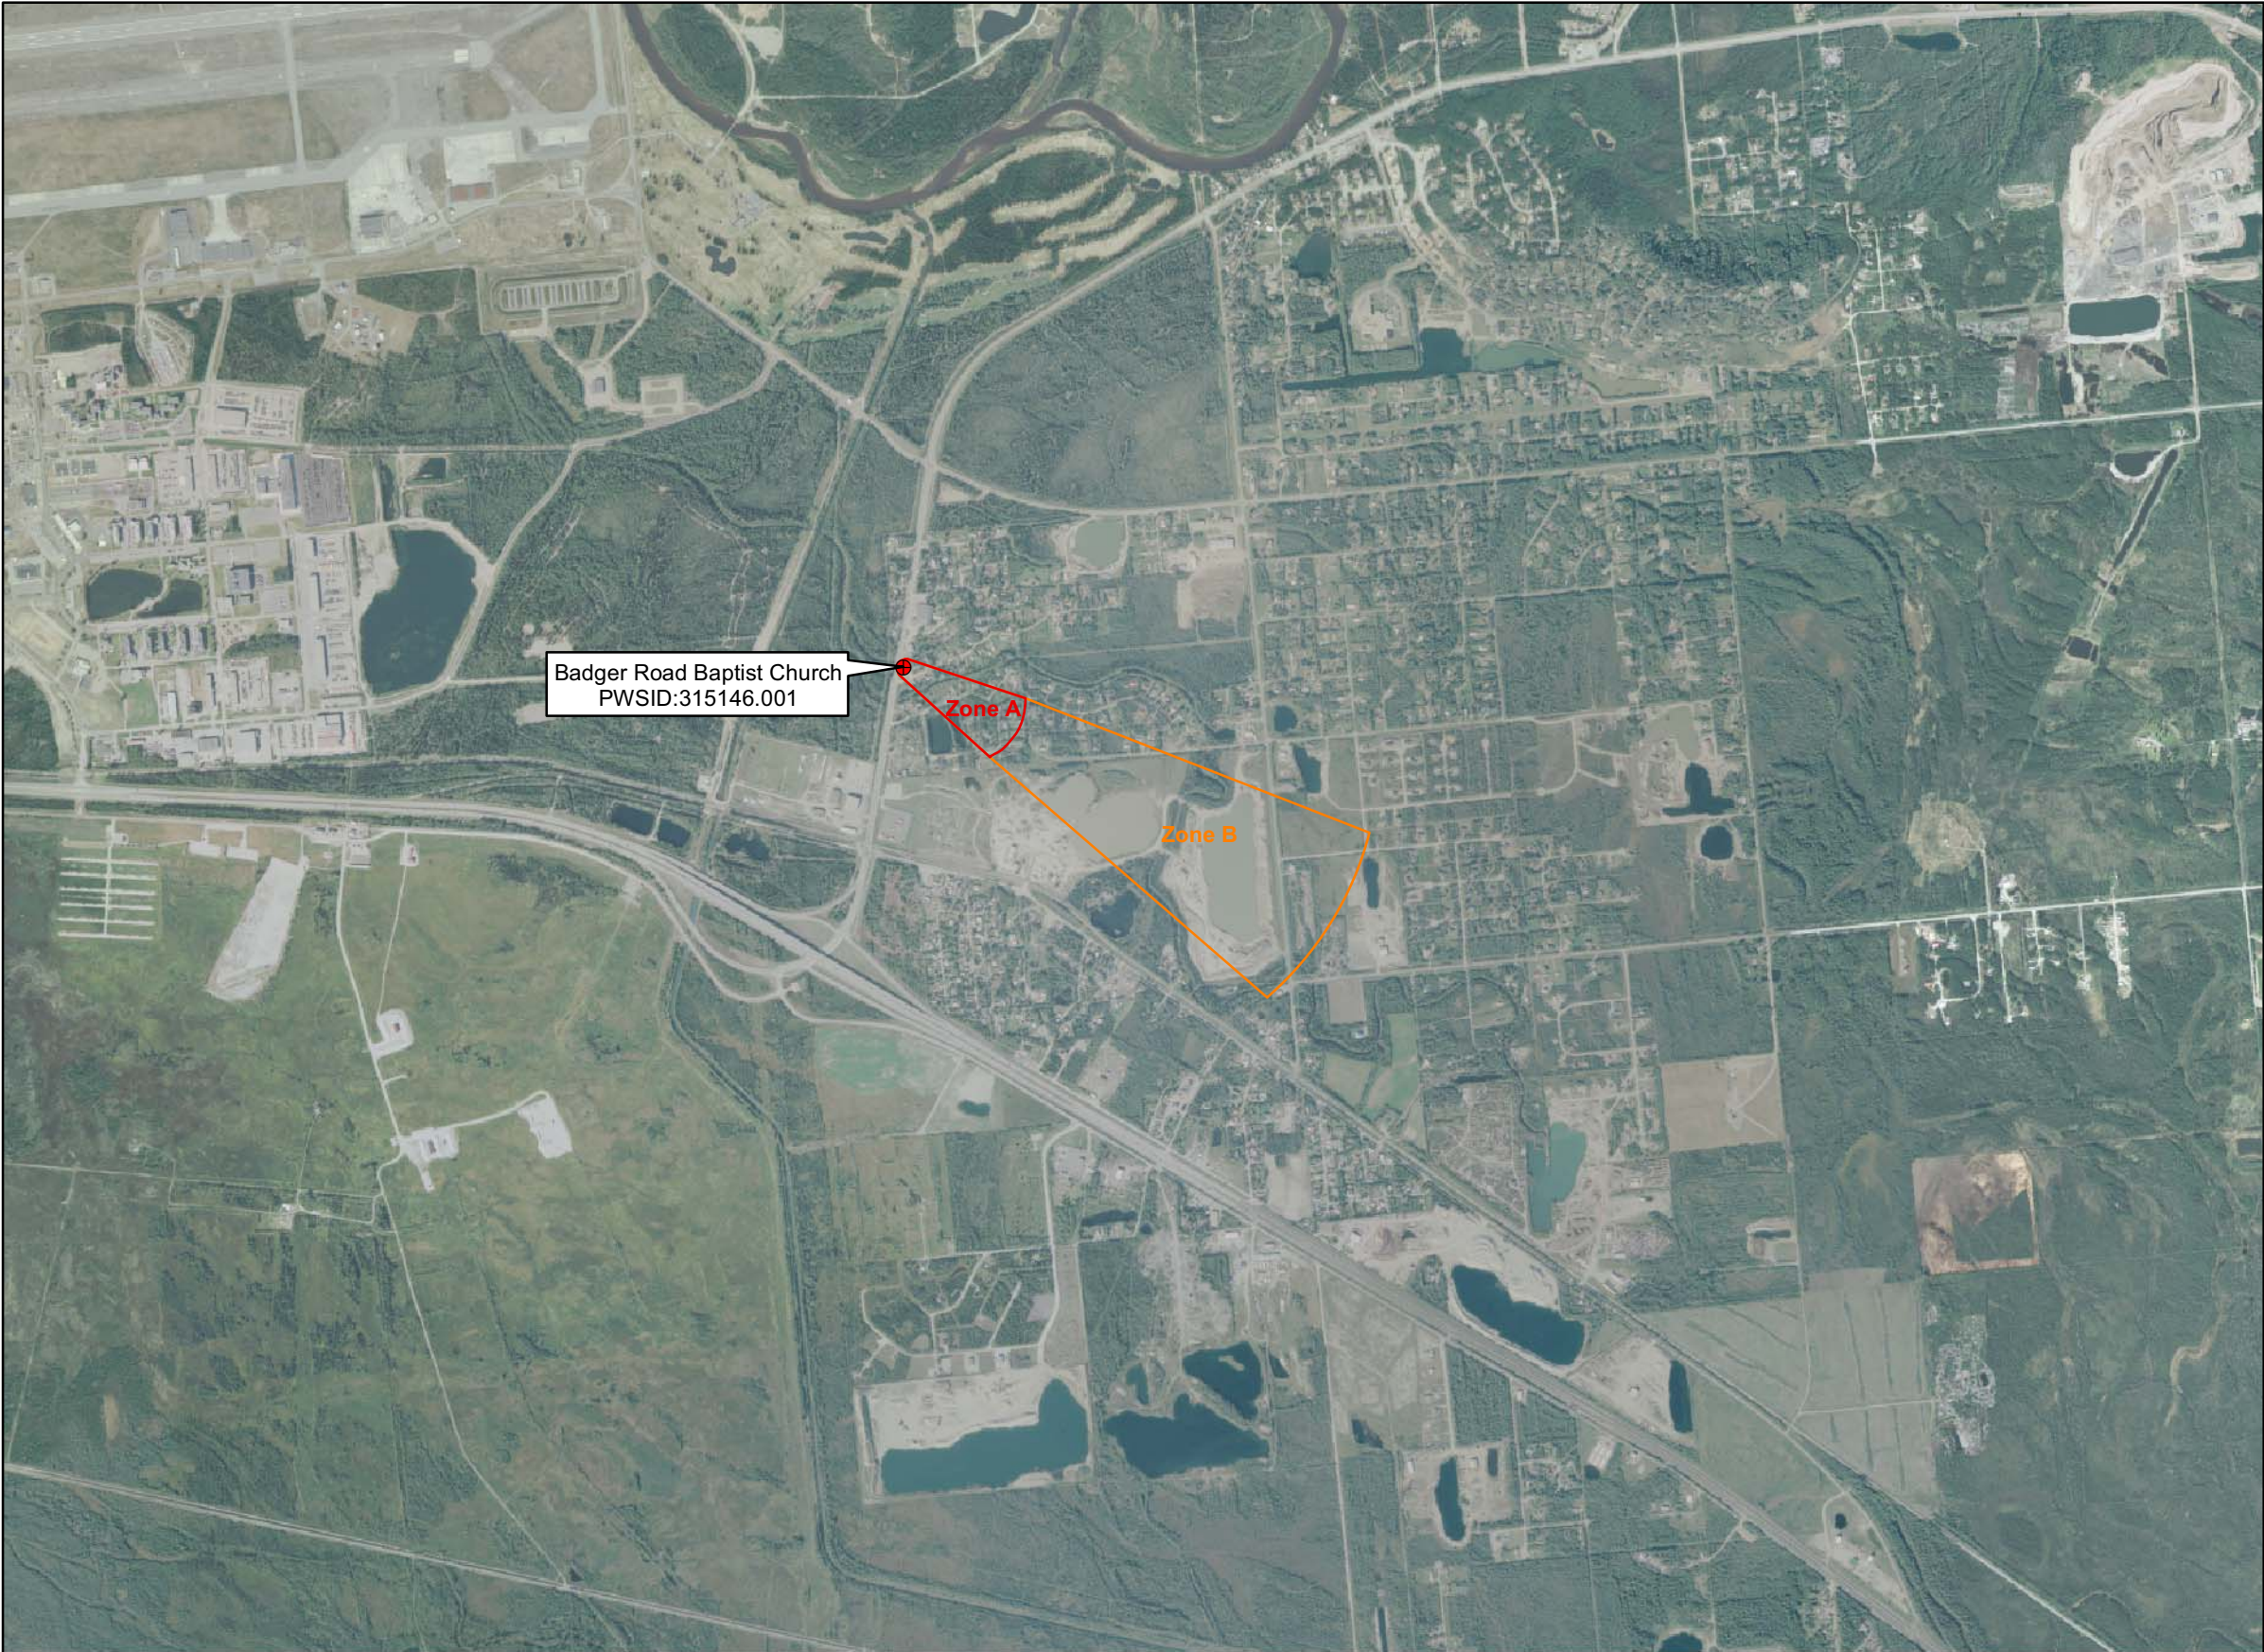
Appendix A Map A

The drinking water protection area for Badger Road Baptist Church was determined using an analytical calculation and includes Zones A and B (See Map A of Appendix A).

Public Water Well System for PWS #315146.001 Badger Road Baptist Church

The most probable area for contamination to reach the drinking water well is the drinking water protection area. The drinking water protection area is the area circling the well (the area influenced by pumping) and also the area upgradient of the well, usually forming a parabola shape. Because releases of contaminants within the protection area are most likely to impact the well, this area will serve as the focus for voluntary protection efforts.

The protection areas established for wells by the DEC are usually separated into two zones, limited by the watershed. These zones correspond to differences in the time-of-travel (TOT) of the water moving through the aquifer to the well. An analytical calculation was used to determine the size and shape of the protection area.
