Source Water Assessment

A Hydrogeologic Susceptibility and
Vulnerability Assessment for
Badger Road Trade Center Drinking Water
System,
Fairbanks area, Alaska

PWSID # 310625

July 2003

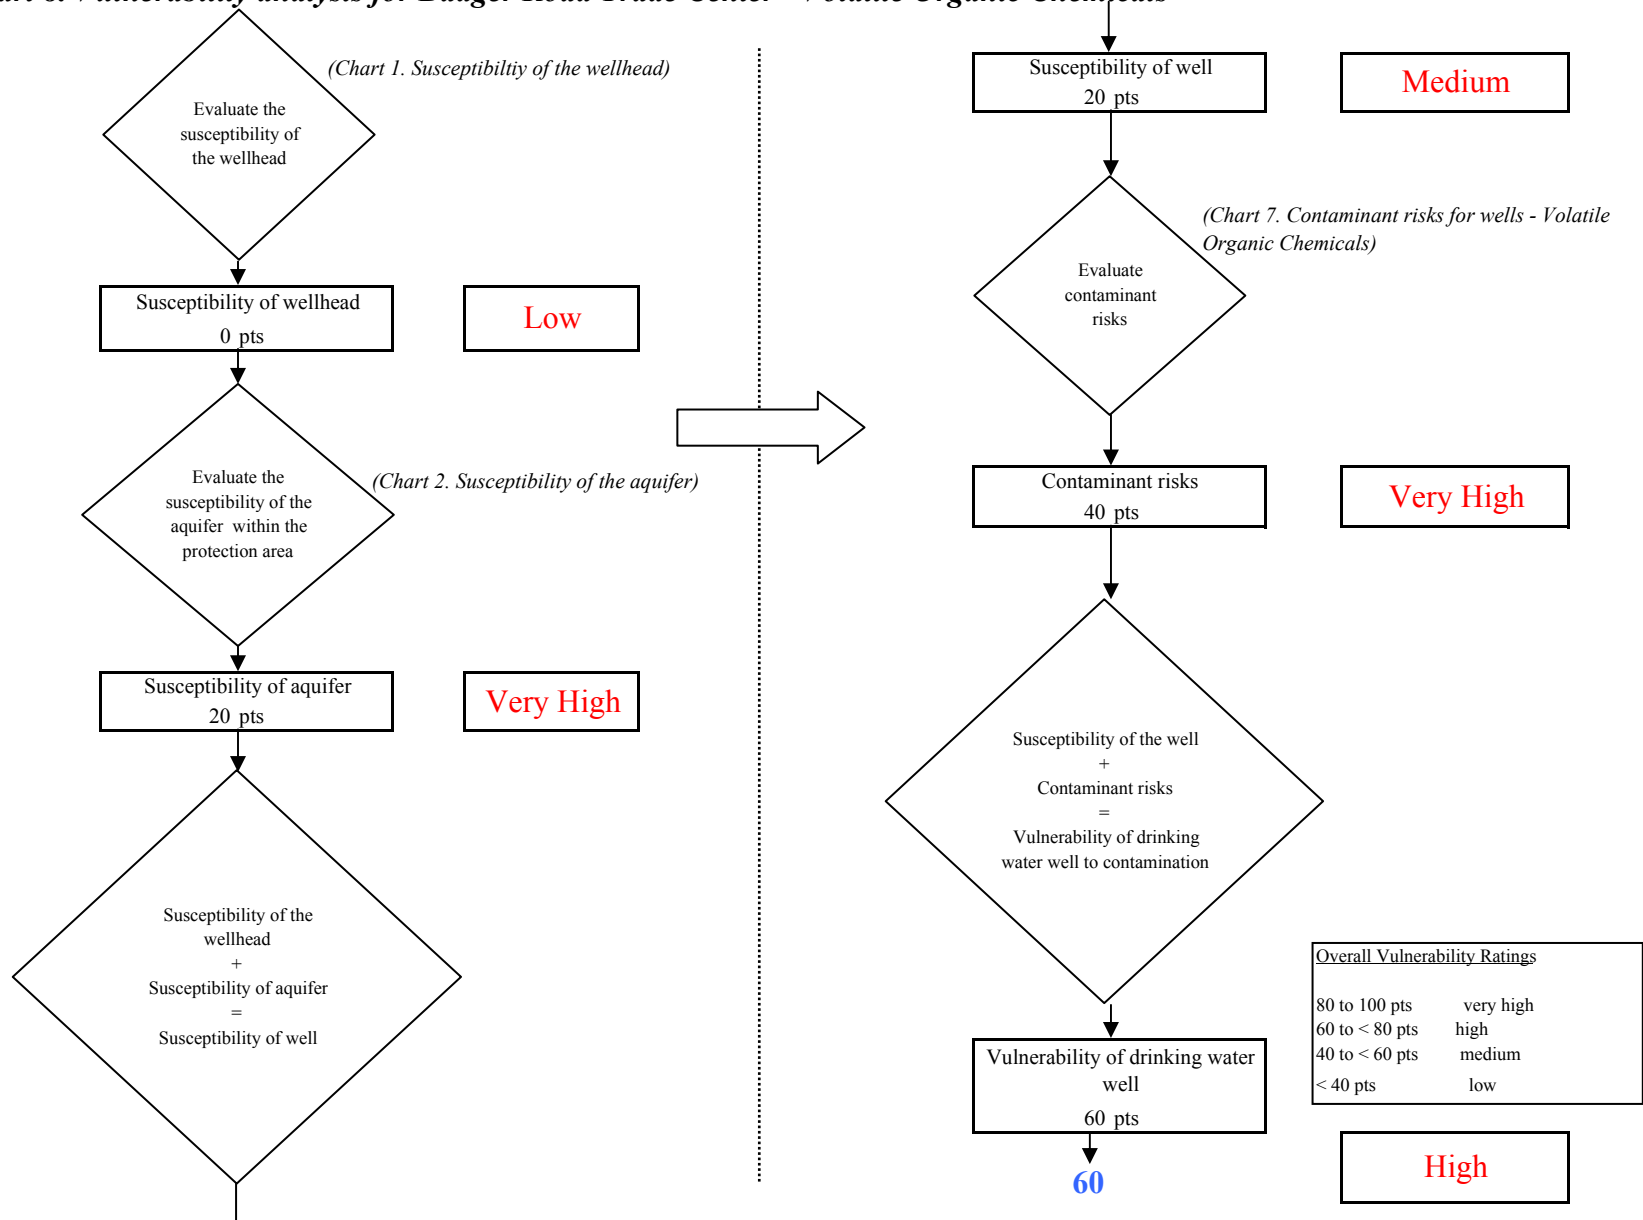
Chart 8. Vulnerability analysis for Badger Road Trade Center - Volatile Organic Chemicals

Volatile Organic Chemicals have not been sampled for in the Badger Road Trade Center public water system. After combining the contaminant risk for volatile organic chemicals with the natural susceptibility of the well, the overall vulnerability of the well to contamination is high.
