Source Water Assessment

A Hydrogeologic Susceptibility and
Vulnerability Assessment for
Chena Hot Springs Resort Drinking Water
System,
Fairbanks Area, Alaska

PWSID 310146

DRINKING WATER PROTECTION PROGRAM REPORT Report 1494
Alaska Department of Environmental Conservation

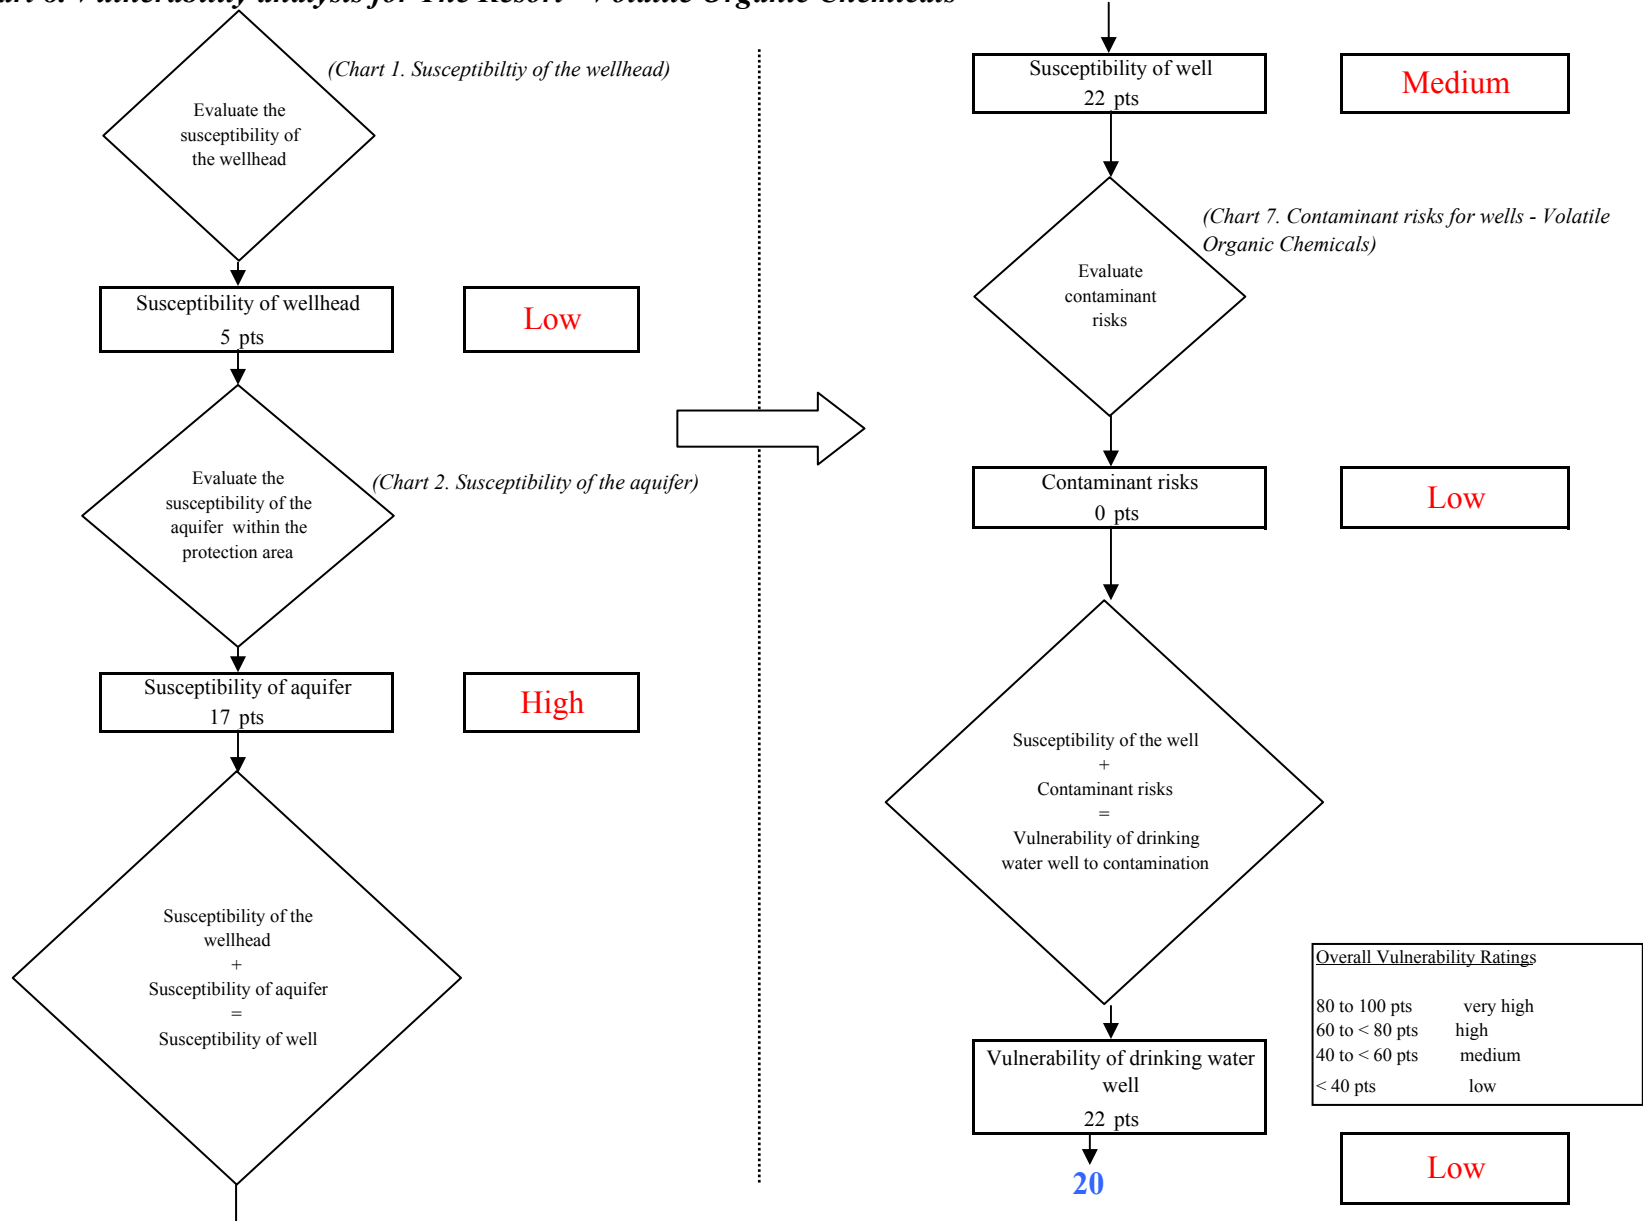
Chart 8. Vulnerability analysis for The Resort - Volatile Organic Chemicals

Volatile Organic Chemicals have not been sampled for in this water system. After combining the contaminant risk for volatile organic chemicals with the natural susceptibility of the well, the overall vulnerability of the well to contamination is low.
