Source Water Assessment

A Hydrogeologic Susceptibility and
Vulnerability Assessment for
Crossroads Baptist Church Drinking Water
System,

Fairbanks area, Alaska

PWSID # 314478

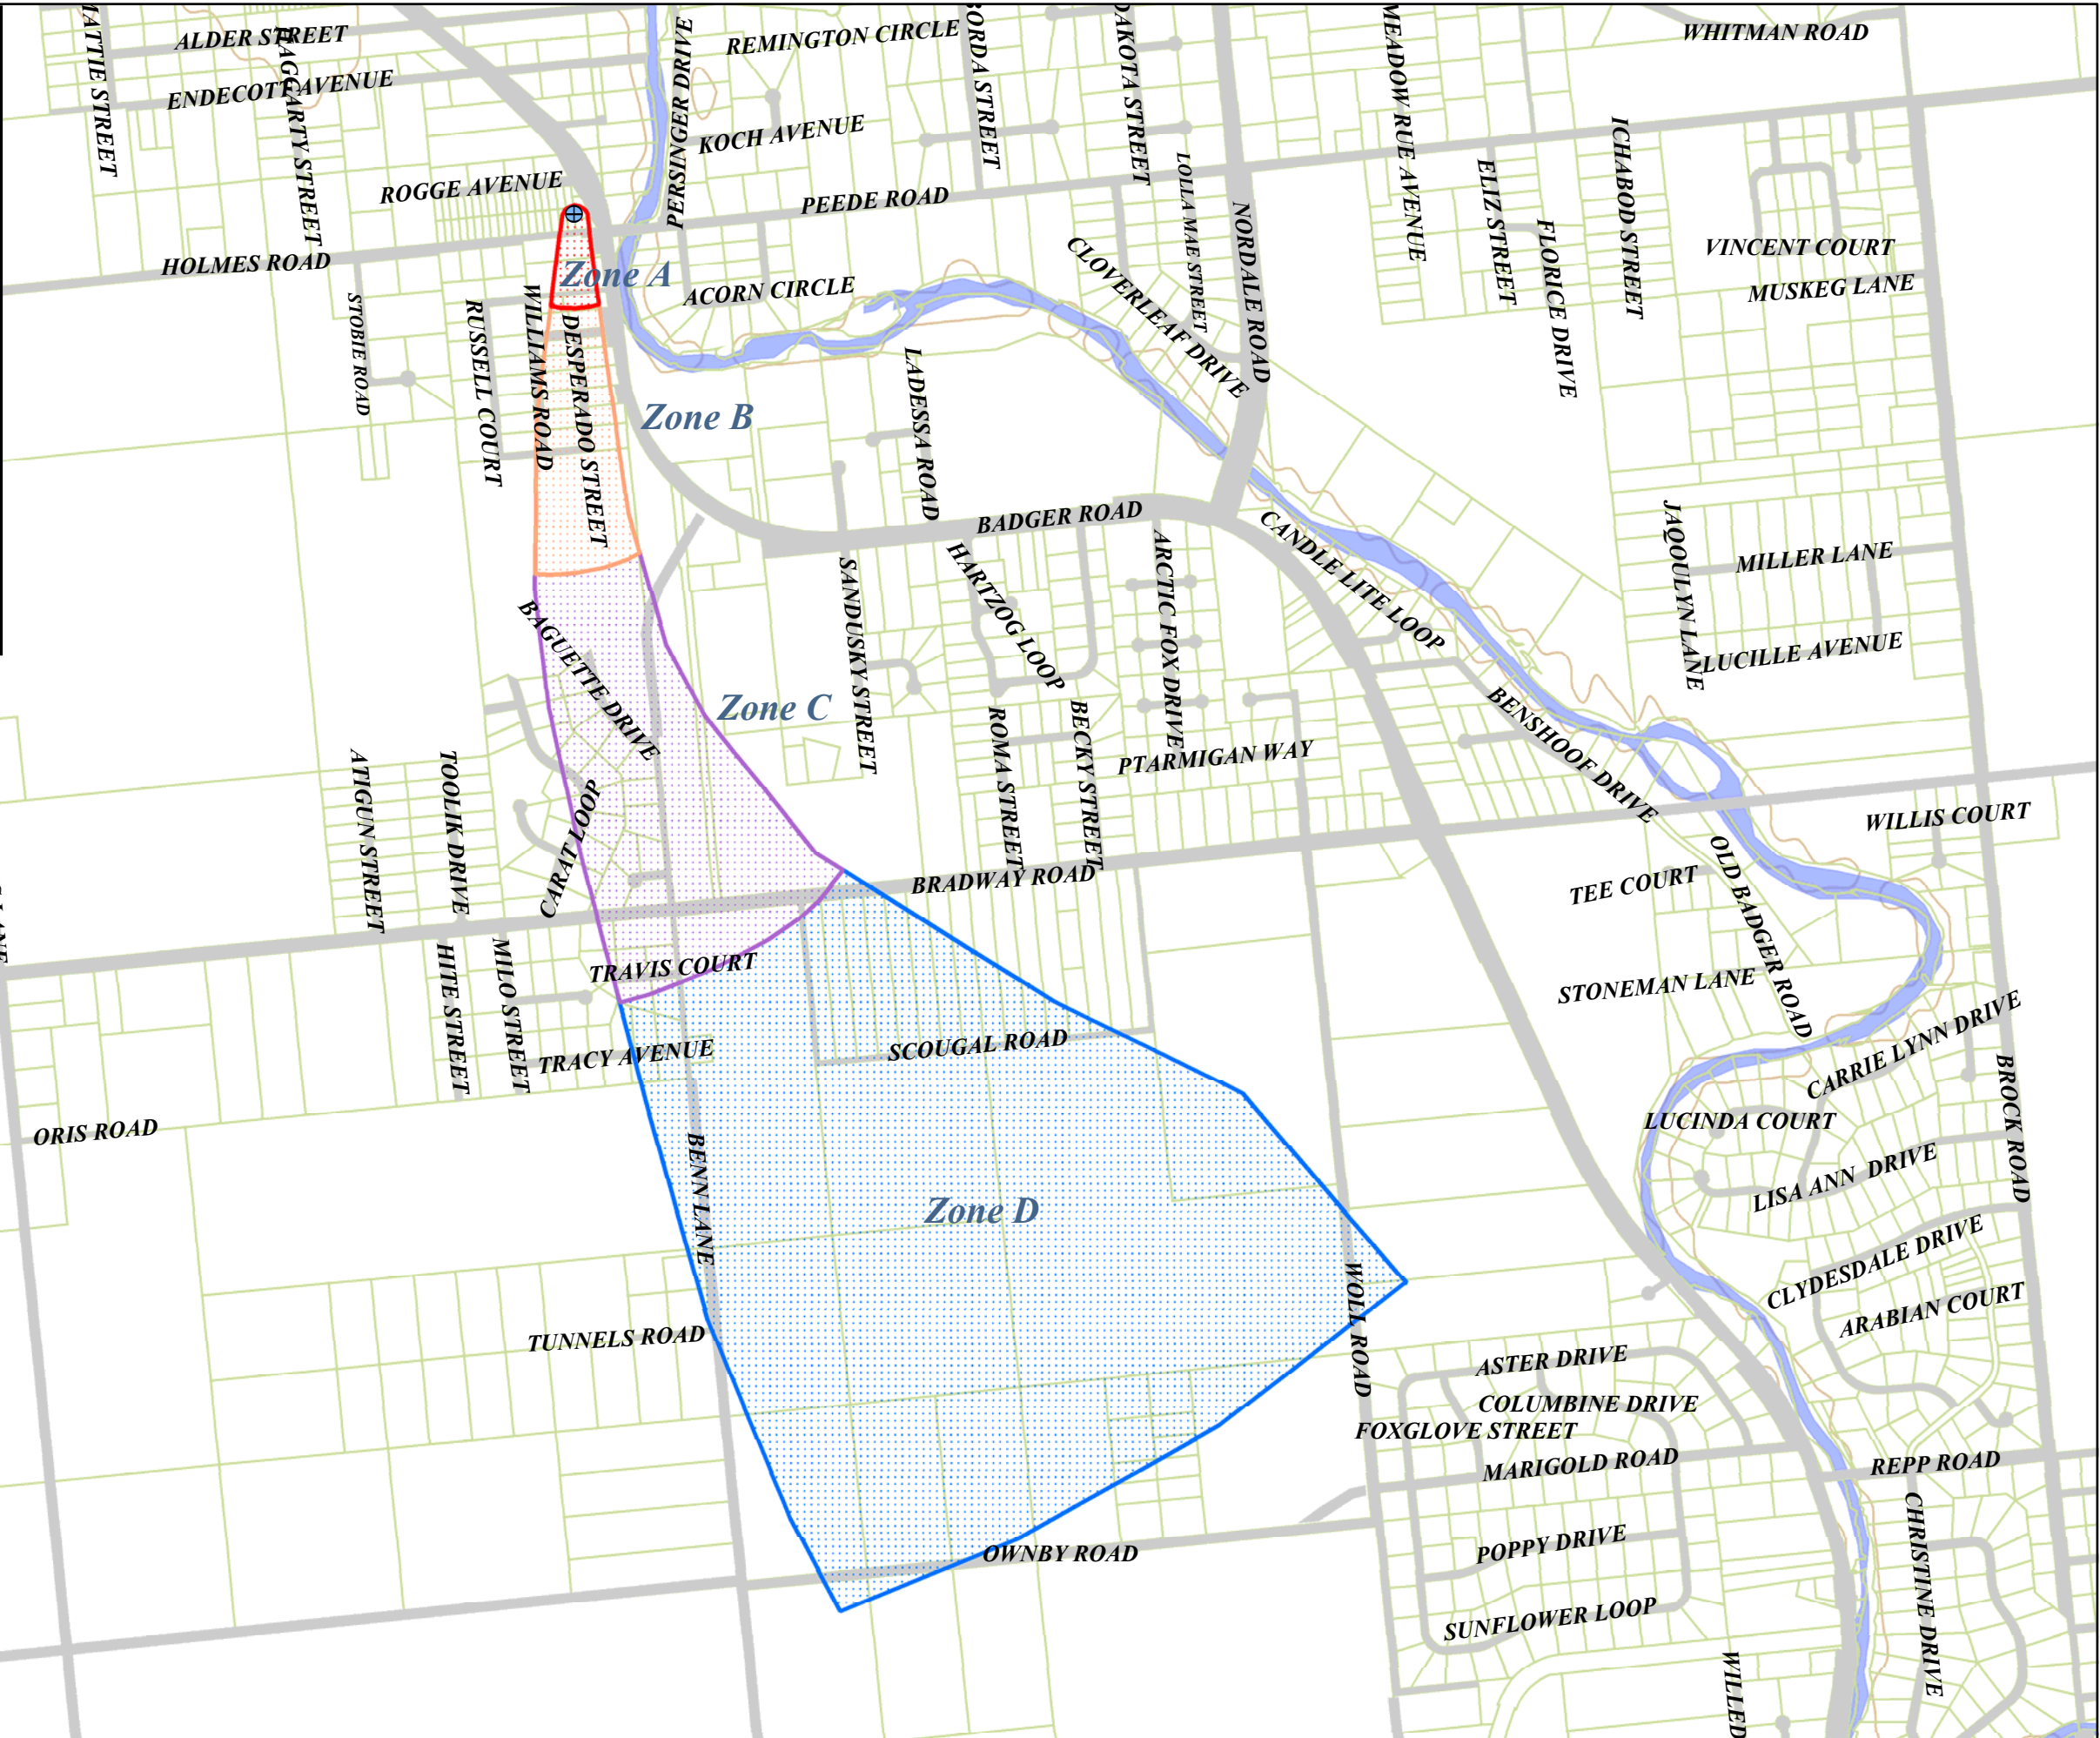
Map 1. Crossroads Baptist Church Drinking Water Protection Area

The drinking water protection area outlined for the Crossroads Baptist Church on Map 1 of Appendix A will serve as the focus for voluntary protection efforts.

- Crossroads Baptist Church well
- Zone A Several months travel time
- Zone B Less than 2 years travel time
- Zone C Less than 5 years travel time
- Zone D Less than 10 years travel time
- Roads
- Parcels
- Surface water

The protection areas established for wells are usually separated into four zones, limited by the watershed. These zones correspond to times-of-travel (TOT) of the water moving through the aquifer to the well (plus the factor of safety).

Zone	Definition
A	¼ the distance for the 2-yr. time-of-travel
B	Less than 2 years time-of-travel
C	Less than 5 years time-of-travel
D	Less than 10 years time-of-travel

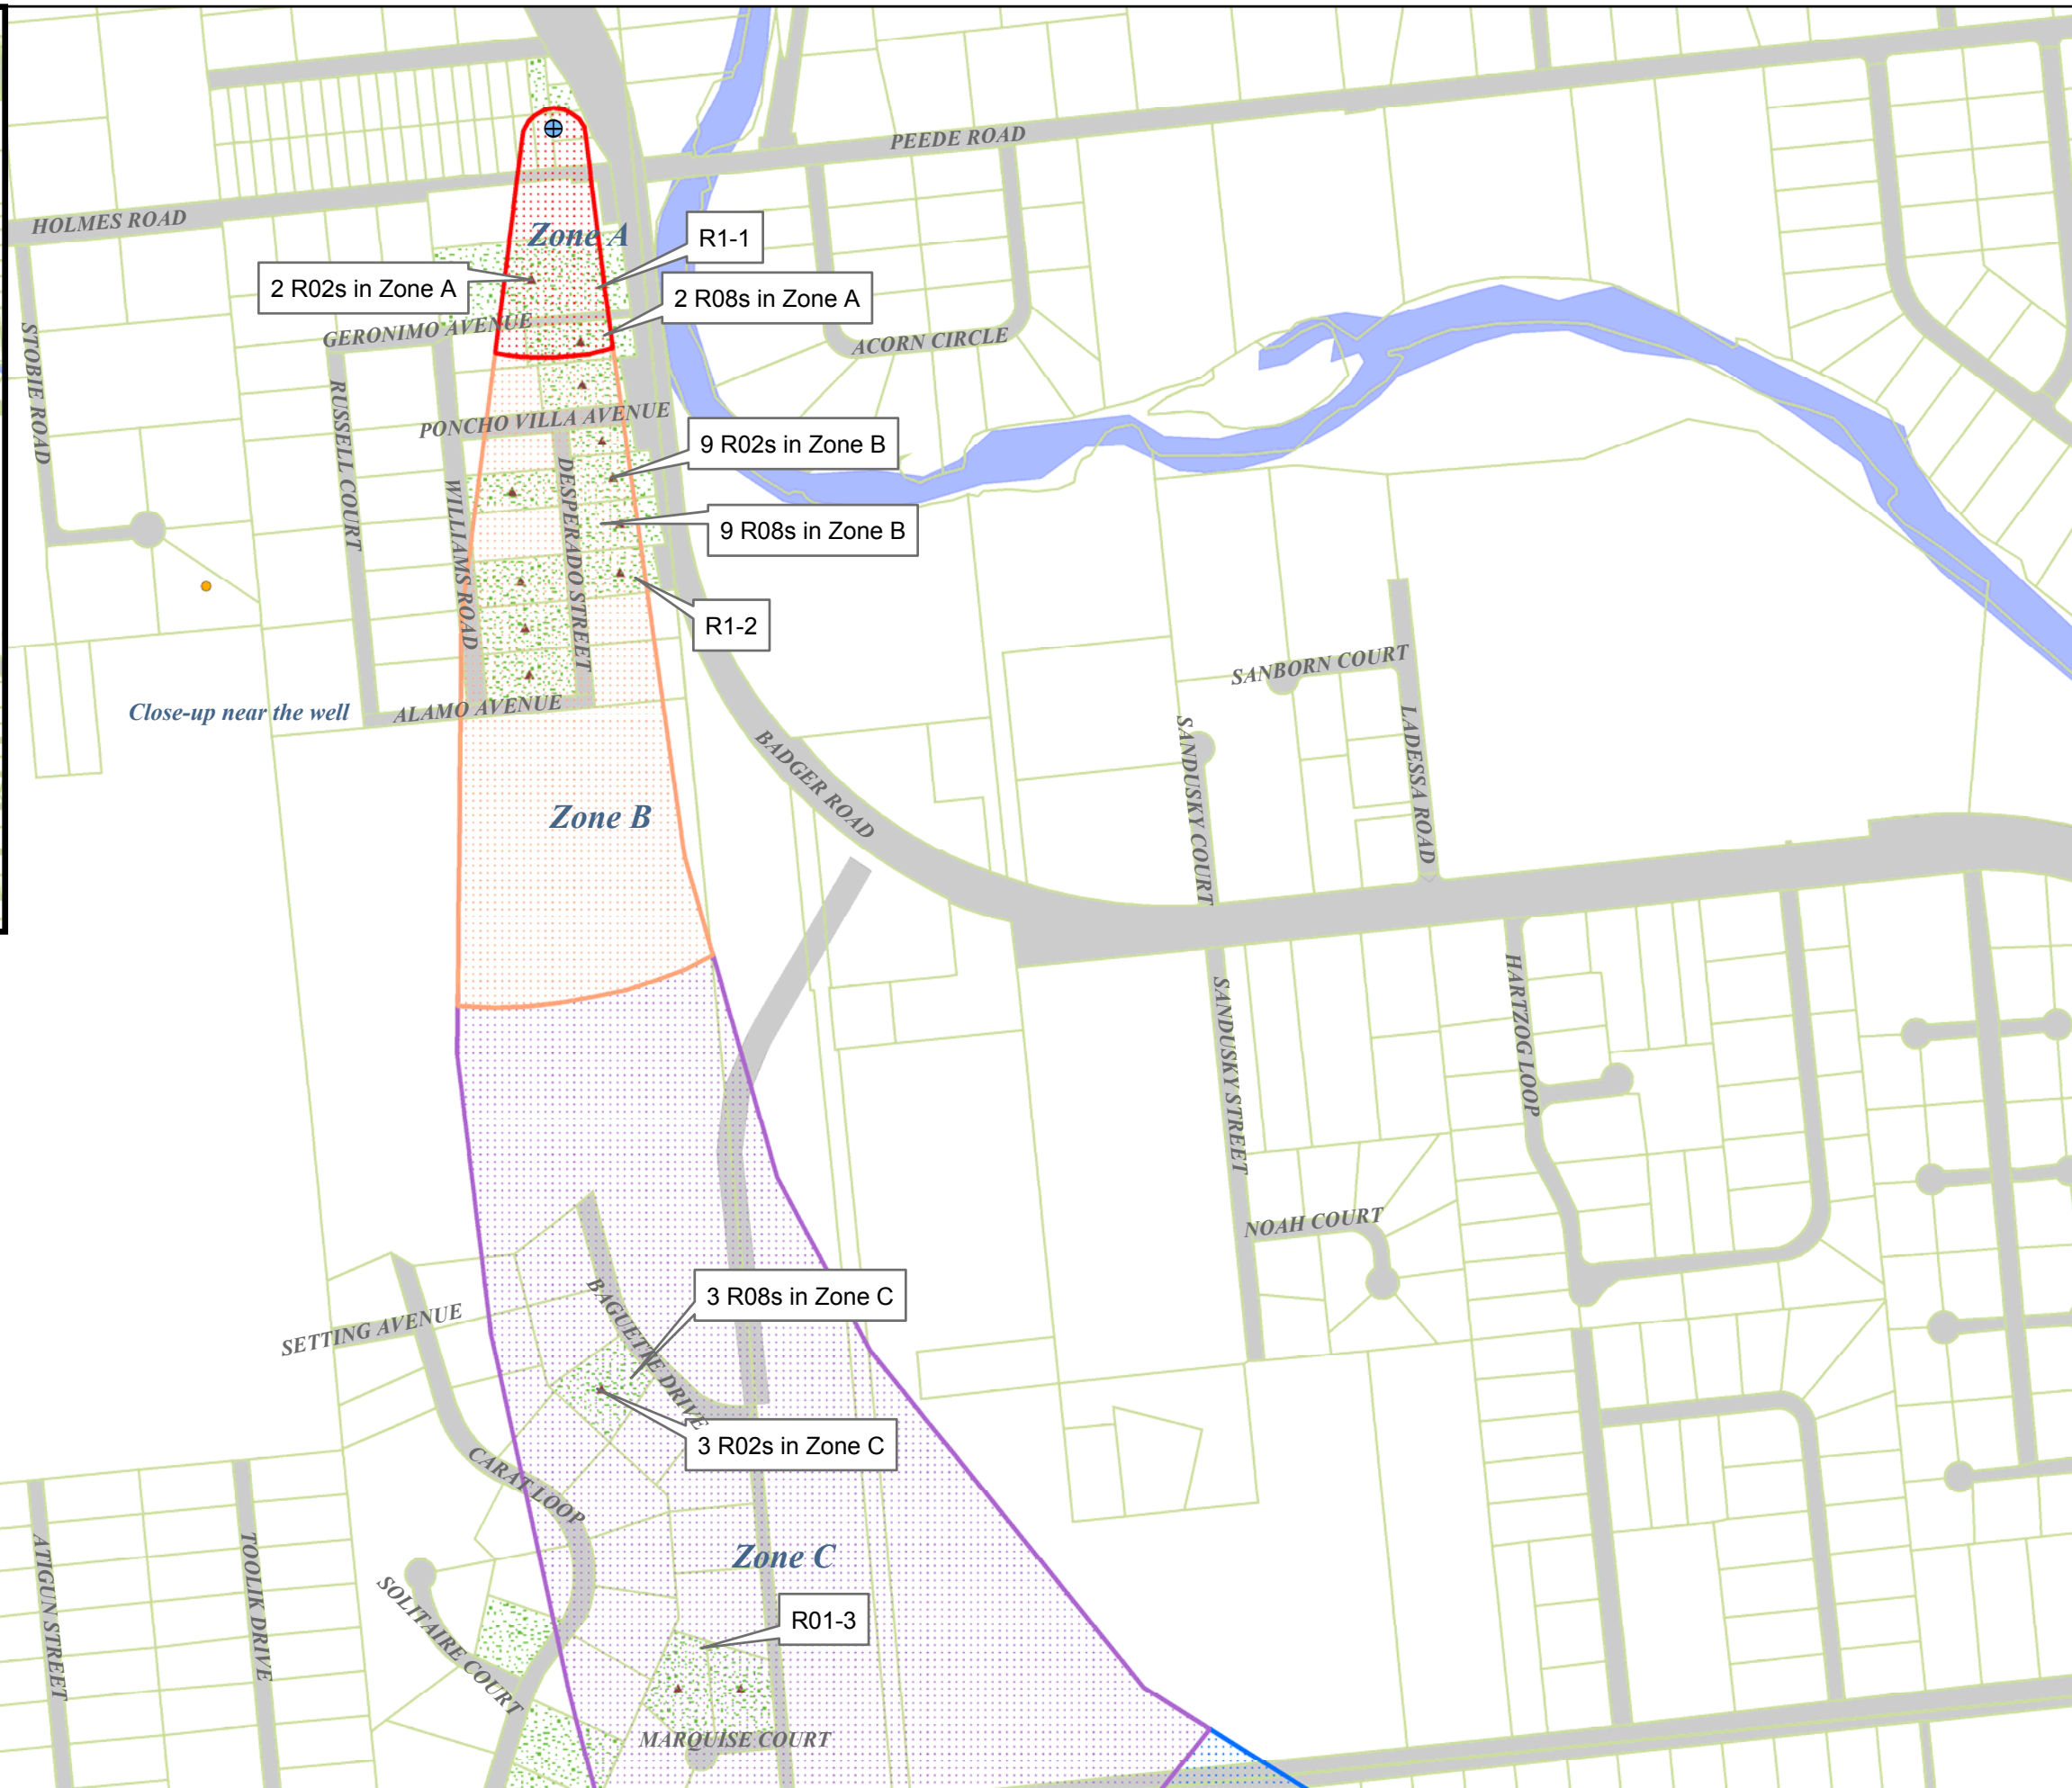
Crossroads Baptist Church Drinking Water Protection Area and Potential and Existing Contaminant Sources (Map 2)

The sources are displayed on Map 2 of Appendix C and summarized in Table 1 of Appendix B.

- ⊕ Crossroads Baptist Church well
- Zone A Several months travel time
- Zone B Less than 2 years travel time
- Zone C Less than 5 years travel time
- Zone D Less than 10 years travel time
- Parcels
- Roads (X20 or X24)
- ▲ Residential septic system (R02)
- Residential area (R01)
- Residential heating oil tank (R08)
- Surface water

Contaminant Source Type	Contaminant Source ID	CS ID tag	Zone	Map Number	Comments
Residential Areas	R01	R01-1	A	2	Approximately 25 acres of residential area in Zone A
Septic systems (serves one single-family home)	R02		A	2	Assumed 2 septics based on number of tax parcels designated as residential
Tanks, heating oil, residential (above ground)	R08		A	2	Assumed 2 tanks based on number of tax parcels designated as residential
Highways and roads, paved (cement or asphalt)	X20		A	2	Badger Road
Residential Areas	R01	R01-2	B	2	Approximately 75 acres of residential area in Zone B
Septic systems (serves one single-family home)	R02		B	2	Assumed 9 septics based on number of tax parcels designated as residential
Tanks, heating oil, residential (above ground)	R08		B	2	Assumed 9 tanks based on number of tax parcels designated as residential
Highways and roads, paved (cement or asphalt)	X20		B	2	Poncho Villa Avenue, Desperado Street, Alamo Avenue

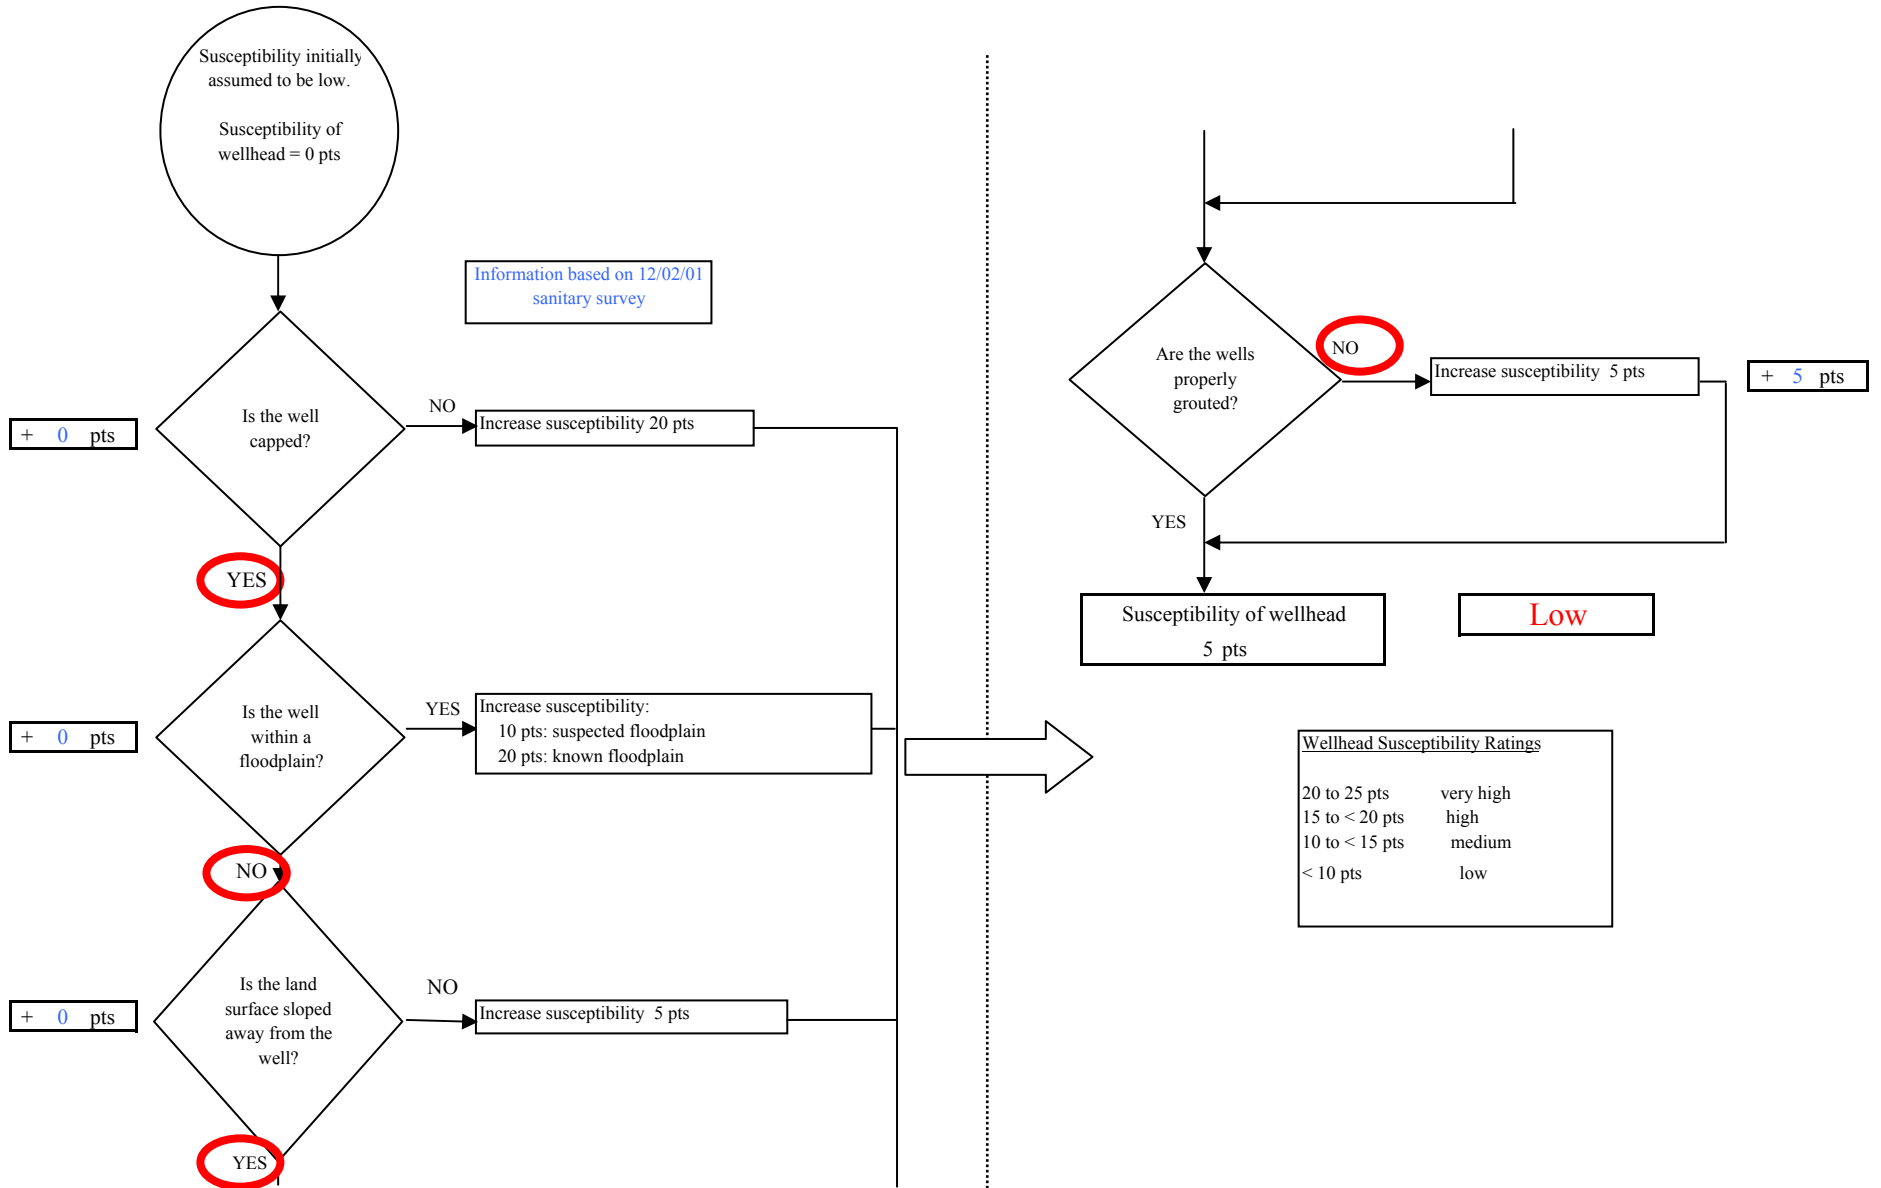
Chart 1. Susceptibility of the wellhead - Crossroads Baptist Church

The wellhead for the Crossroads Baptist Church received a Low Susceptibility rating. According to the 12/02/01 Sanitary Survey, the well is capped with a sanitary seal, the well is not within a floodplain, and the land surface is sloped away from the well. However, the well is not grouted. Grouting helps to prevent potential contaminants from traveling down the well casing.

Score	Rating
Susceptibility of the Wellhead	5	Low
Susceptibility of the Aquifer	19	High
Natural Susceptibility	24	Medium

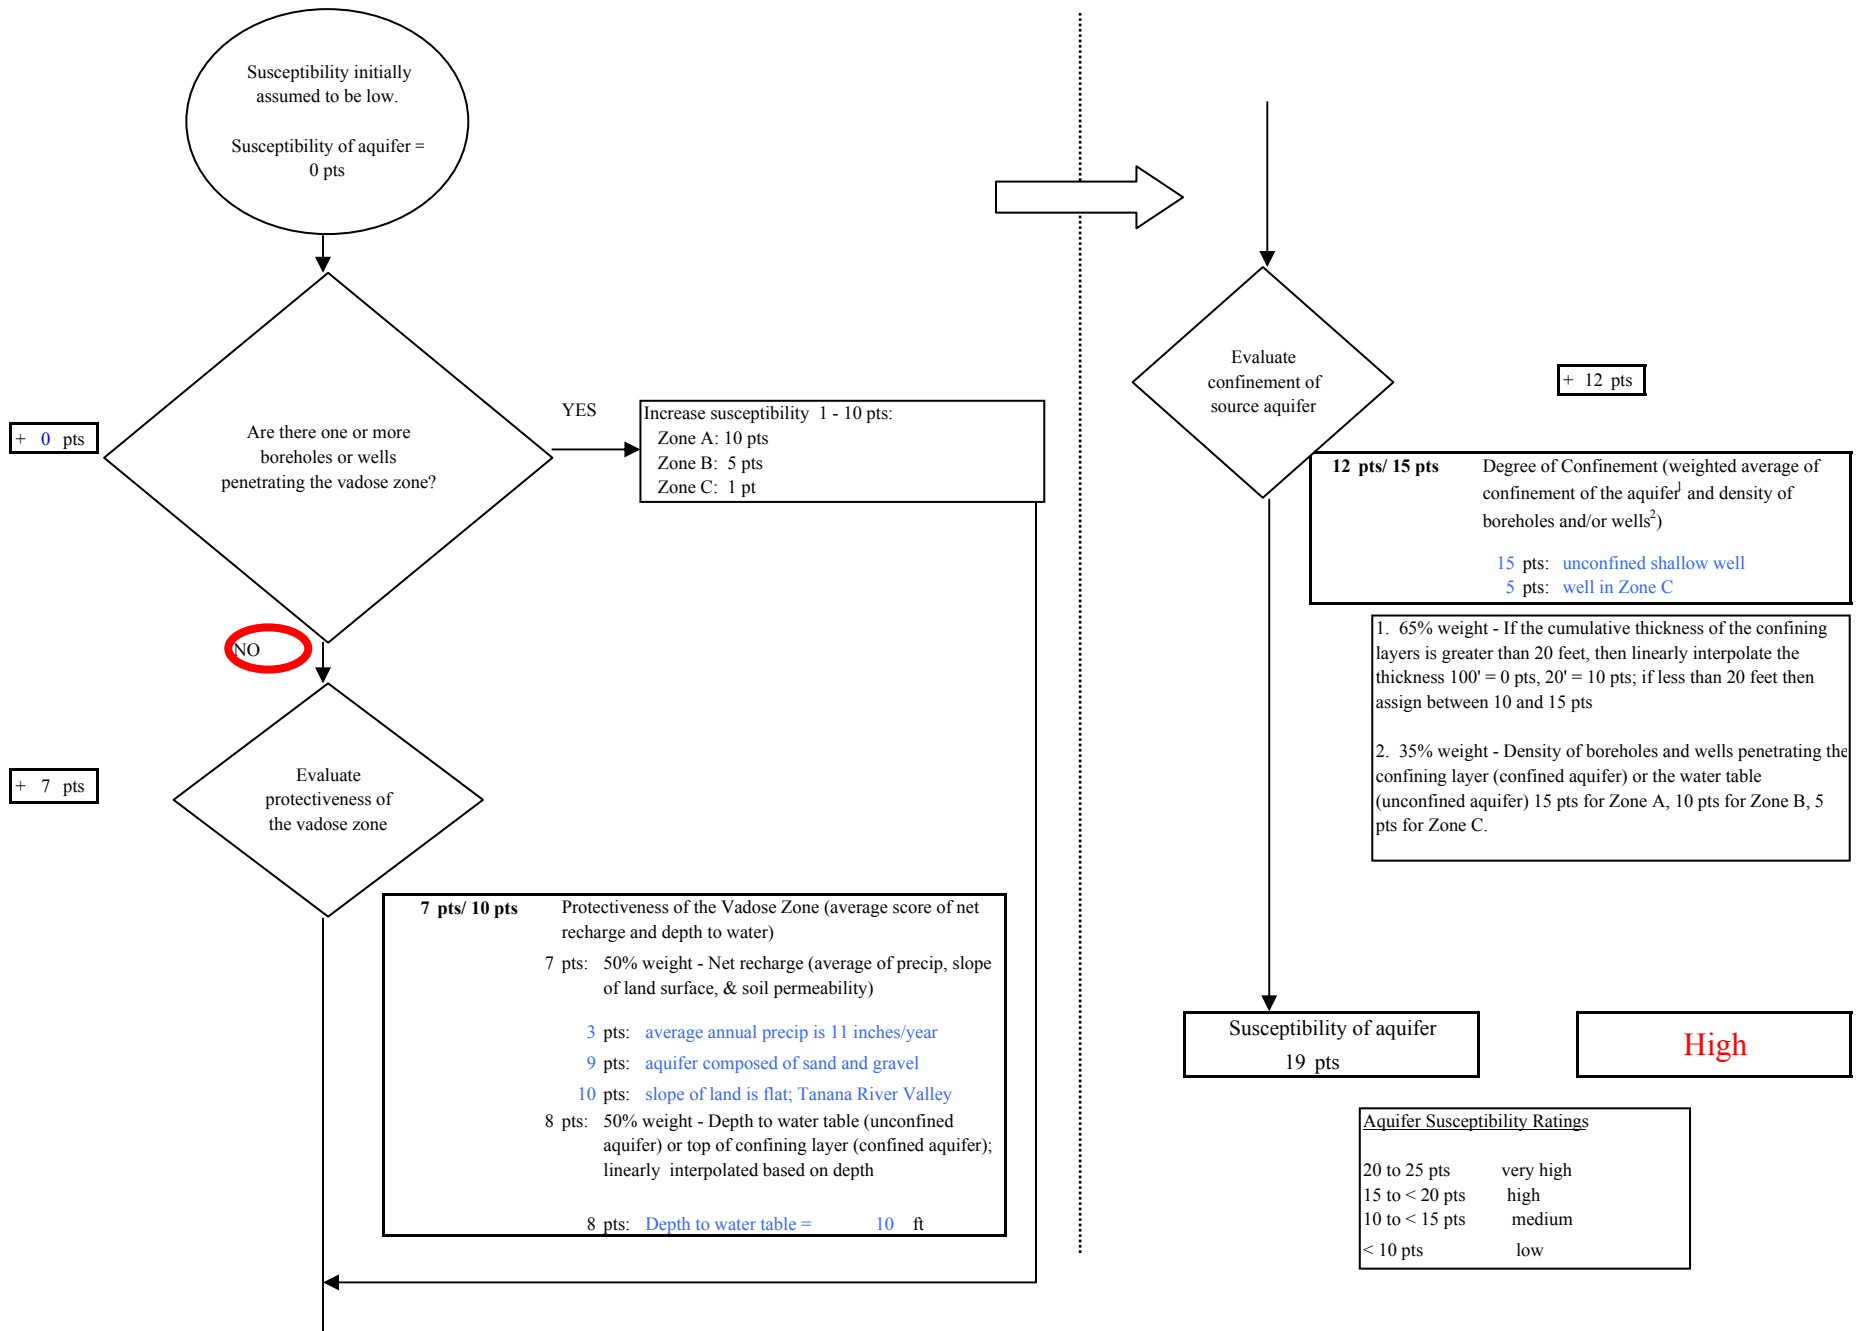
Chart 2. Susceptibility of the aquifer - Crossroads Baptist Church

The aquifer the Crossroads Baptist Church well is completed in received a High Susceptibility rating. The highly transmissive aquifer material and the high water table in the area allow contaminants to travel downward from the surface with the precipitation and surface water runoff. Table 2 summarizes the Susceptibility scores and ratings for Crossroads Baptist Church.

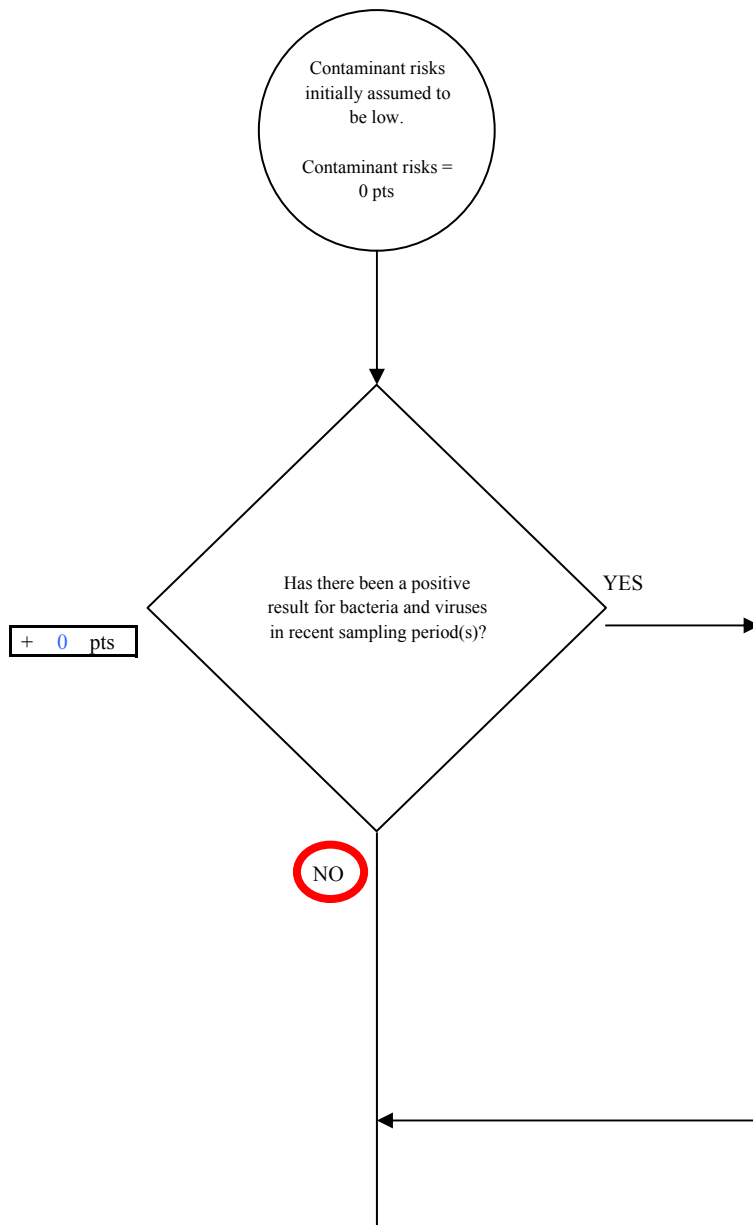
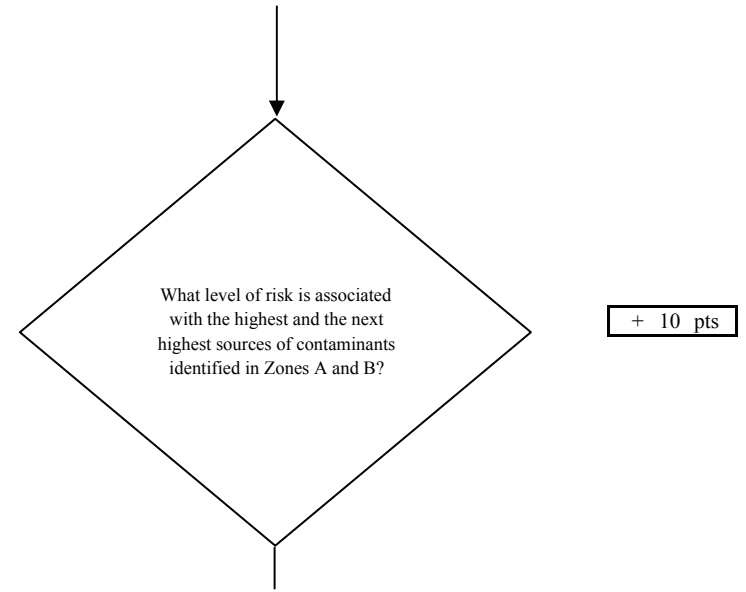
Chart 3. Contaminant risks for Crossroads Baptist Church - Bacteria & Viruses

Risk Rankings for Contaminant Sources Identified in Zones A and B			
	Zone A	Zone B	Total
Very High(s)	0	0	0
High(s)	0	0	0
Medium(s)	0	0	0
Low(s)	4	3	7

Matrix Score 10

Category	Score	Rating
Bacteria and Viruses	10	Low
Nitrates and/or Nitrites	10	Low
Volatile Organic Chemicals	30	High

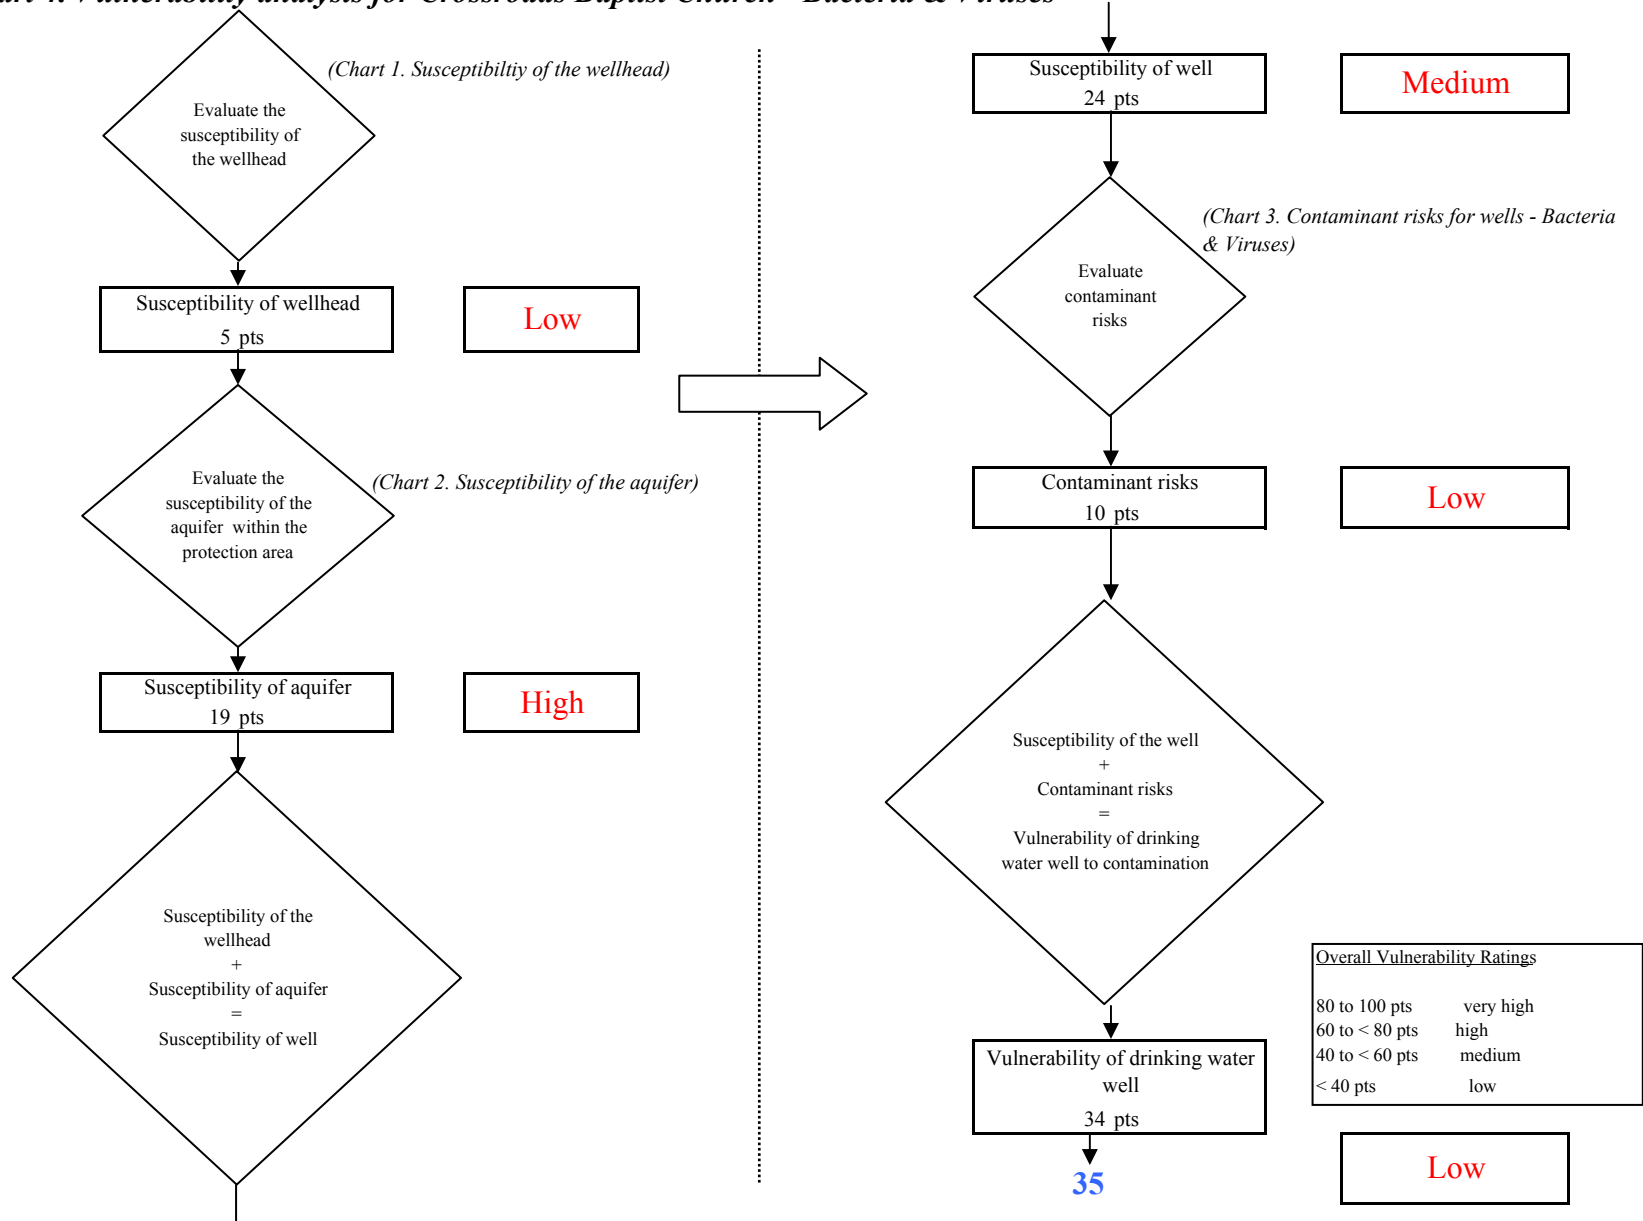
Chart 4. Vulnerability analysis for Crossroads Baptist Church - Bacteria & Viruses

After combining the contaminant risk for bacteria and viruses with the natural susceptibility of the well, the overall vulnerability of the well to contamination is Low.

Category	Score	Rating
Bacteria and Viruses	35	Low
Nitrates and Nitrites	35	Low
Volatile Organic Chemicals	55	Medium

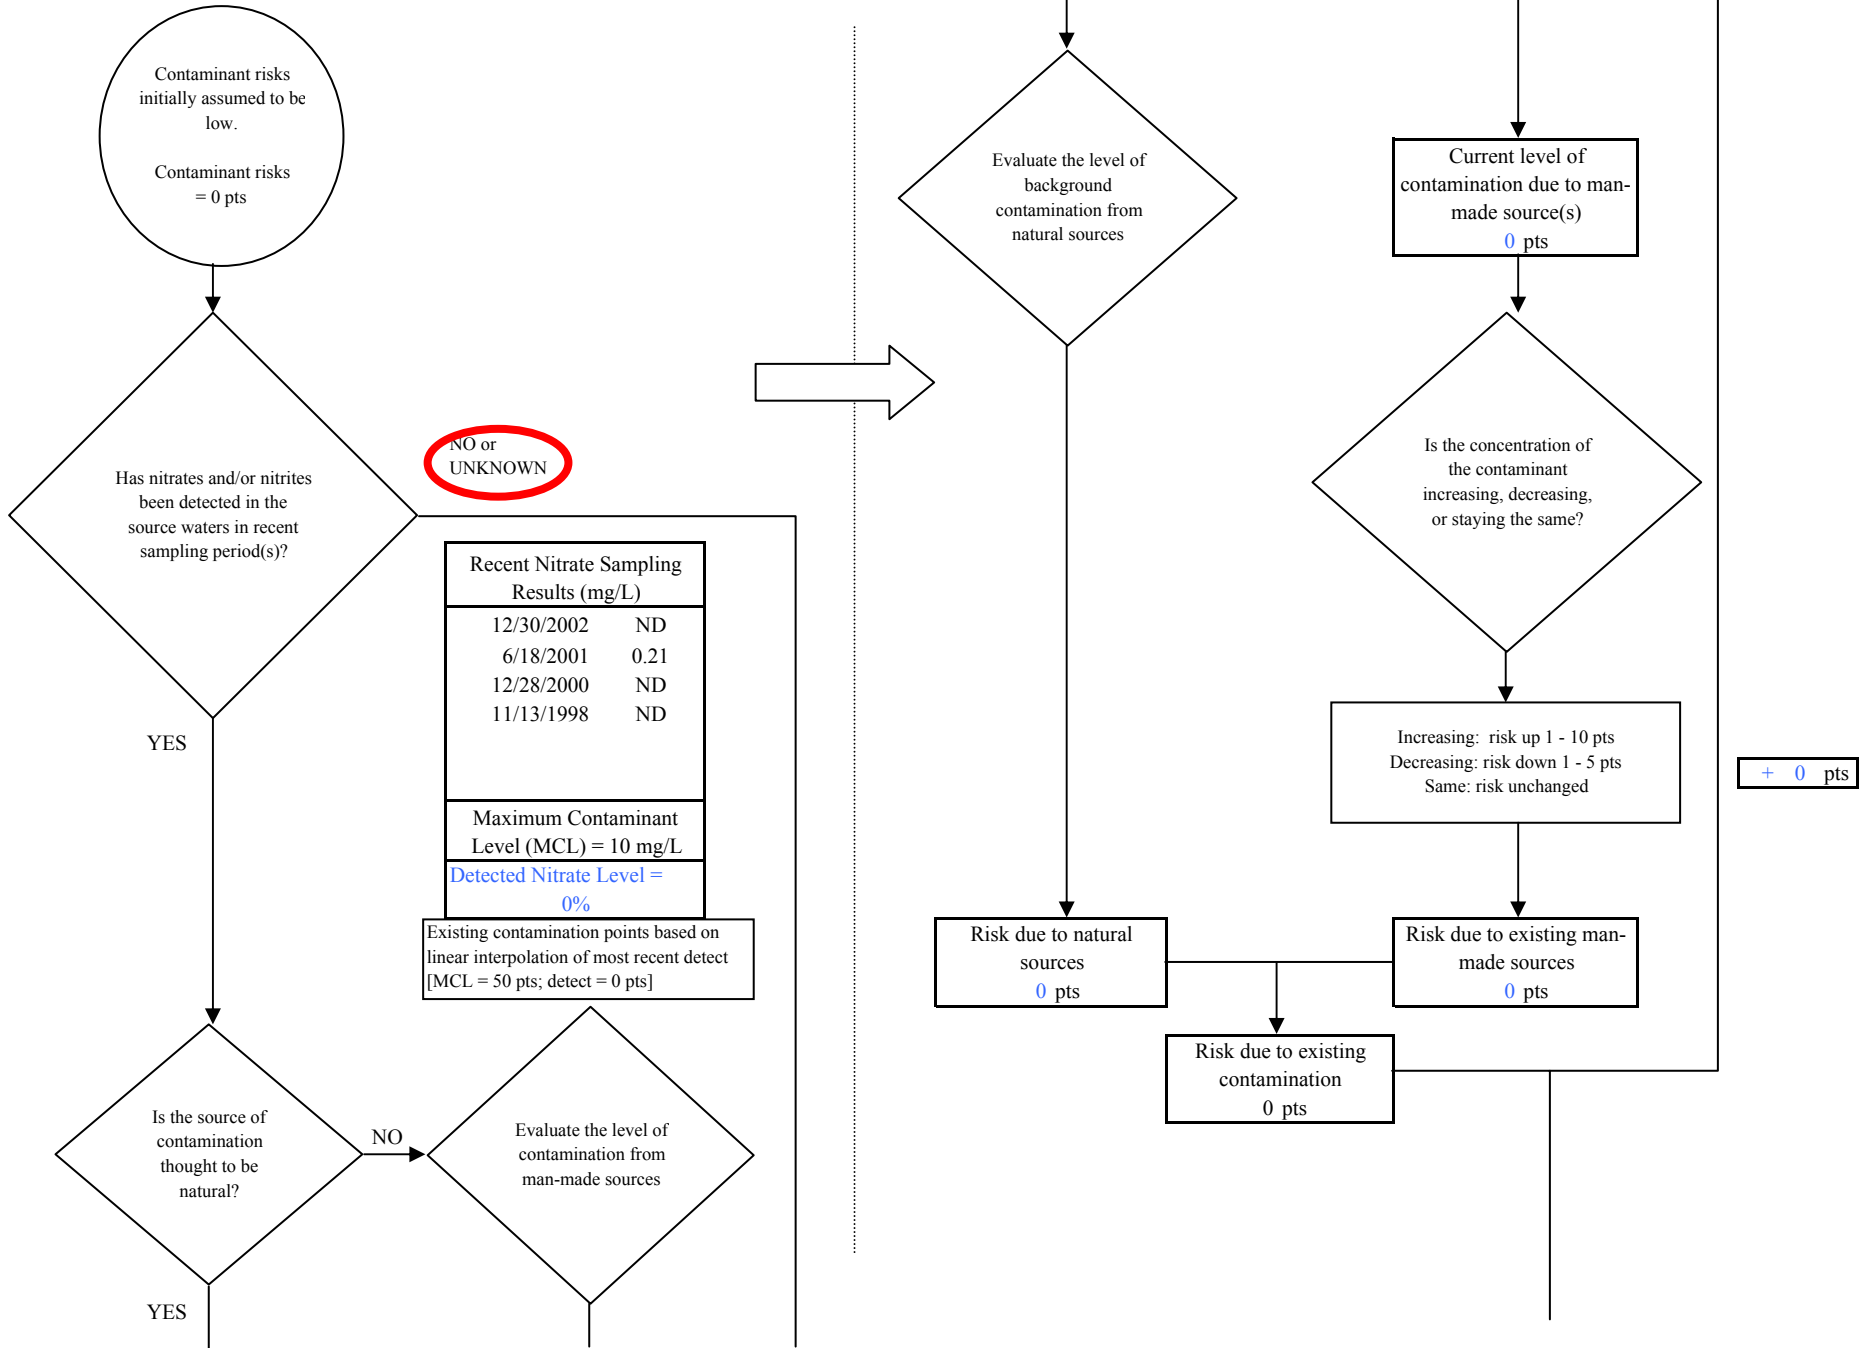
Chart 5. Contaminant risks for Crossroads Baptist Church - Nitrates and Nitrites

Risk Levels for Contaminant Sources identified in Zones A, B and C			
	Zone A	Zones B&C	Total
Very Highs(s)	0	0	0
High(s)	0	0	0
Medium(s)	0	0	0
Low(s)	4	5	9

Matrix Score 10

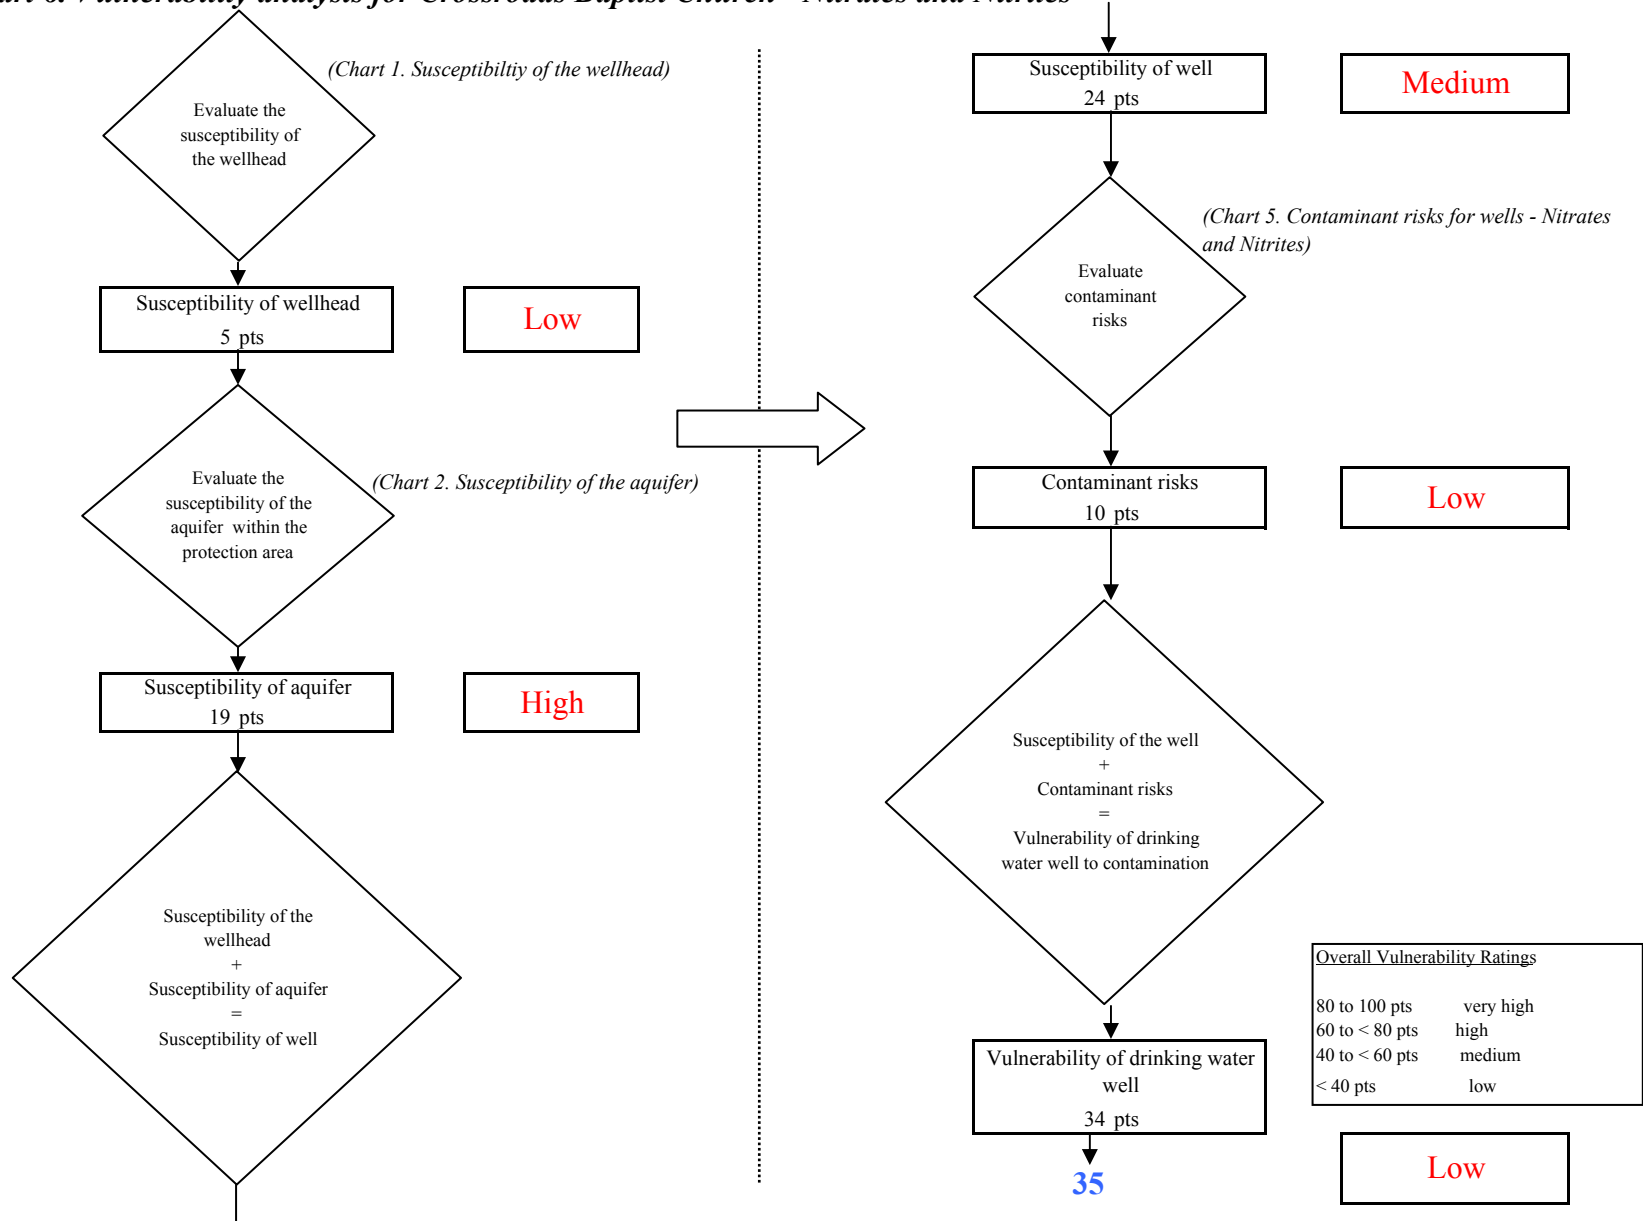
Chart 6. Vulnerability analysis for Crossroads Baptist Church - Nitrates and Nitrites

After combining the contaminant risk for nitrates and nitrites with the natural susceptibility of the well, the overall vulnerability of the well to contamination is low.
