Source Water Assessment

A Hydrogeologic Susceptibility and
Vulnerability Assessment for
Crossroads Baptist Church Drinking Water
System,

Fairbanks area, Alaska

PWSID # 314478

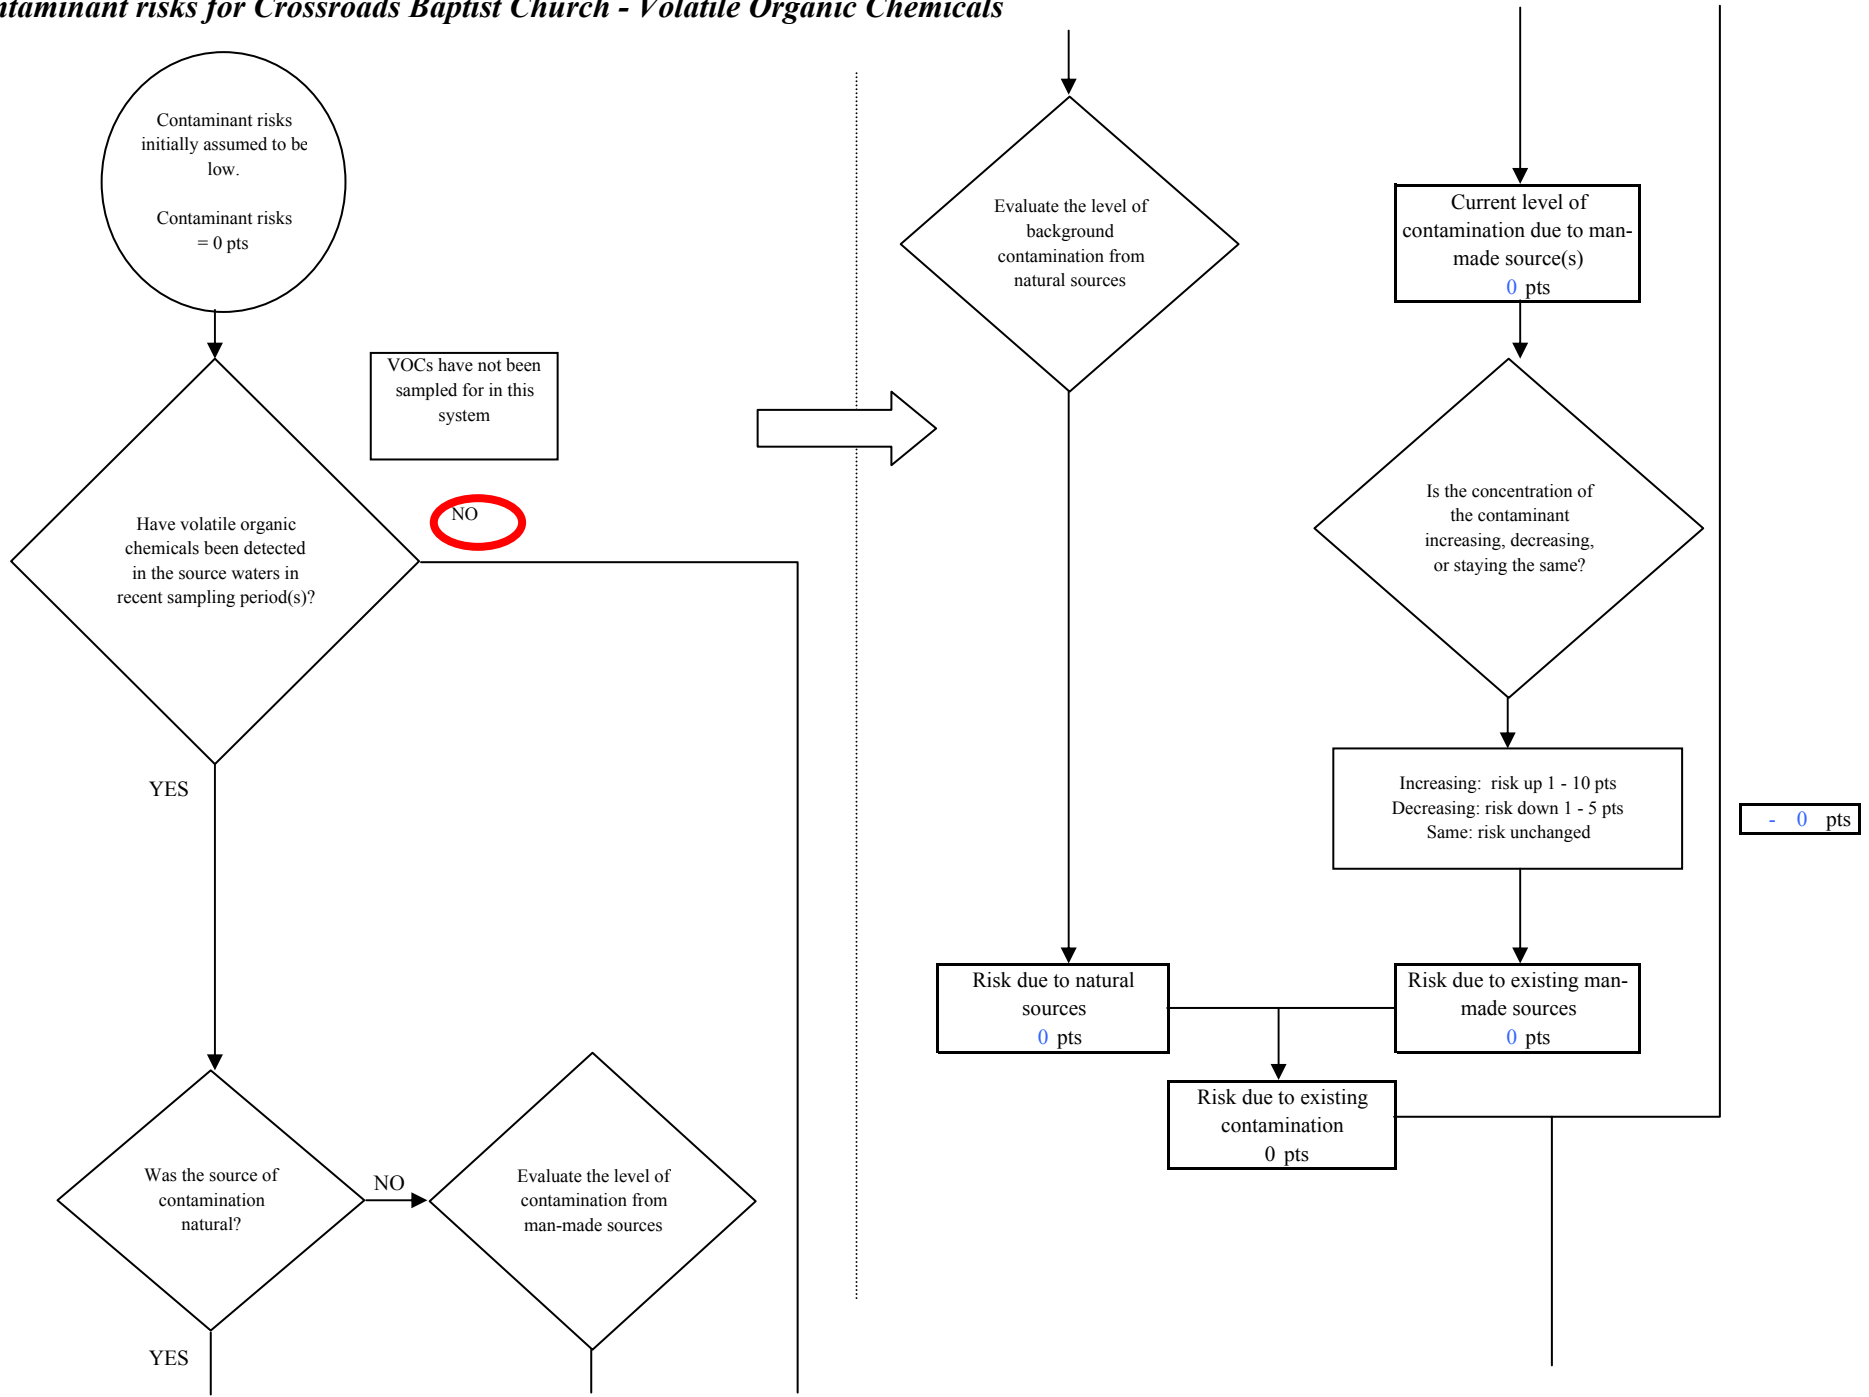
Chart 7. Contaminant risks for Crossroads Baptist Church - Volatile Organic Chemicals

Risk Levels for Contaminant Sources identified in Zones A, B and C			
	Zone A	Zones B&C	Total
Very High(s)	0	0	0
High(s)	0	0	0
Medium(s)	2	14	16
Low(s)	3	4	7

Matrix Score 25

The residential heating oil tanks represent the greatest risk for volatile organic chemical contamination to the well.

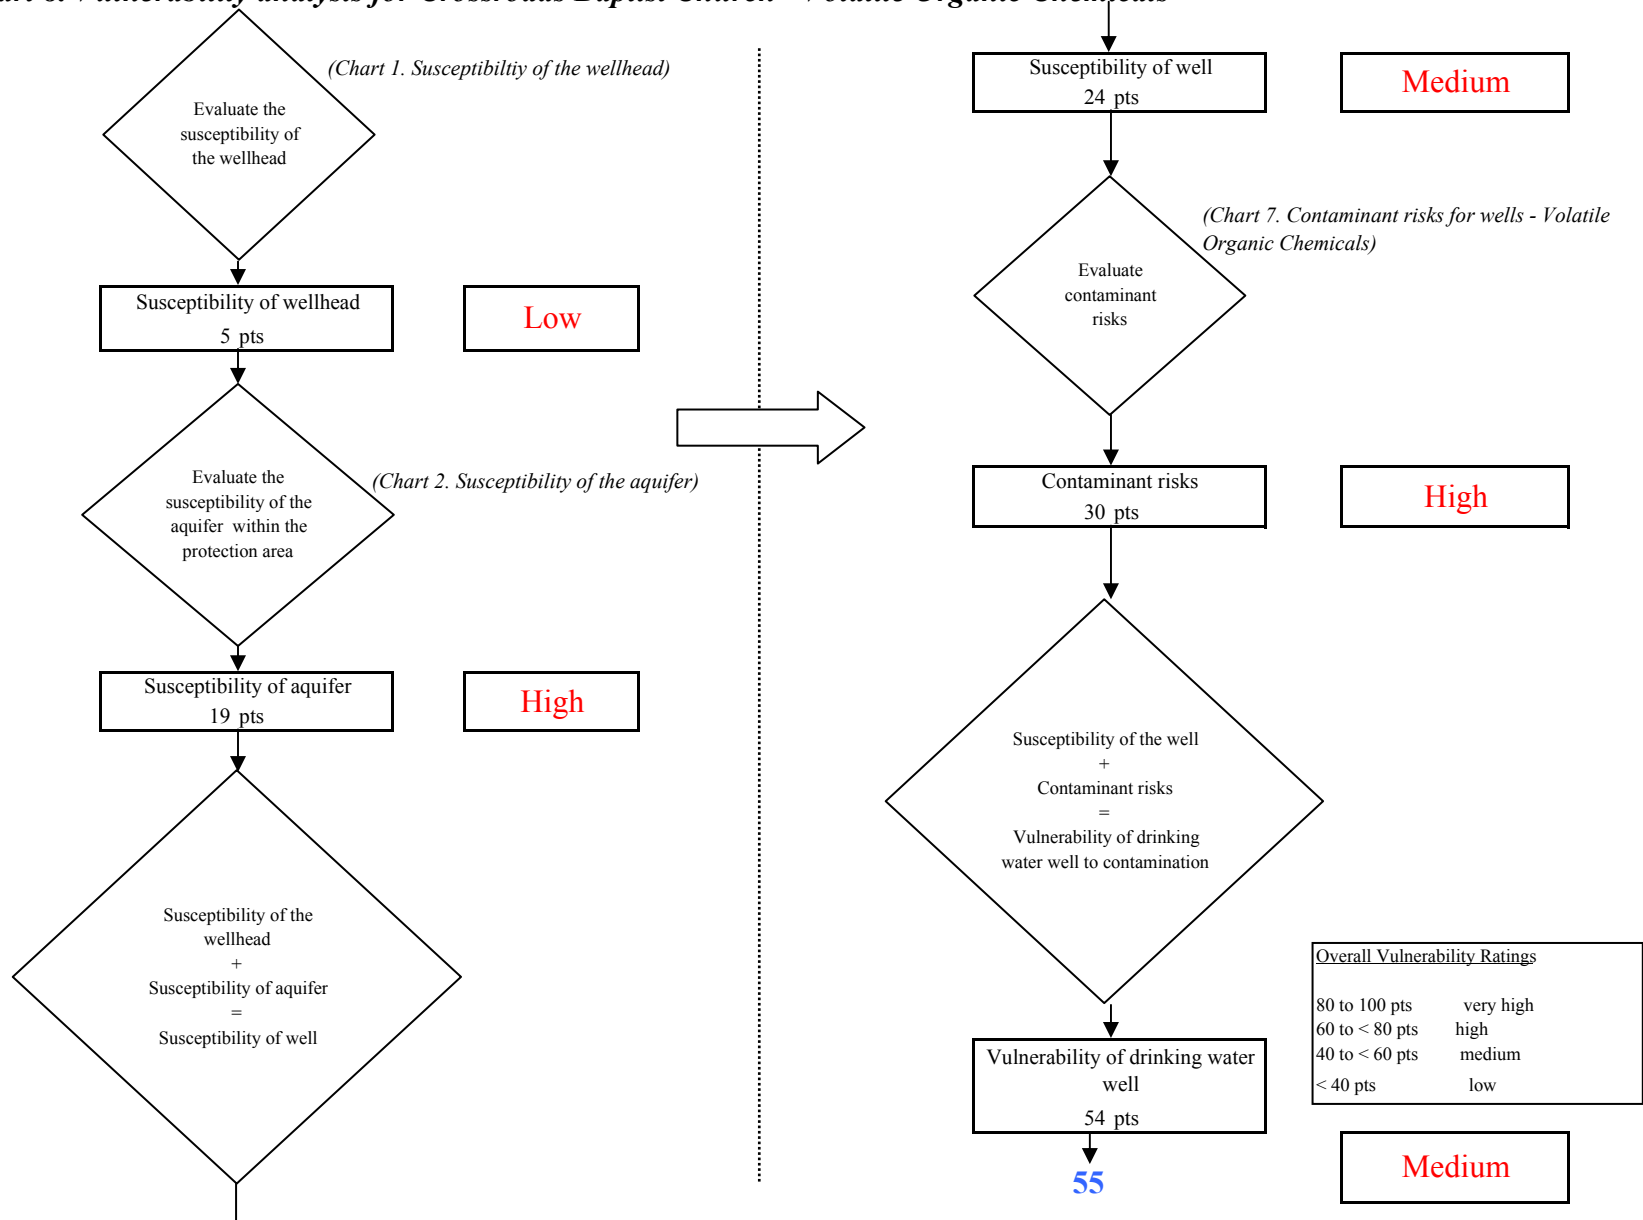
Chart 8. Vulnerability analysis for Crossroads Baptist Church - Volatile Organic Chemicals

Volatile Organic Chemicals have not been sampled for in the Crossroads Baptist Church public water system. After combining the contaminant risk for volatile organic chemicals with the natural susceptibility of the well, the overall vulnerability of the well to contamination is medium.

Category	Score	Rating
Bacteria and Viruses	35	Low
Nitrates and Nitrites	35	Low
Volatile Organic Chemicals	55	Medium
