Source Water Assessment

A Hydrogeologic Susceptibility and
Vulnerability Assessment for
North Star Golf Club Drinking Water
System,
Fairbanks area, Alaska

PWSID # 313796

January 2003

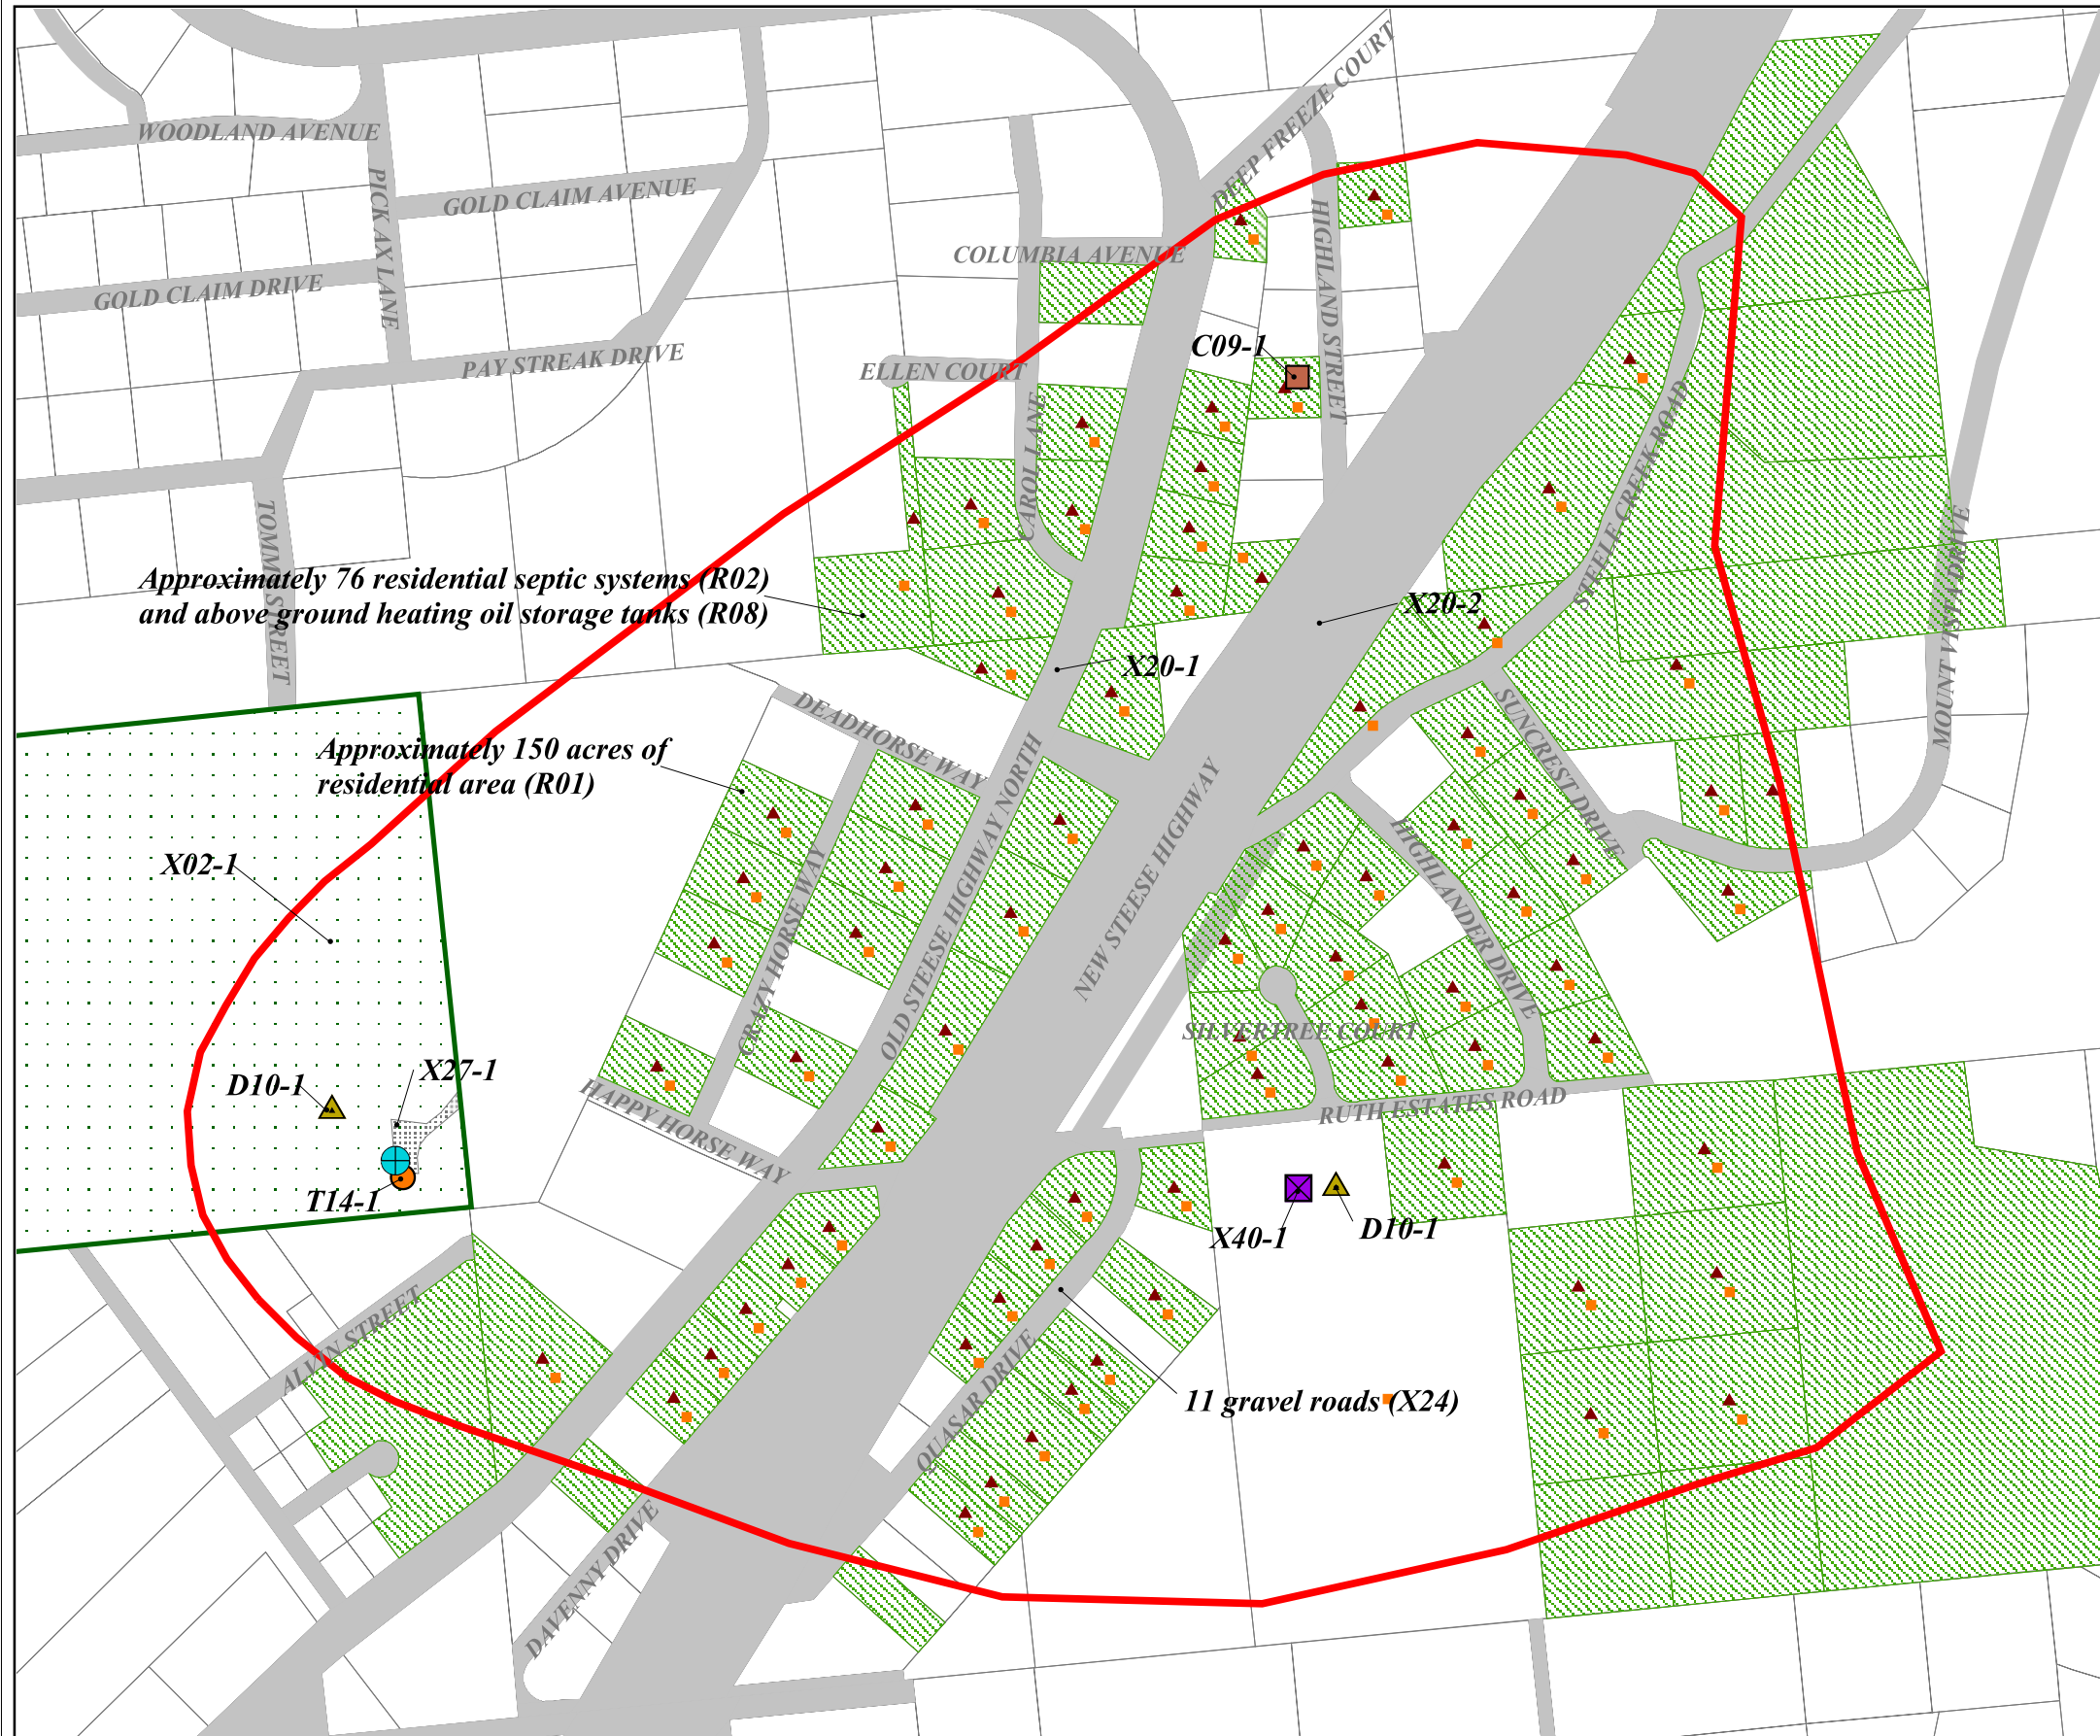
North Star Golf Club Drinking Water Protection Area with Potential and Existing Contaminant Sources

The sources are displayed on Map 2 of Appendix C and summarized in Table 1 of Appendix B.

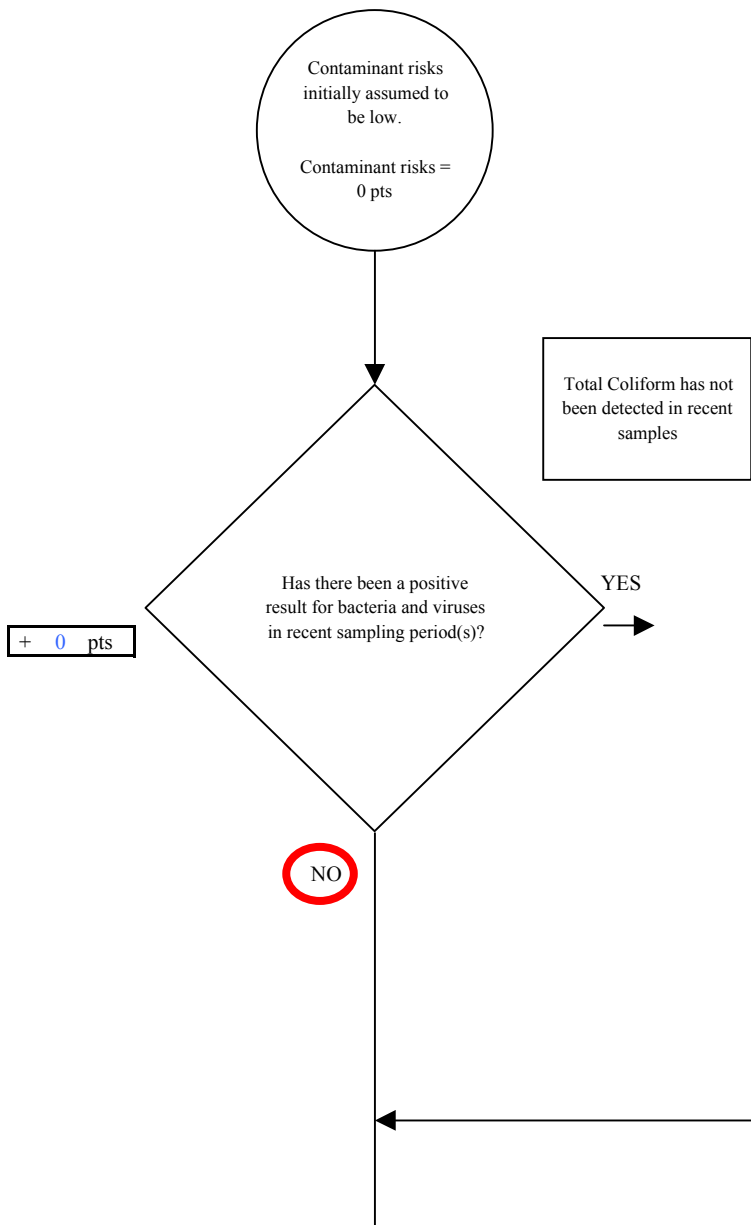
Chart 3. Contaminant risks for North Star Golf Club - Bacteria & Viruses

Matrix Score 40

The contaminant risk for bacteria and viruses is very high with the large capacity septic systems near the well representing the greatest risk to the drinking water well (See Chart 3 – Contaminant Risks for Bacteria and Viruses in Appendix D).

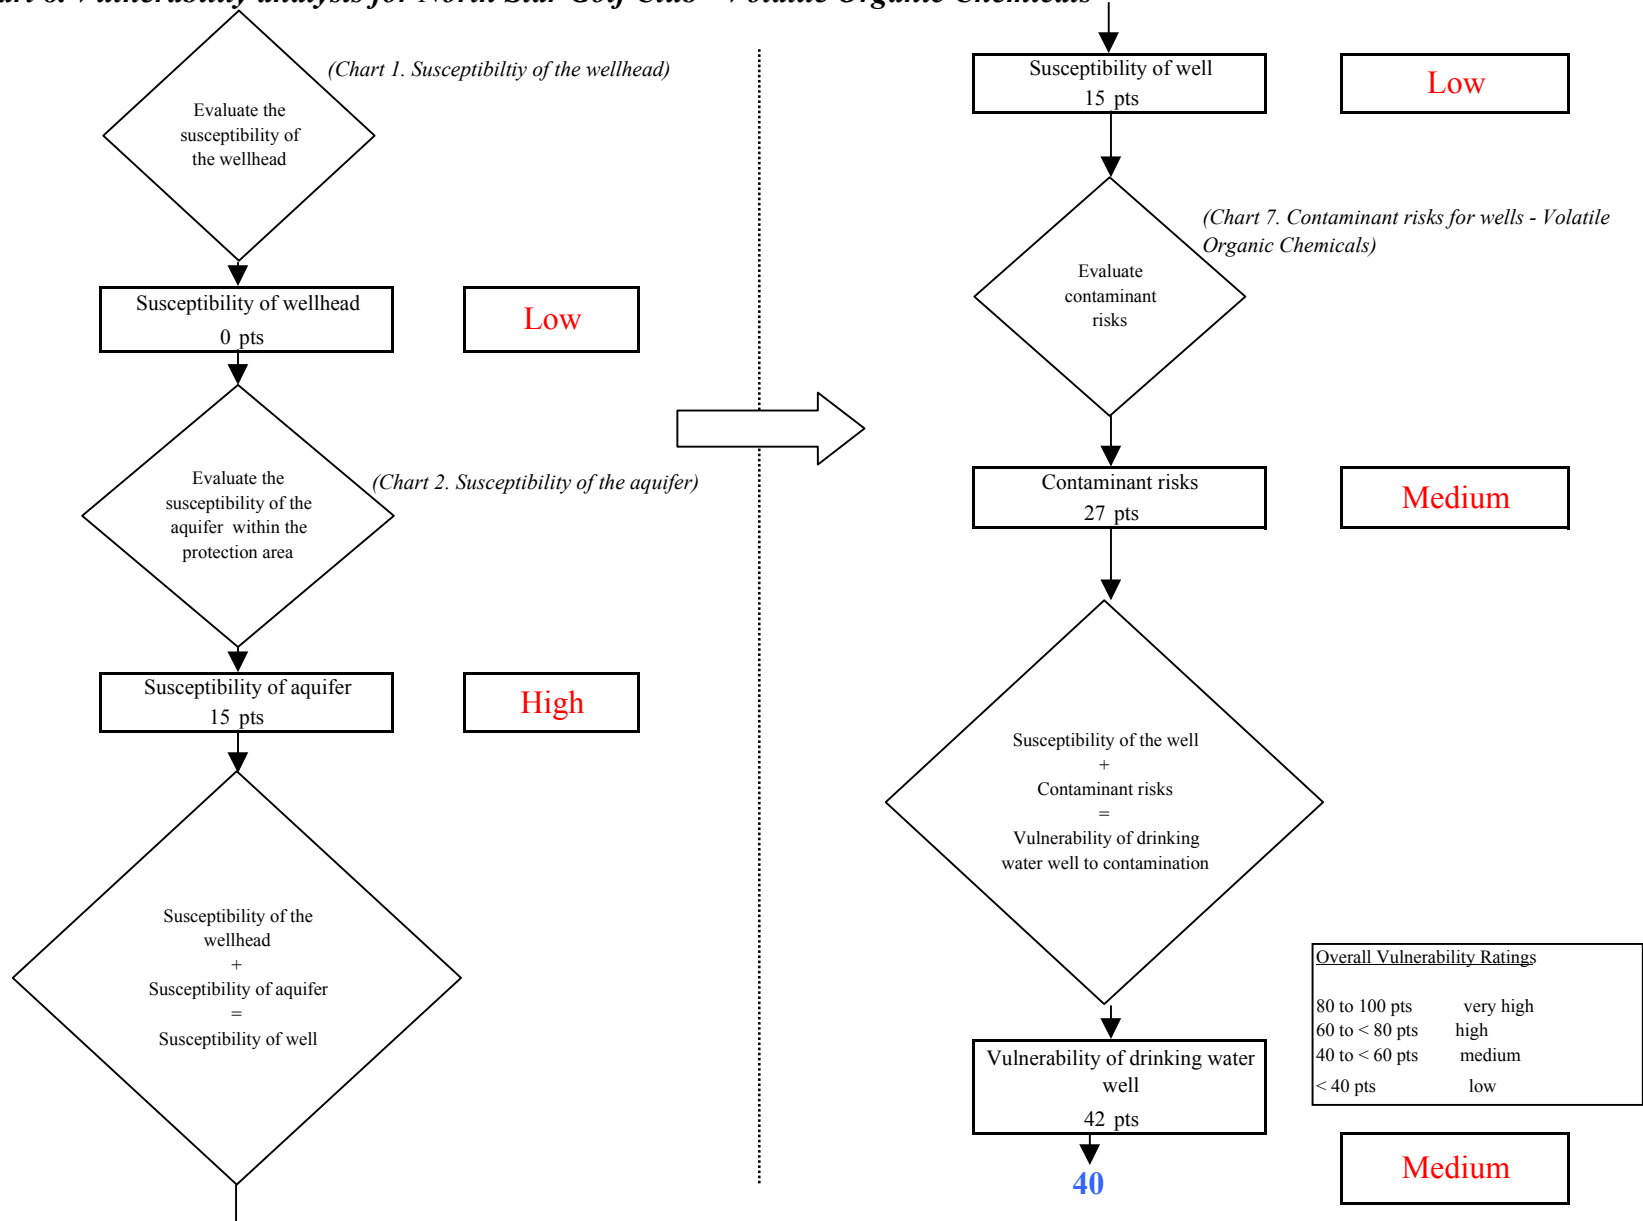
Chart 8. Vulnerability analysis for North Star Golf Club - Volatile Organic Chemicals

Volatile Organic Chemicals have not been sampled for in the North Star Golf Club public water system. After combining the contaminant risk for volatile organic chemicals with the natural susceptibility of the well, the overall vulnerability of the well to contamination is medium.
