Source Water Assessment

A Hydrogeologic Susceptibility and
Vulnerability Assessment for
Hidden Lake Campground Loop A-2
Drinking Water System,
Hidden Lake, Alaska
PWSID # 245202.001

DRINKING WATER PROTECTION PROGRAM REPORT # 378
Alaska Department of Environmental Conservation

By URS Corporation

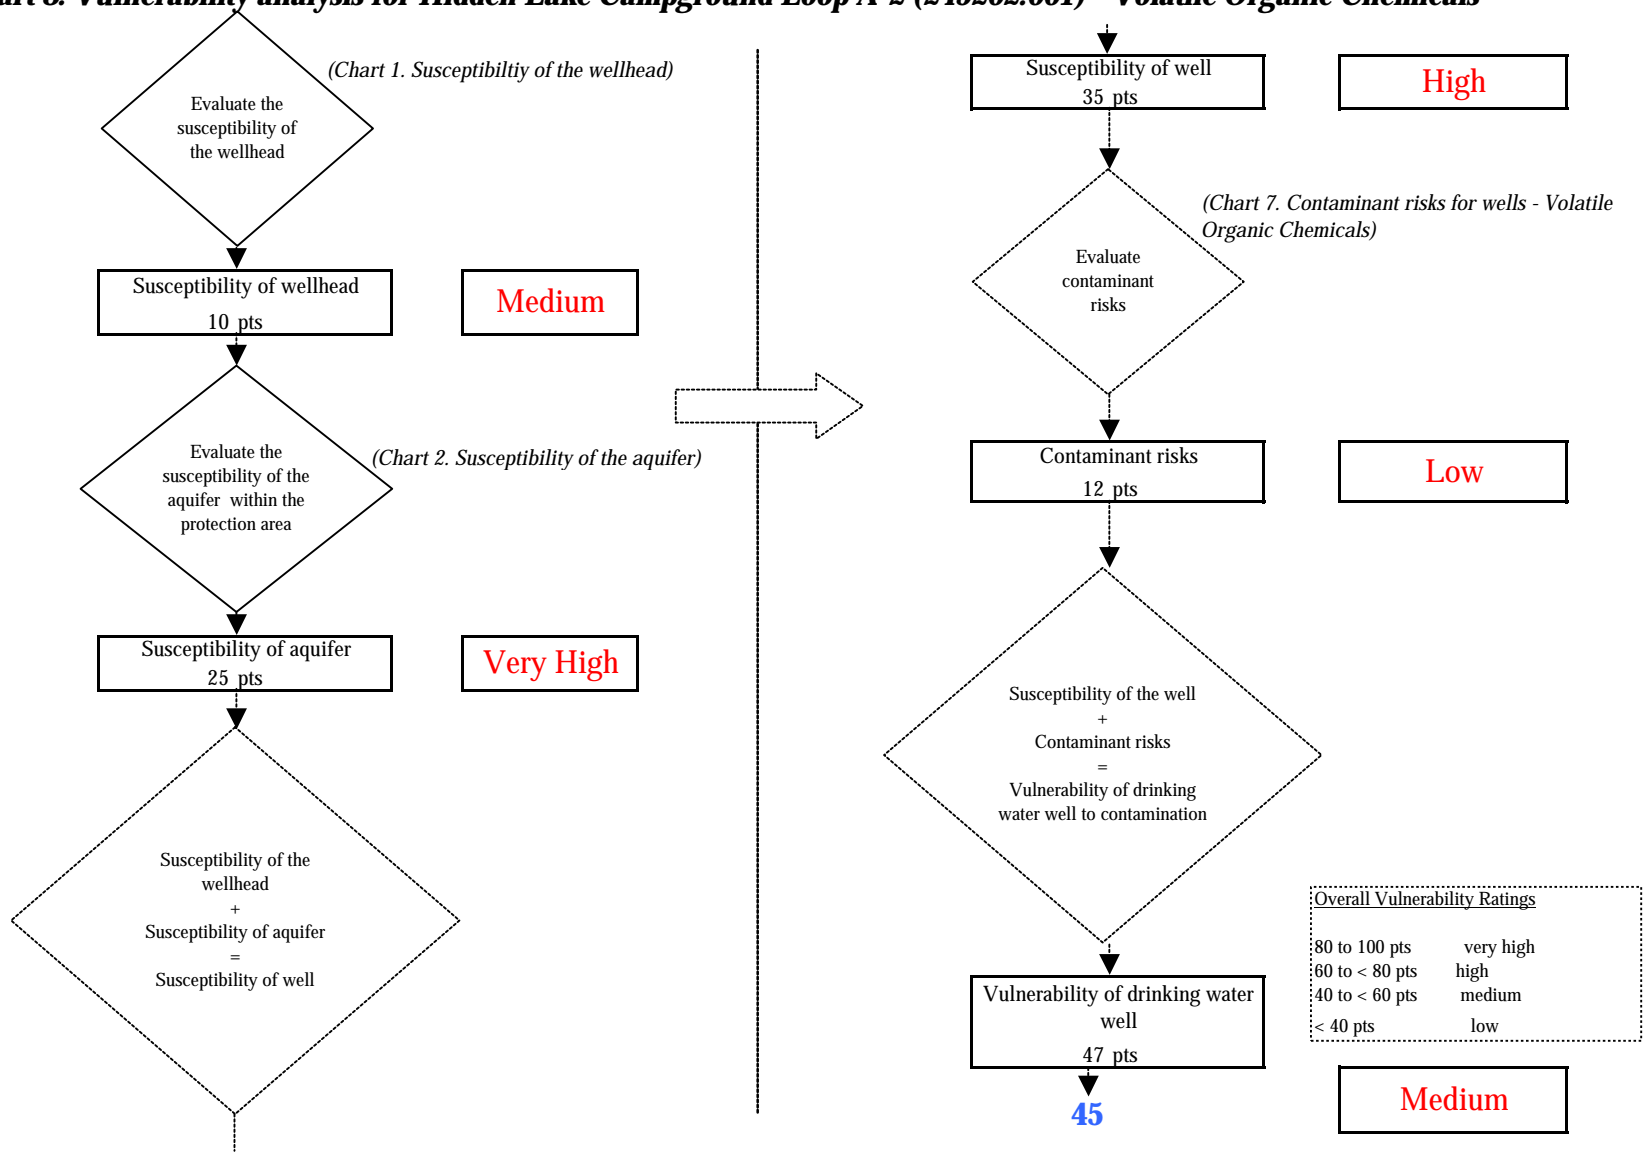
Chart 8. Vulnerability analysis for Hidden Lake Campground Loop A-2 (245202.001) - Volatile Organic Chemicals
