Source Water Assessment

A Hydrogeologic Susceptibility and
Vulnerability Assessment for
Hidden Lake Campground Loop A-4
Drinking Water System,
Hidden Lake, Alaska
PWSID # 245197.001

DRINKING WATER PROTECTION PROGRAM REPORT # 377
Alaska Department of Environmental Conservation

By URS Corporation

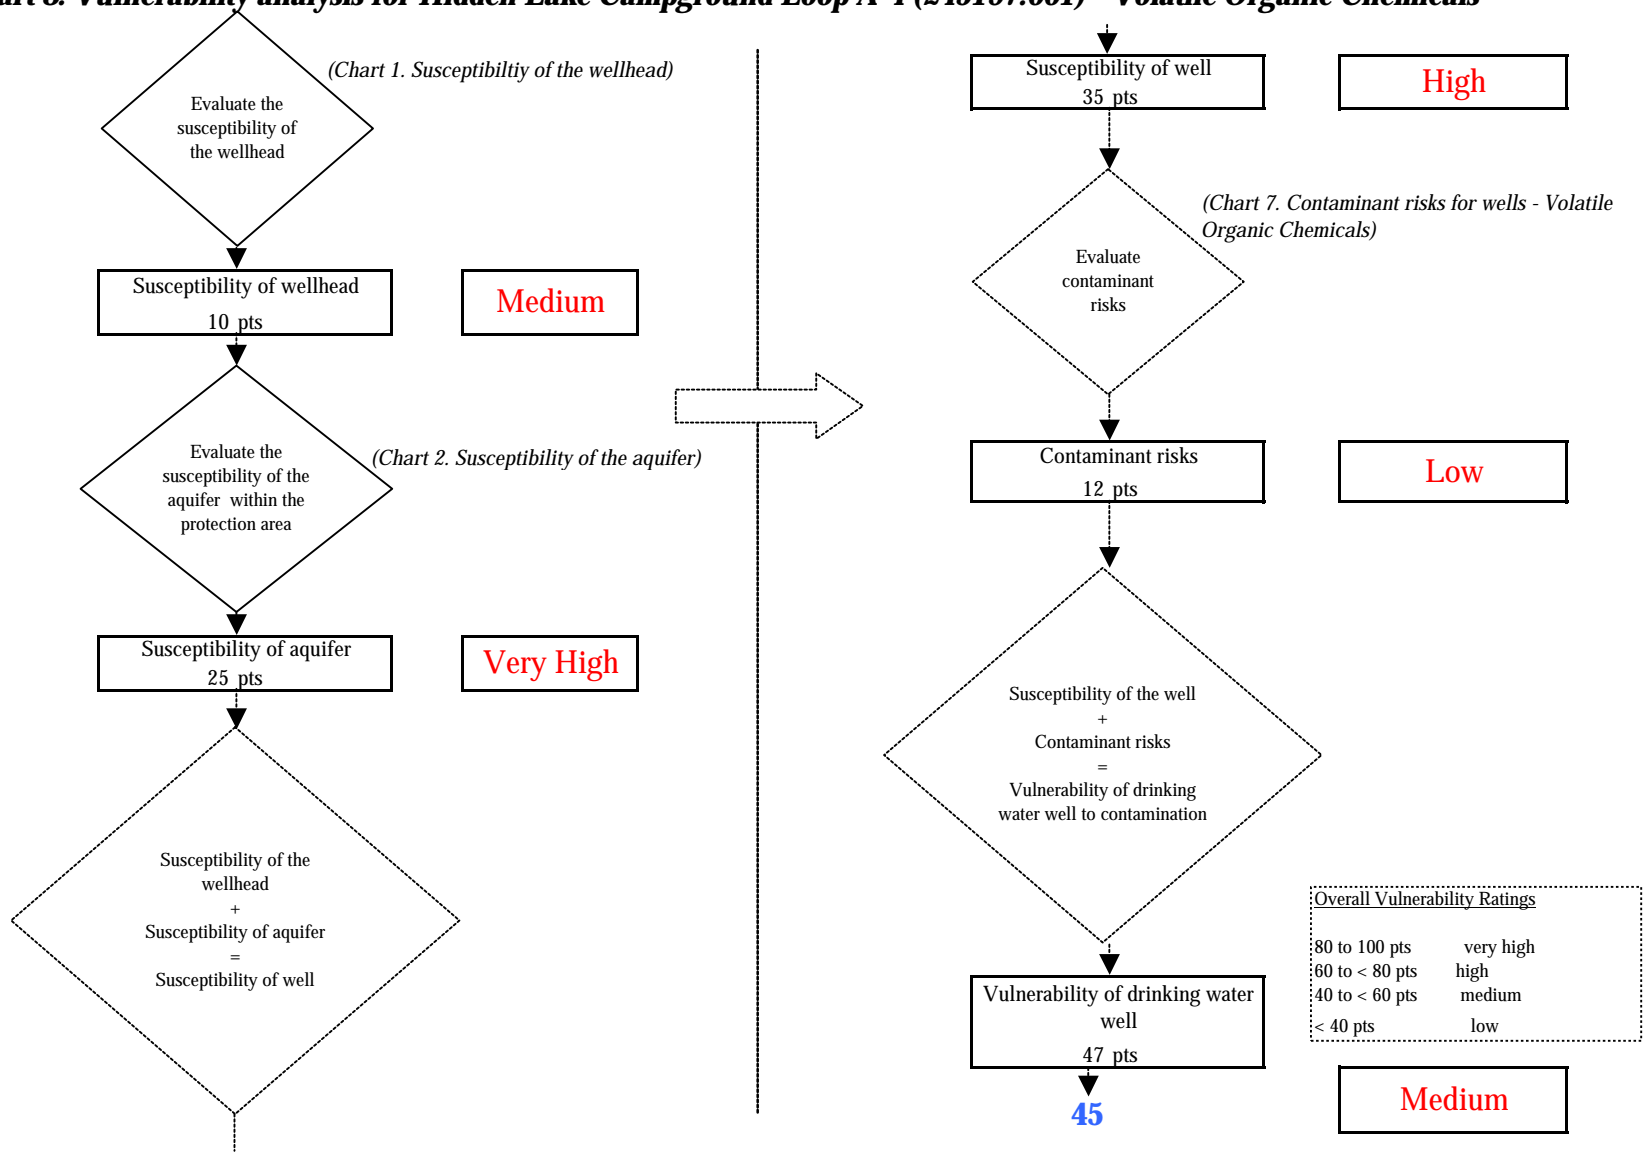
Chart 8. Vulnerability analysis for Hidden Lake Campground Loop A-4 (245197.001) - Volatile Organic Chemicals
