Source Water Assessment

A Hydrogeologic Susceptibility and
Vulnerability Assessment for
USFS Primrose Landing Campground
Drinking Water System,
Kenai Lake, Alaska
PWSID # 240286.001

DRINKING WATER PROTECTION PROGRAM REPORT # 348
Alaska Department of Environmental Conservation

By URS Corporation

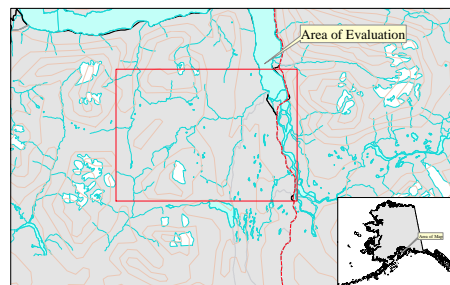
Figure 1

FIGURE	1. Index map showing the location of the Kenai Mountains Watershed	1
--------	--	---

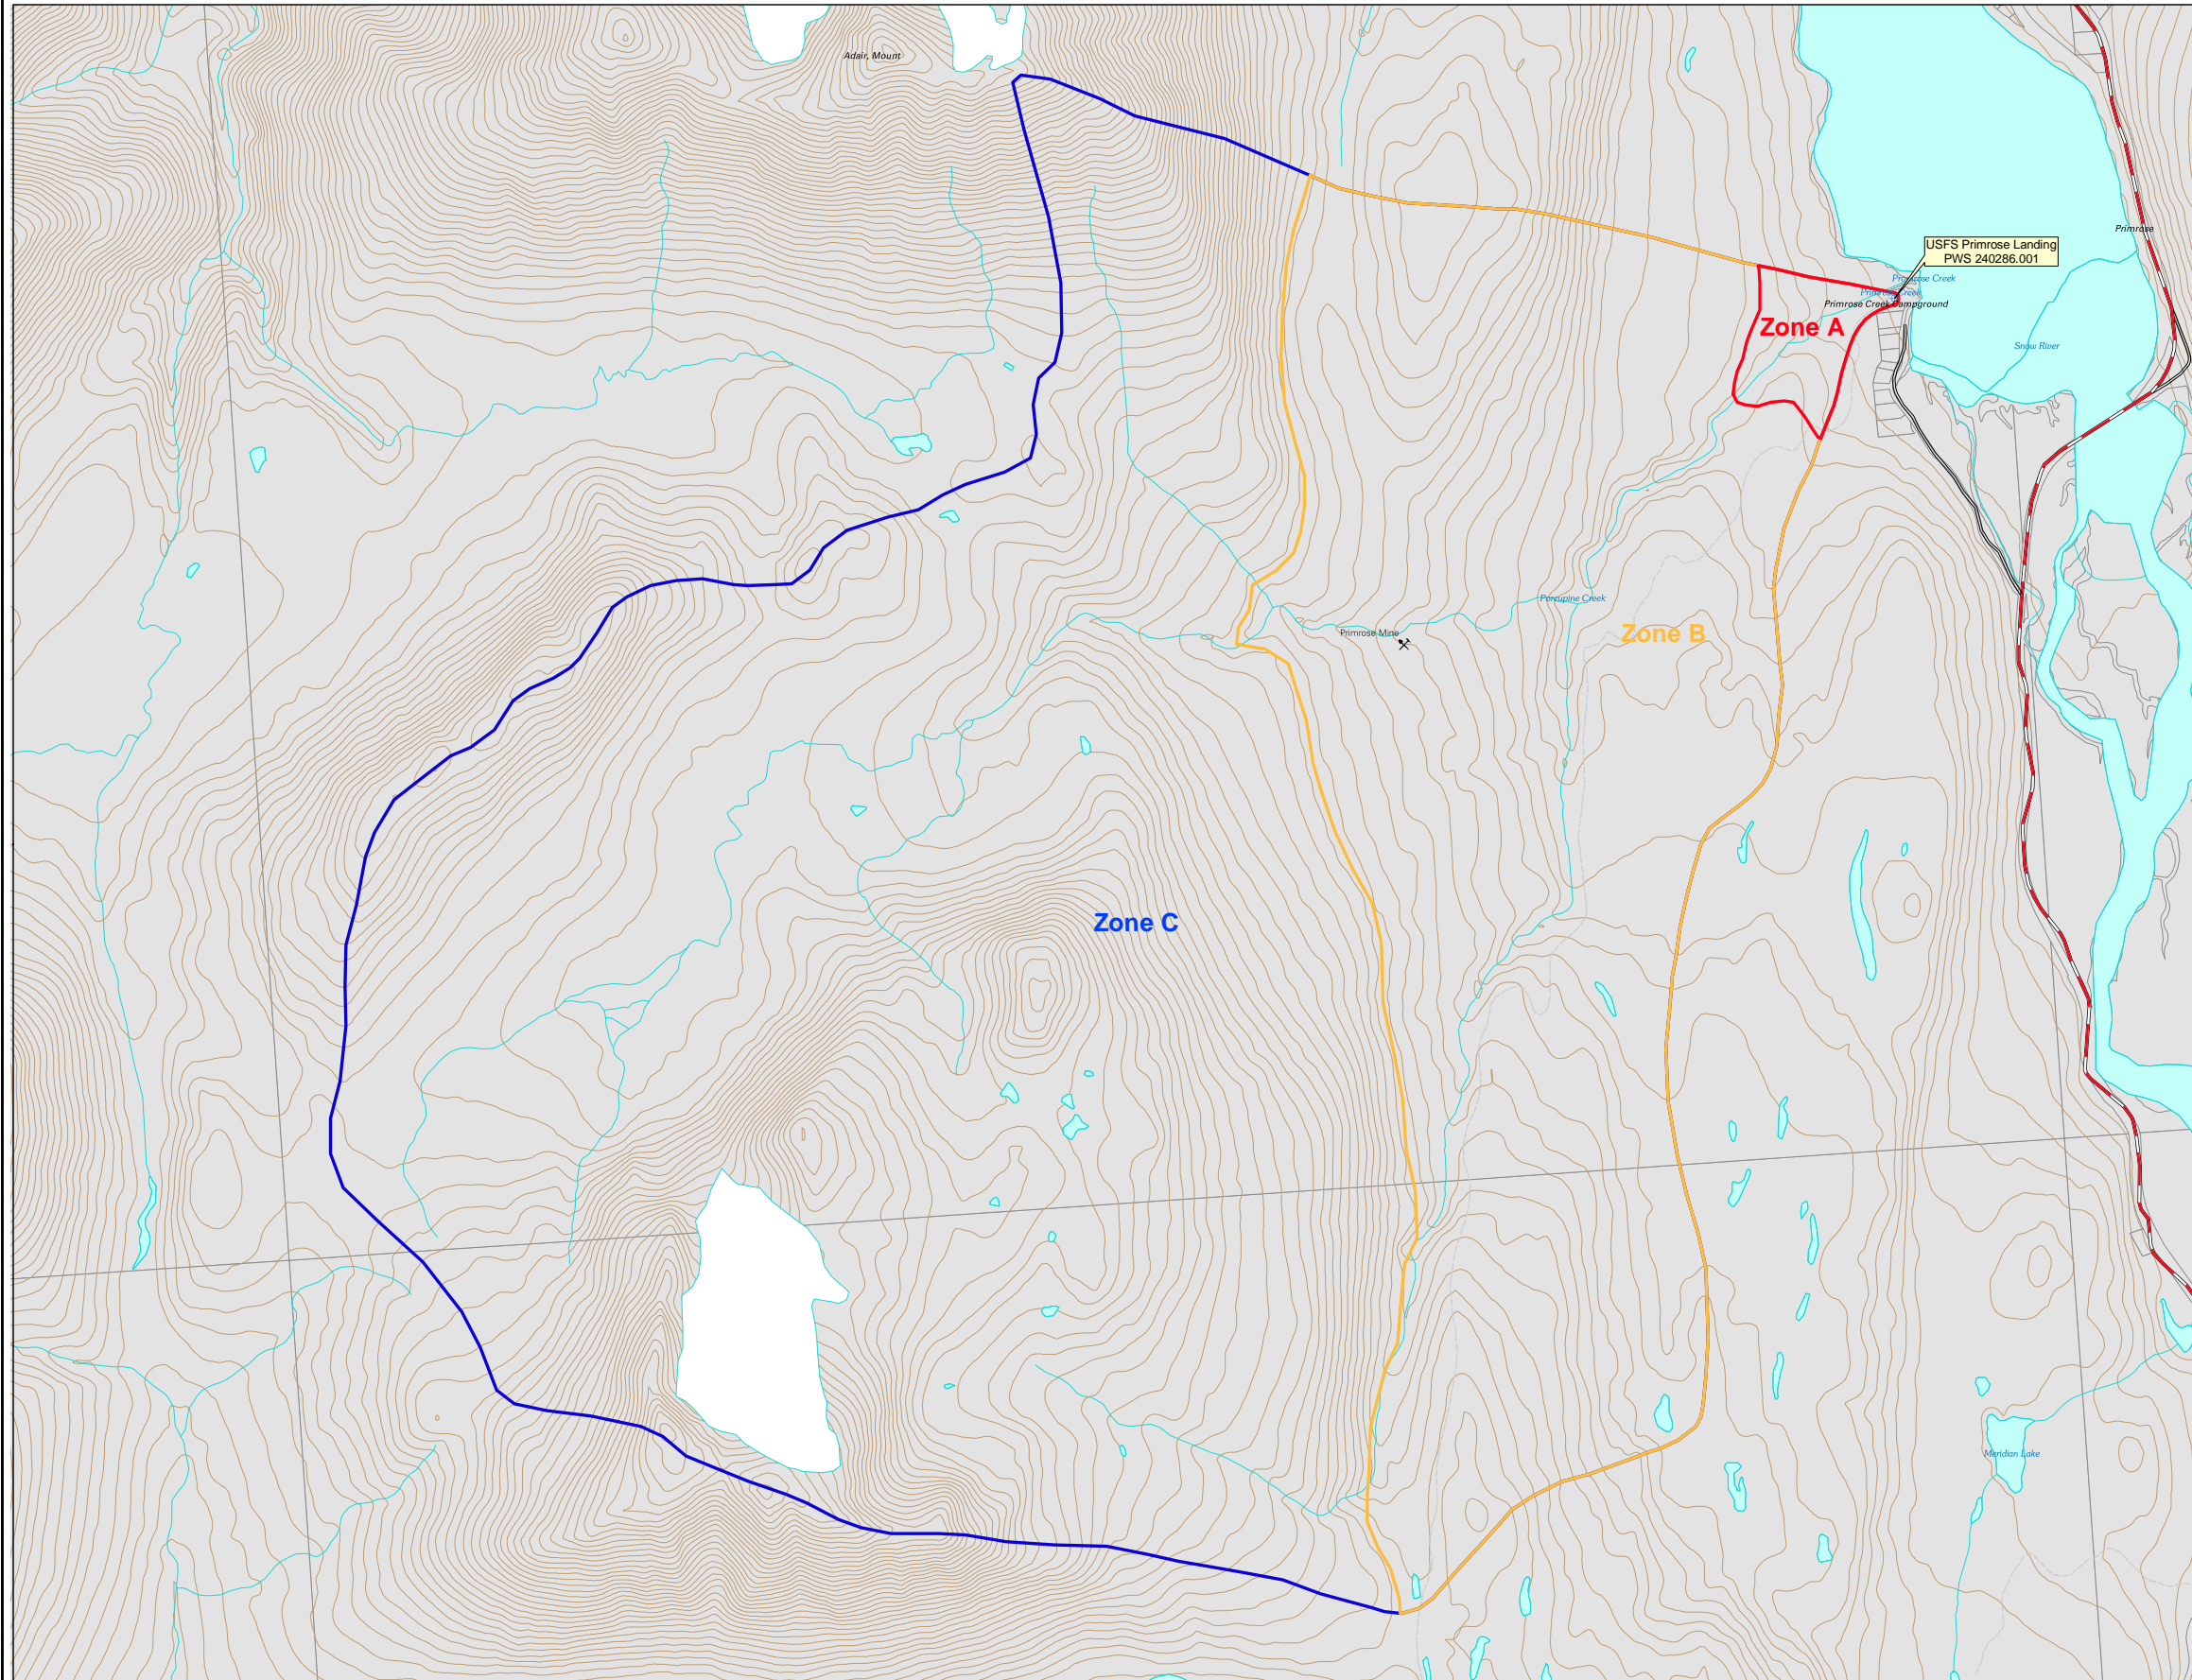
USFS Primrose Landing Campground Drinking Water Protection Area (Map 1)

Drinking Water Protection Areas for the Public Water Well System for PWS # 240286.001 USFS Primrose Landing Campground

- Zone A – Several Months Travel Time
- Zone B – Less Than 2 Years Travel Time
- Zone C – Less Than 5 Years Travel Time

The most probable area for contamination to reach the drinking water well is the area that contributes water to the well, the groundwater recharge area. This area is designated as the Drinking Water Protection Area (DWPA). Because a release of contaminants within the DWPA are most likely to impact the drinking water well, this area will serve as the focus for voluntary protection efforts.

The DWPAs established for wells by the ADEC are usually separated into four zones, limited by the watershed. These zones correspond to differences in the time-of-travel (TOT) of the water moving through the aquifer to the well. An analytical calculation was used to determine the size and shape of the DWPA. The input parameters describing the attributes of the aquifer in this calculation were adopted from the U.S.

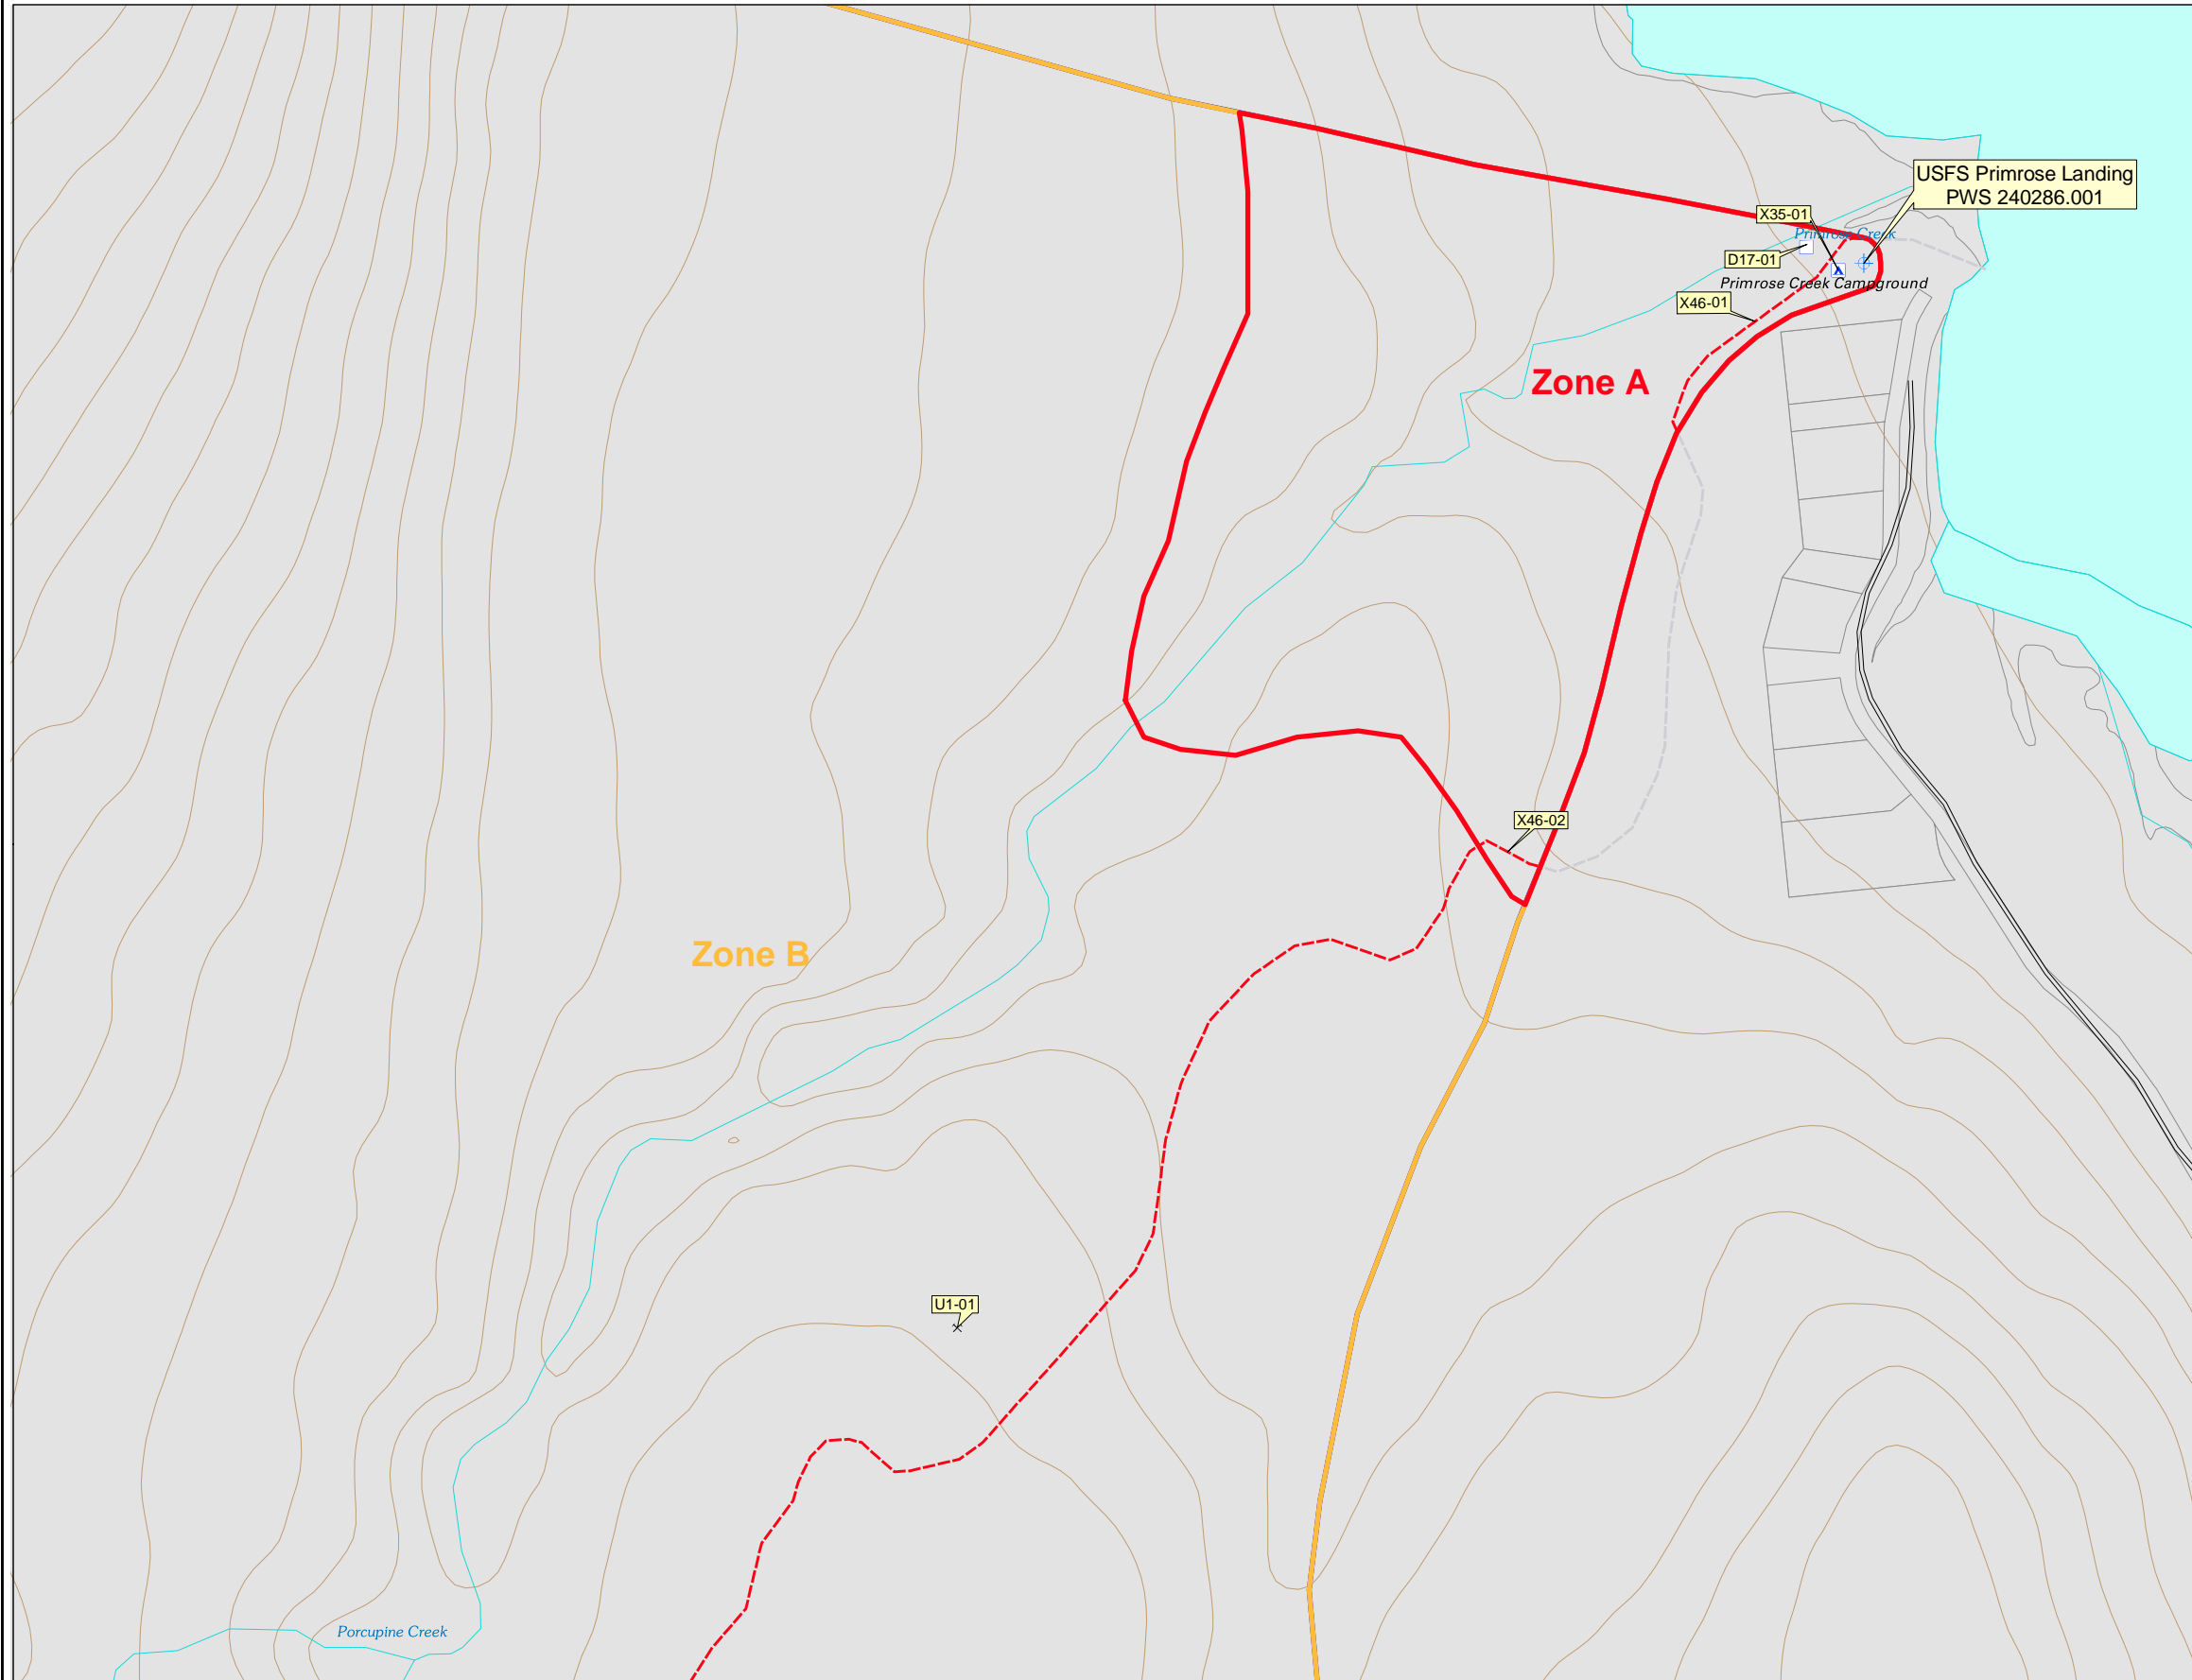
USFS Primrose Landing Campground Drinking Water Protection Area and Potential and Existing Contaminant Sources (Maps 2 and 3)

Drinking Water Protection Areas for the Public Water Well System for PWS # 240286.001 USFS Primrose Landing Campground

Showing Potential and Existing Sources of Contamination

- Campgrounds and RV Parks (X35)
- Pit Toilets (vaulted) nonresidential (one or more) (D17)
- Abandoned Mine Spoils or mine tailings piles/ponds (U1)
- Foot Trails and Dog Walking Areas (X46)

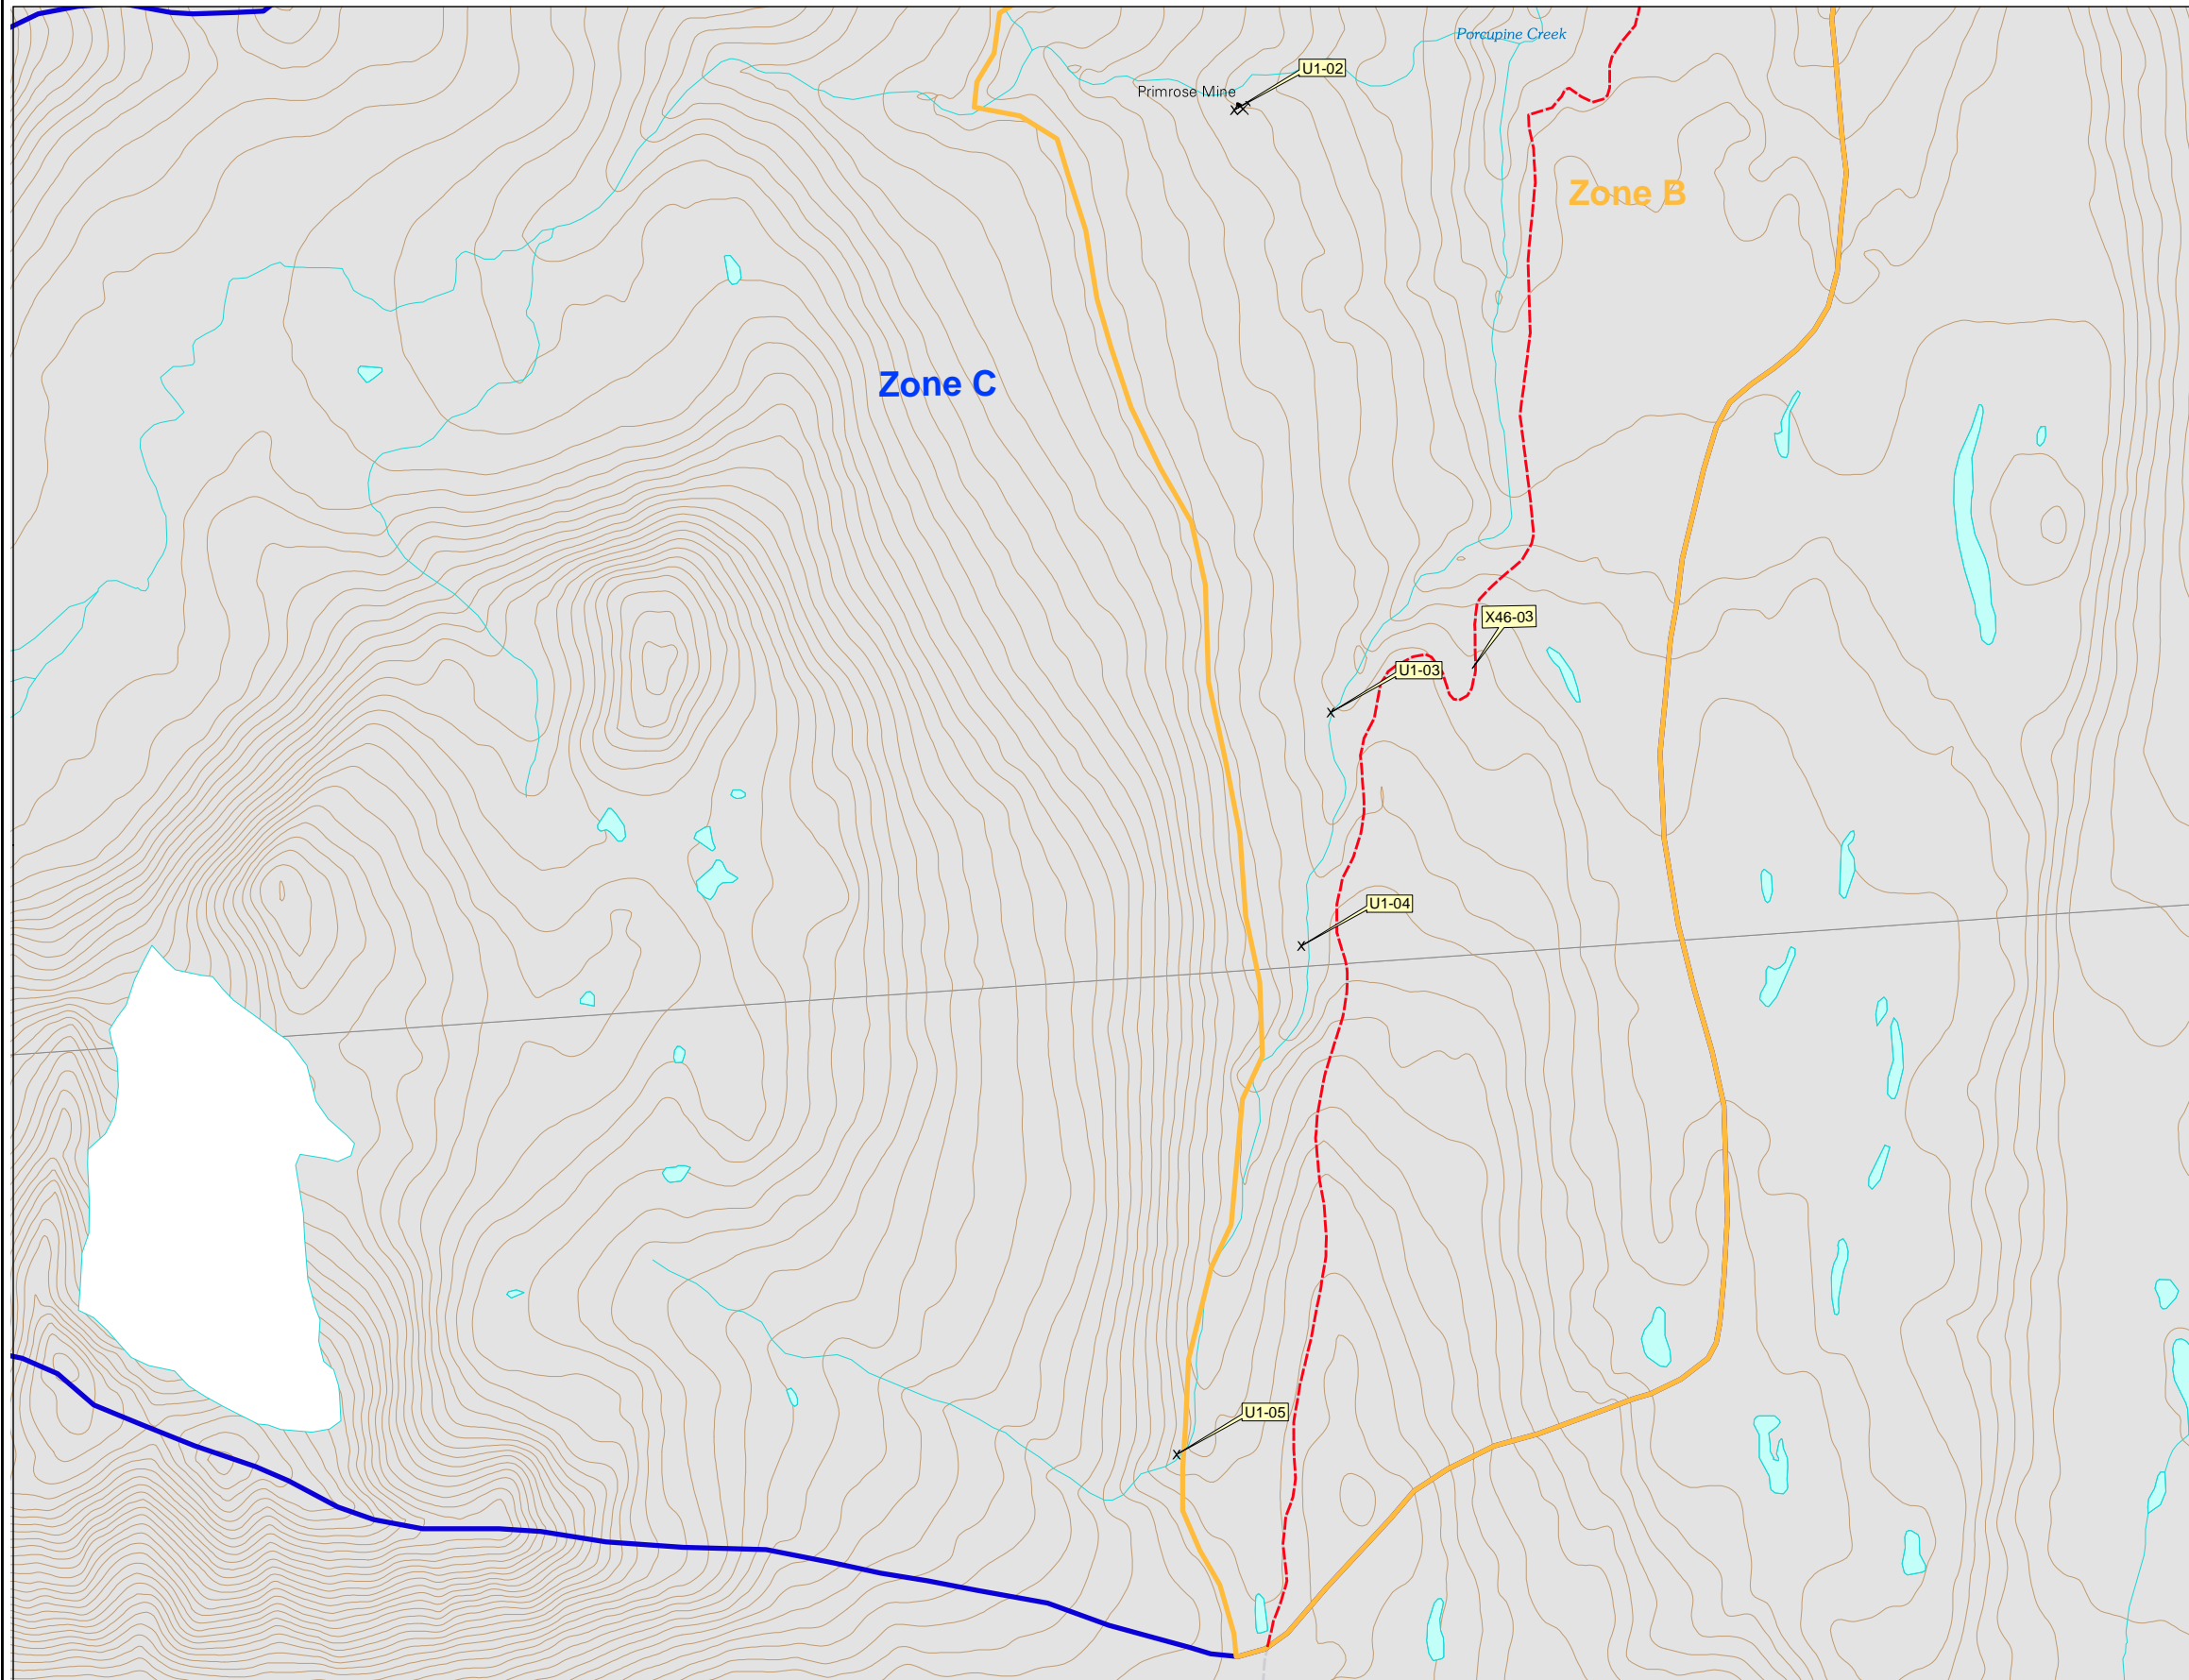
Drinking Water Protection Areas for the Public Water Well System for PWS # 240286.001 USFS Primrose Landing Campground Showing Potential and Existing Sources of Contamination

- Campgrounds and RV Parks (X35)
- Pit Toilets (vaulted) nonresidential (one or more) (D17)
- Abandoned Mine Spoils or mine tailings piles/ponds (U1)
- Foot Trails and Dog Walking Areas (X46)

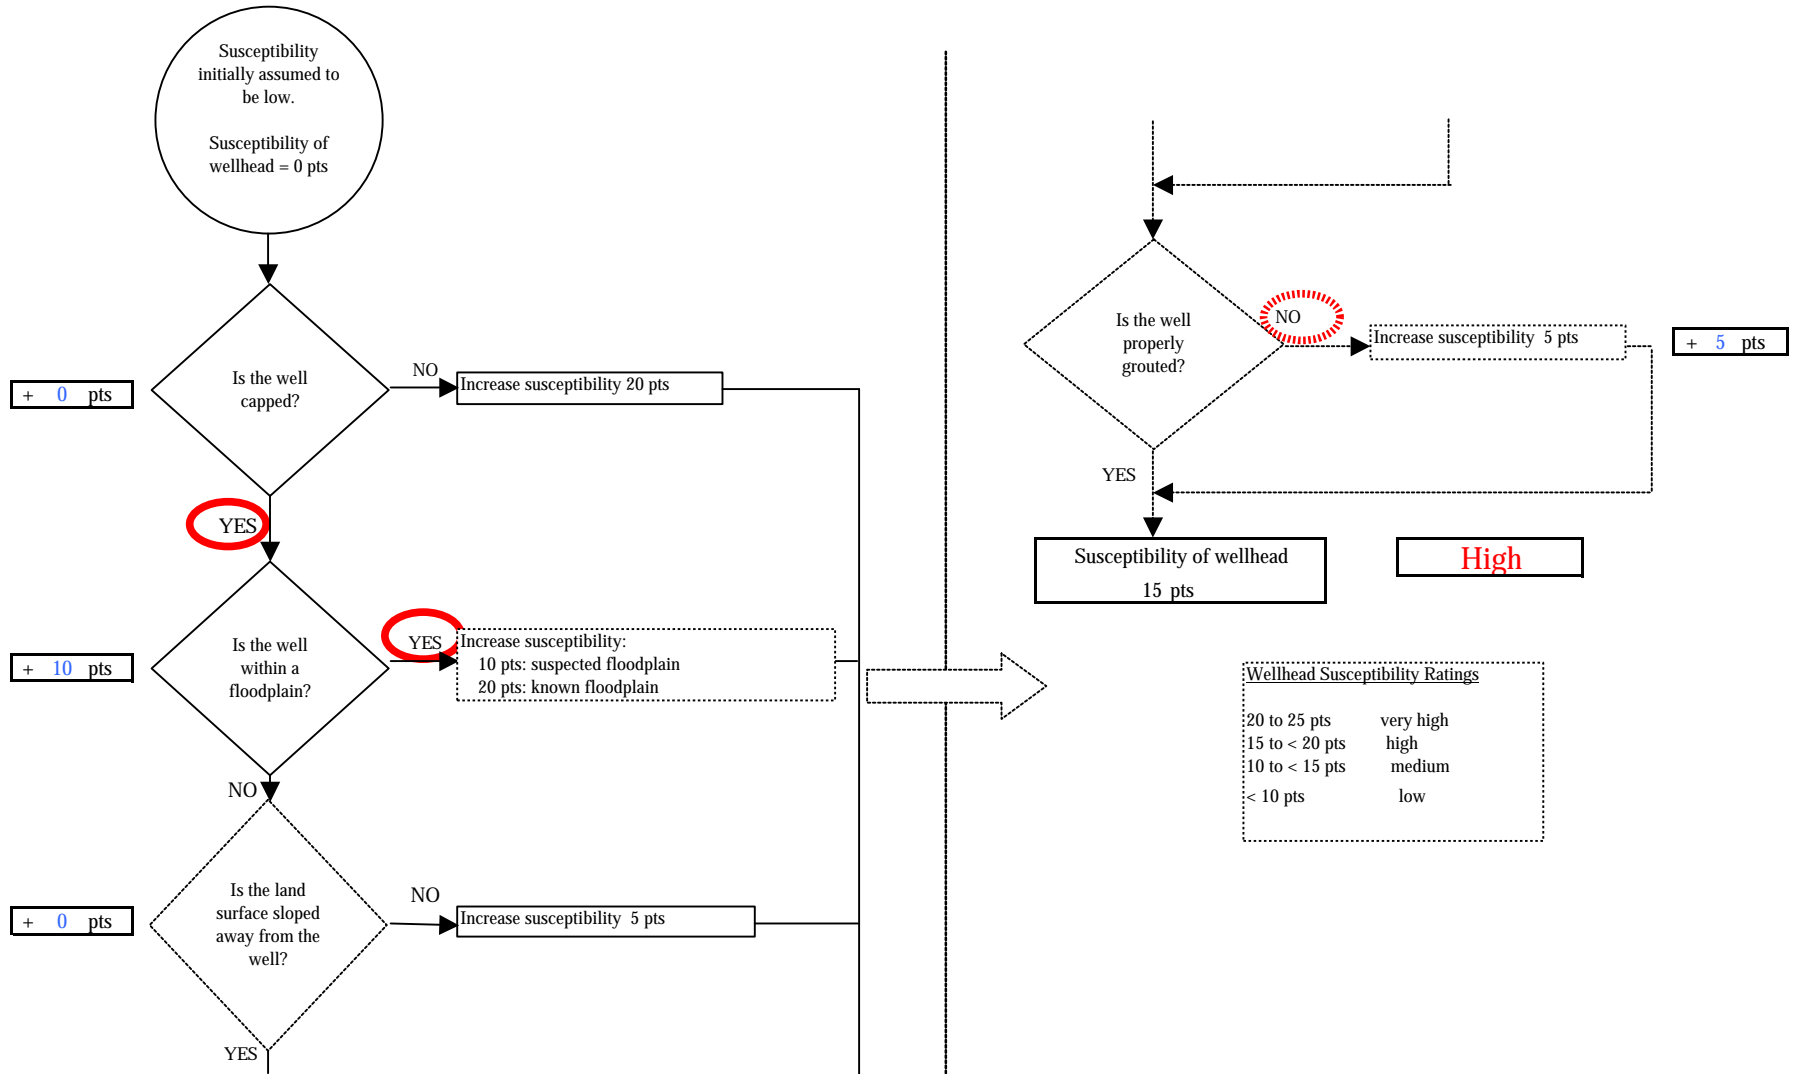
Chart 1. Susceptibility of the wellhead - USFS Primrose Landing Campground (240286.001)

Appendix D contains eight charts, which together form the ‘Vulnerability Analysis’ for a source water assessment for a public drinking water source. Chart 1 analyzes the ‘Susceptibility of the Wellhead’ to contamination by looking at the construction of the well and its surrounding area. Chart 2 analyzes the ‘Susceptibility of the Aquifer’ to contamination by looking at the naturally occurring attributes of the water source and influences on the groundwater system that might lead to contamination. Chart 3 analyzes ‘Contaminant Risks’ for the drinking water source with respect to bacteria and viruses. The ‘Contaminant Risks’ portion of the analysis considers potential sources of contaminants as well as a review of contamination that has or may have occurred, but has not arrived or been detected at the well. Lastly, Chart 4 contains the ‘Vulnerability Analysis for Bacteria and Viruses’. Charts 5 through 8 contain the Contaminant Risks and Vulnerability Analyses for nitrates and nitrites and volatile organic chemicals, respectively.

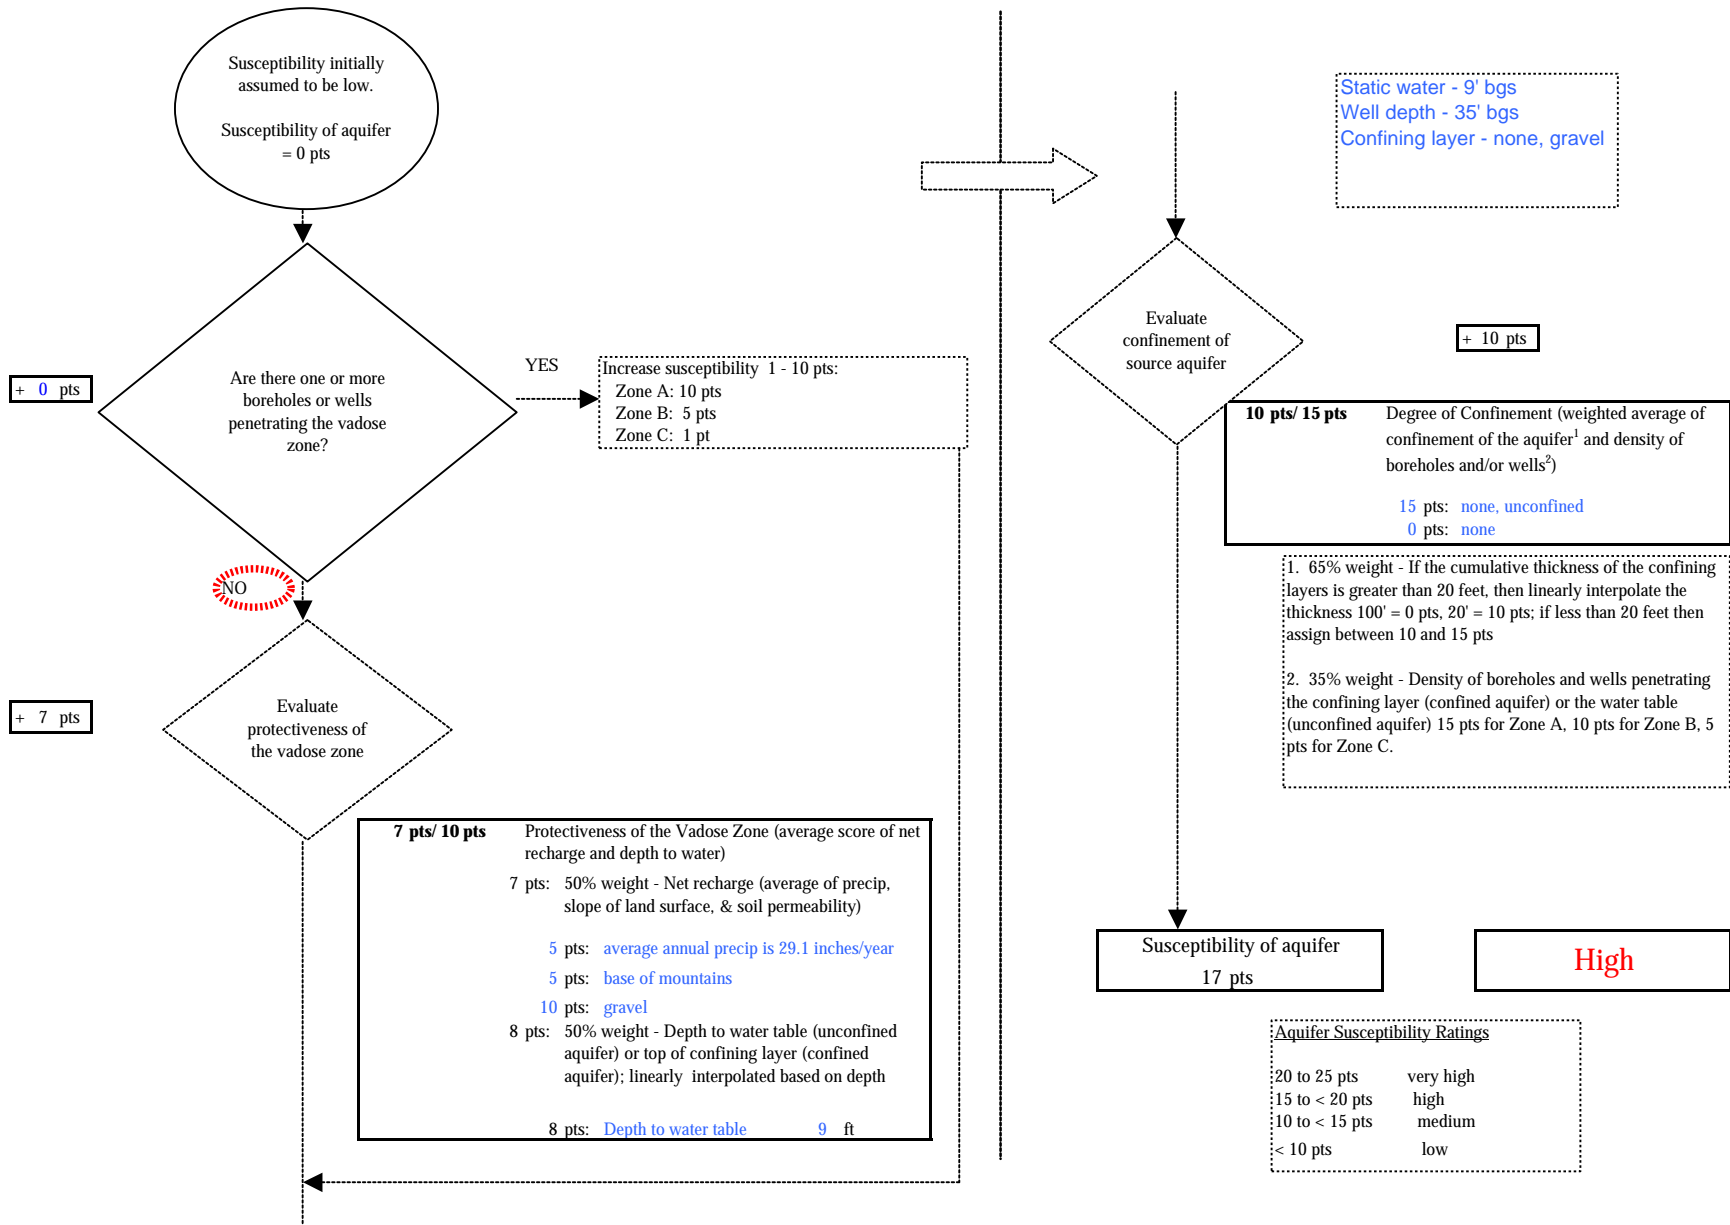
Chart 2. Susceptibility of the aquifer - USFS Primrose Landing Campground (240286.001)

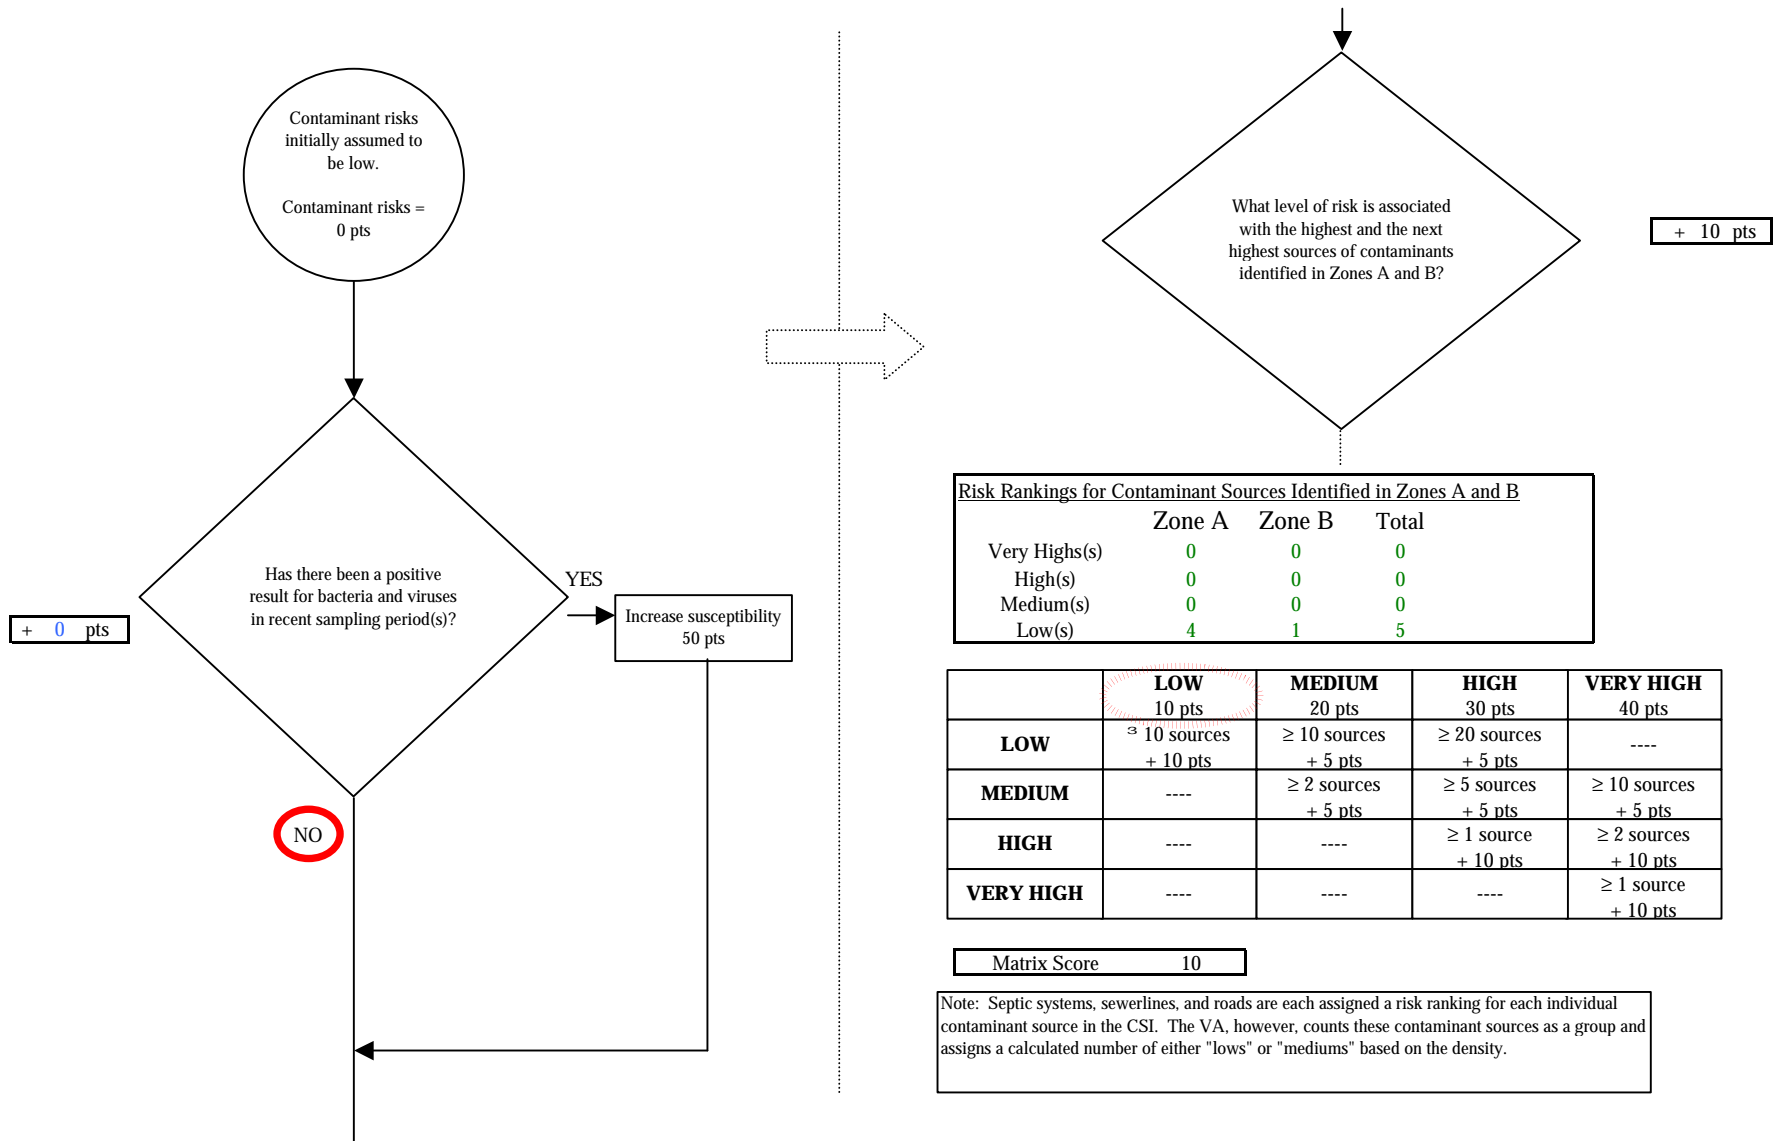
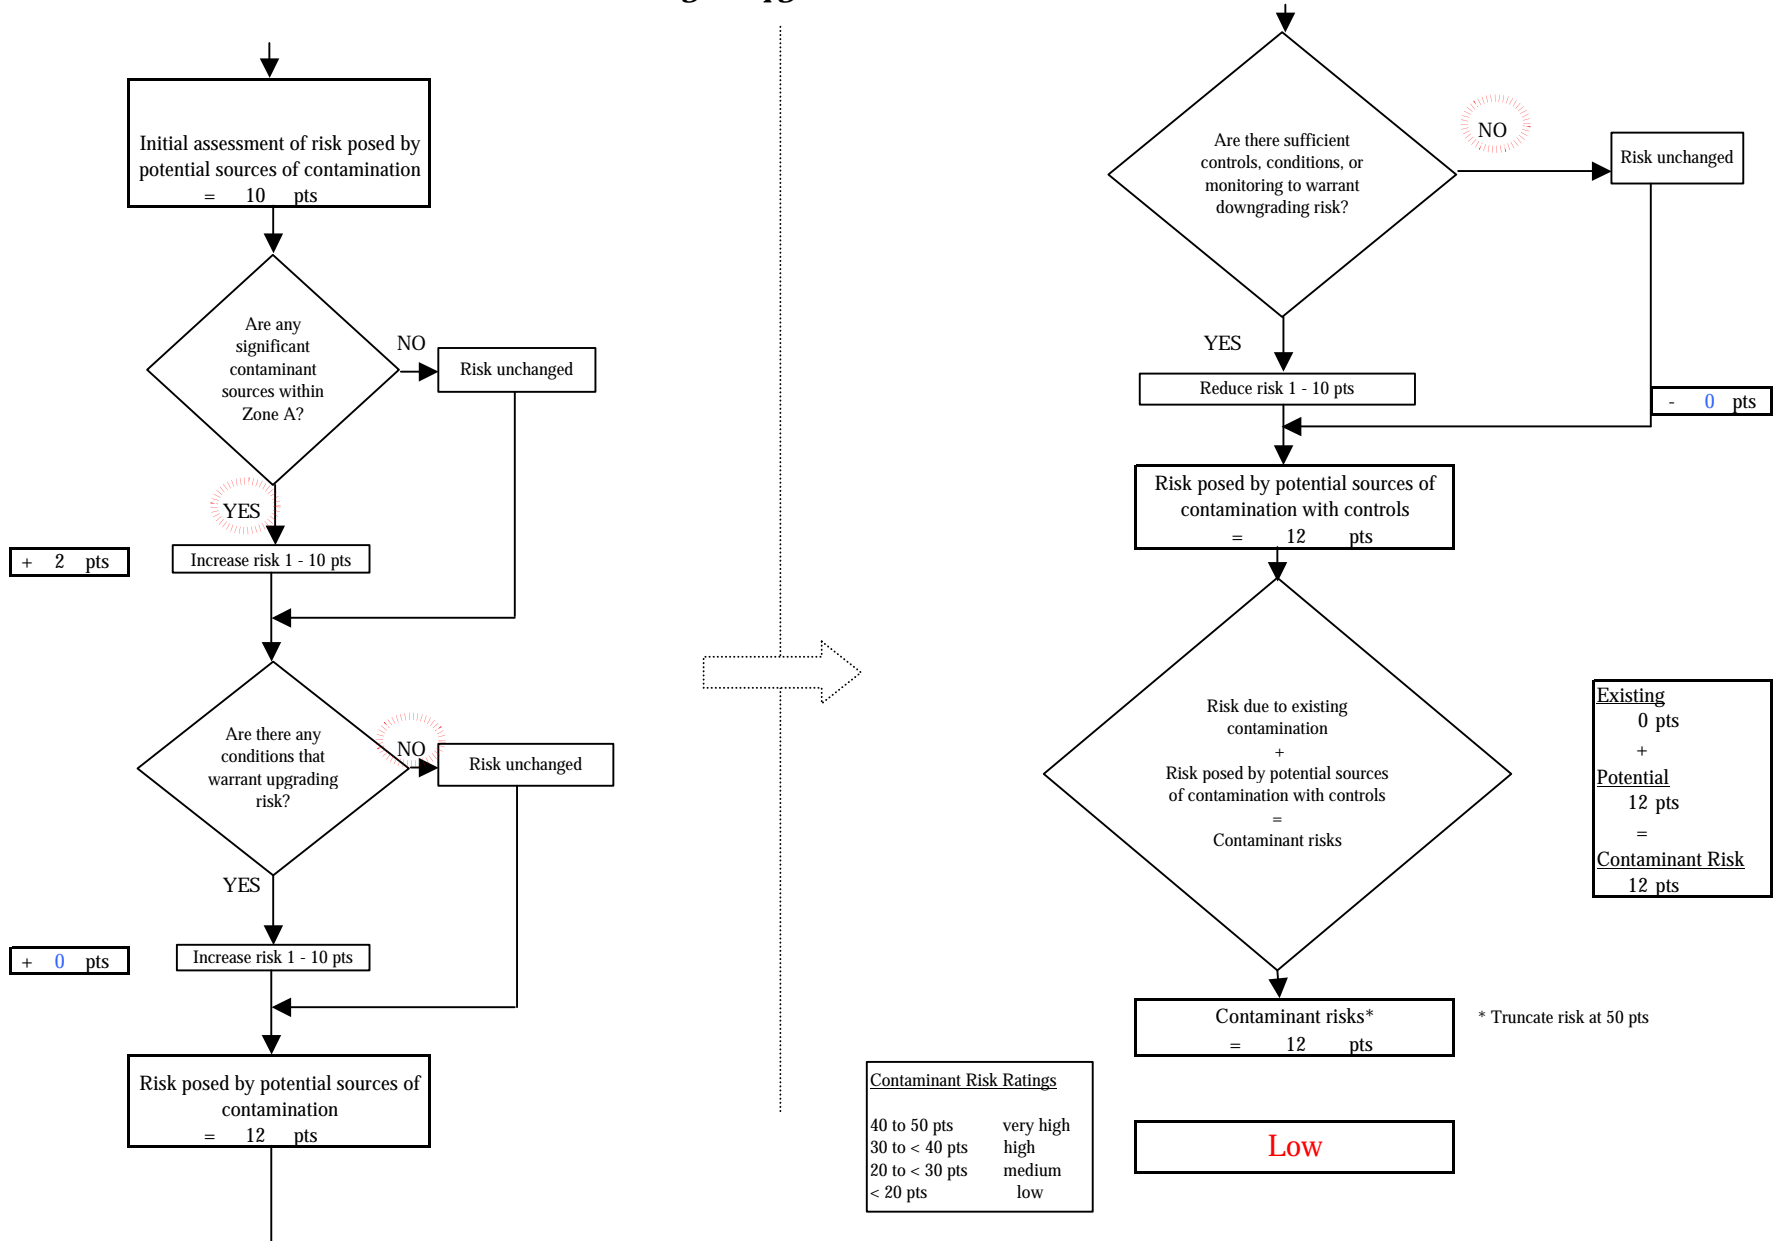
Chart 3. Contaminant risks for USFS Primrose Landing Campground (240286.001) - Bacteria & Viruses

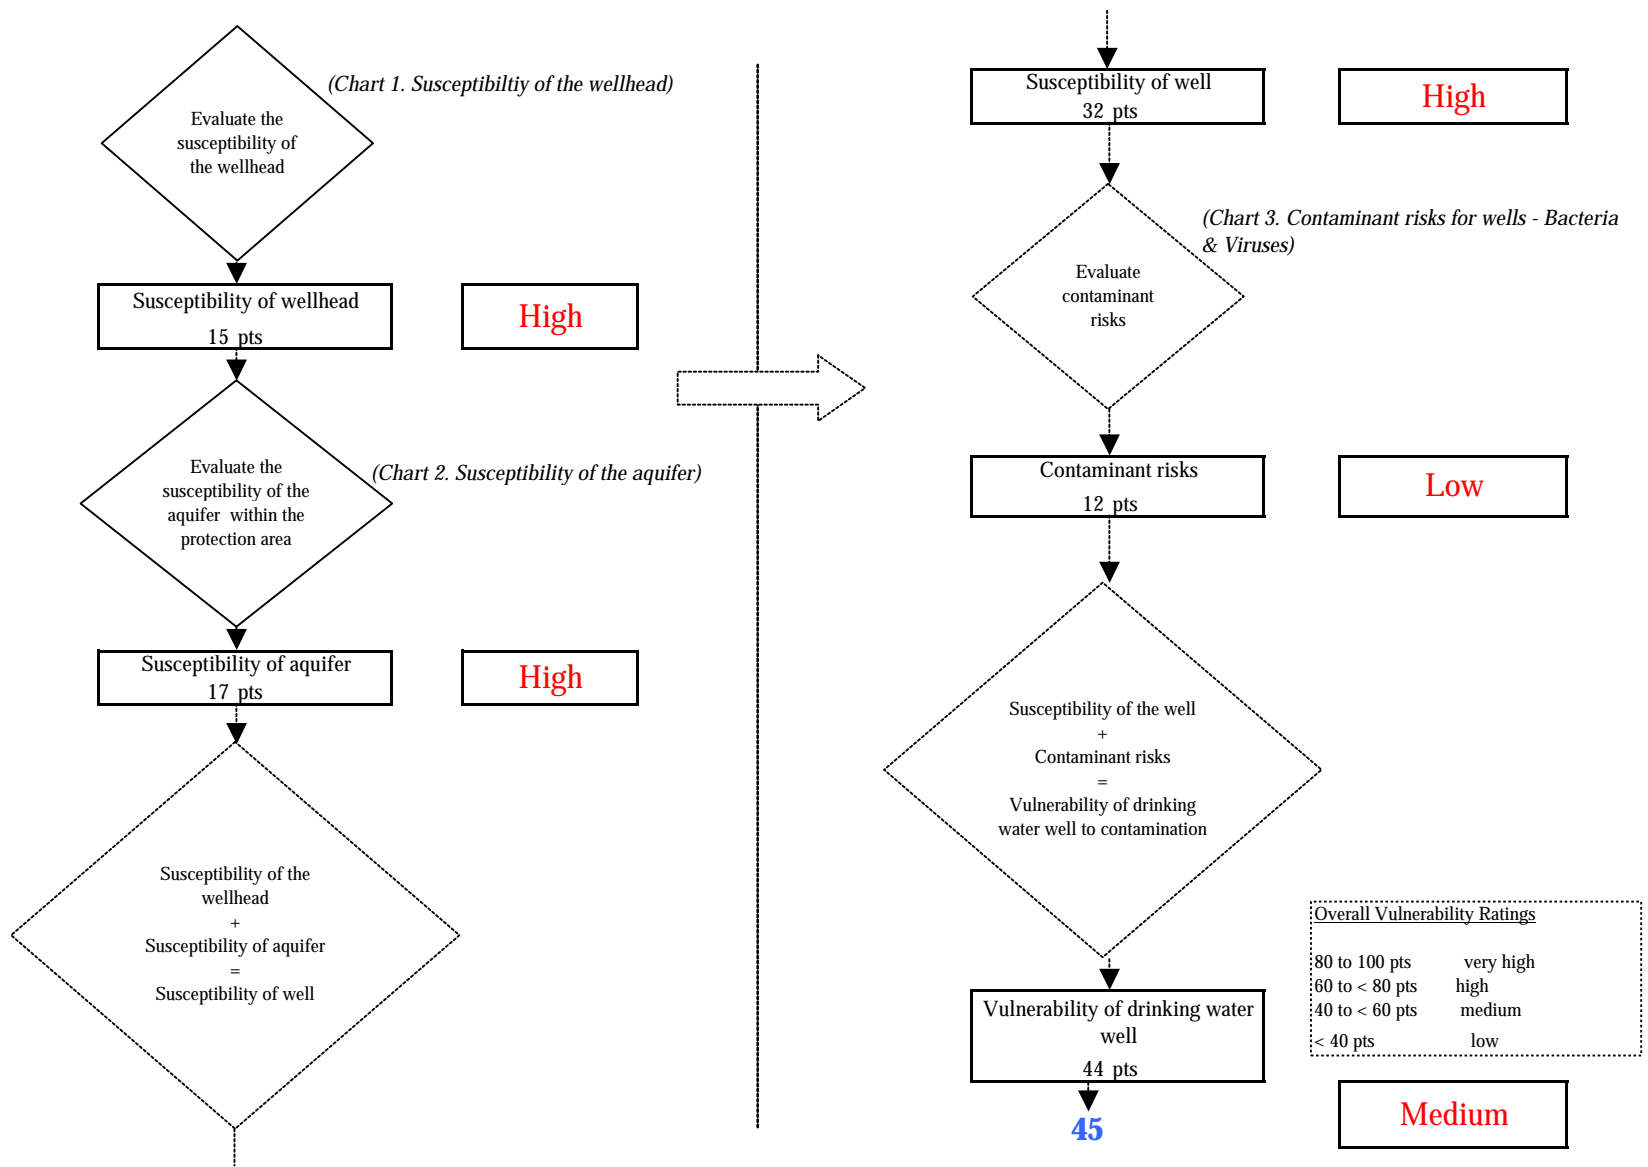
Chart 4. Vulnerability analysis for USFS Primrose Landing Campground (240286.001) - Bacteria & Viruses
