Source Water Assessment

A Hydrogeologic Susceptibility and
Vulnerability Assessment for
USFS Primrose Landing Campground
Drinking Water System,
Kenai Lake, Alaska
PWSID # 240286.001

DRINKING WATER PROTECTION PROGRAM REPORT # 348
Alaska Department of Environmental Conservation

By URS Corporation

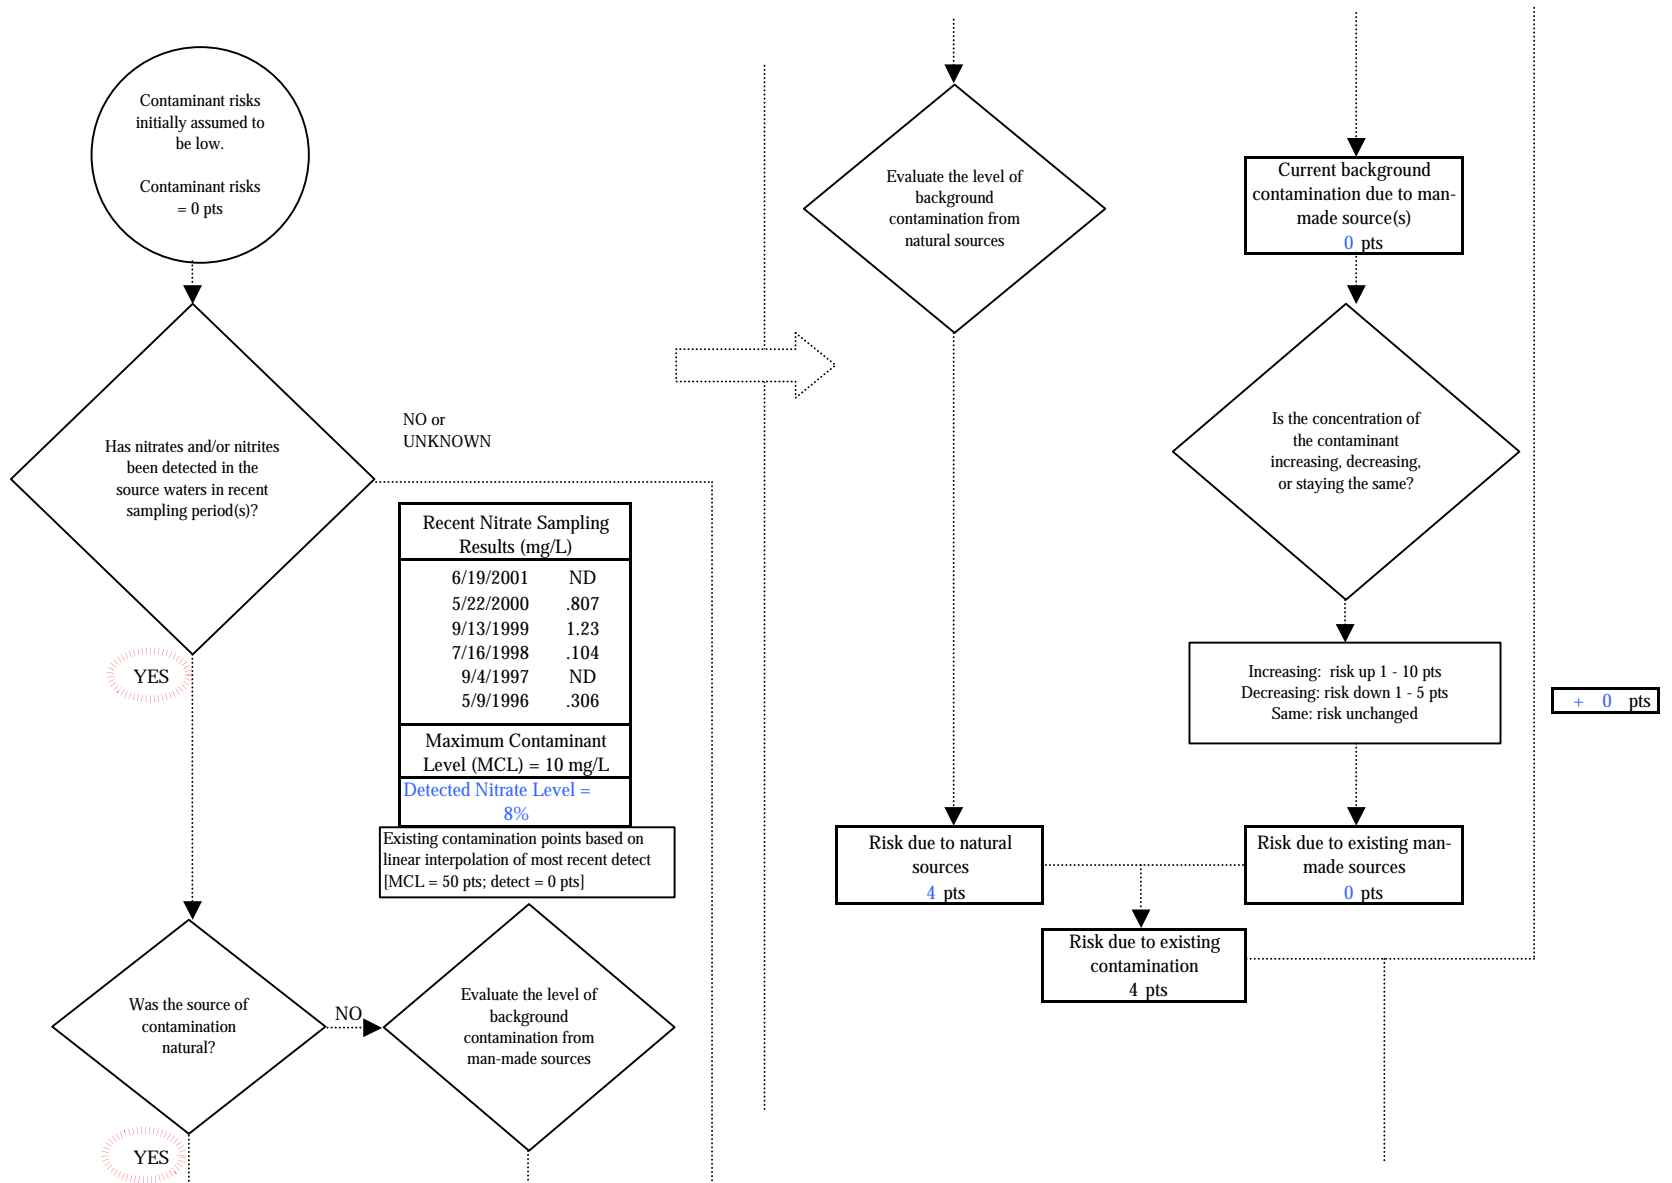
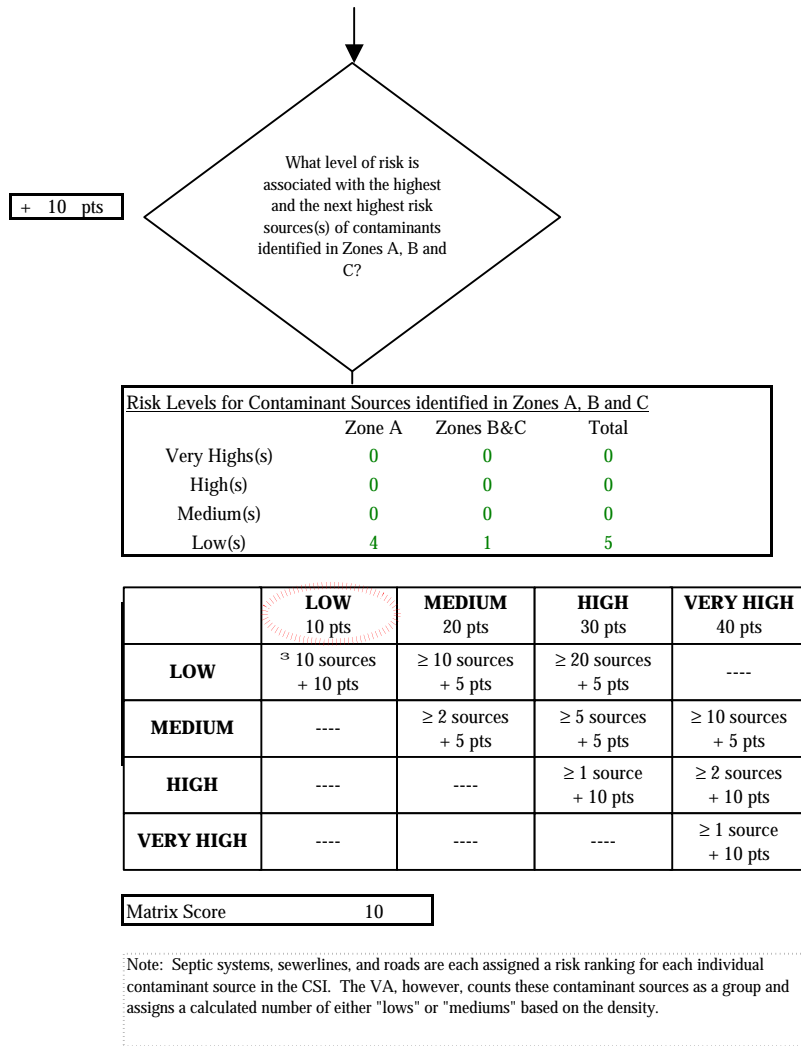
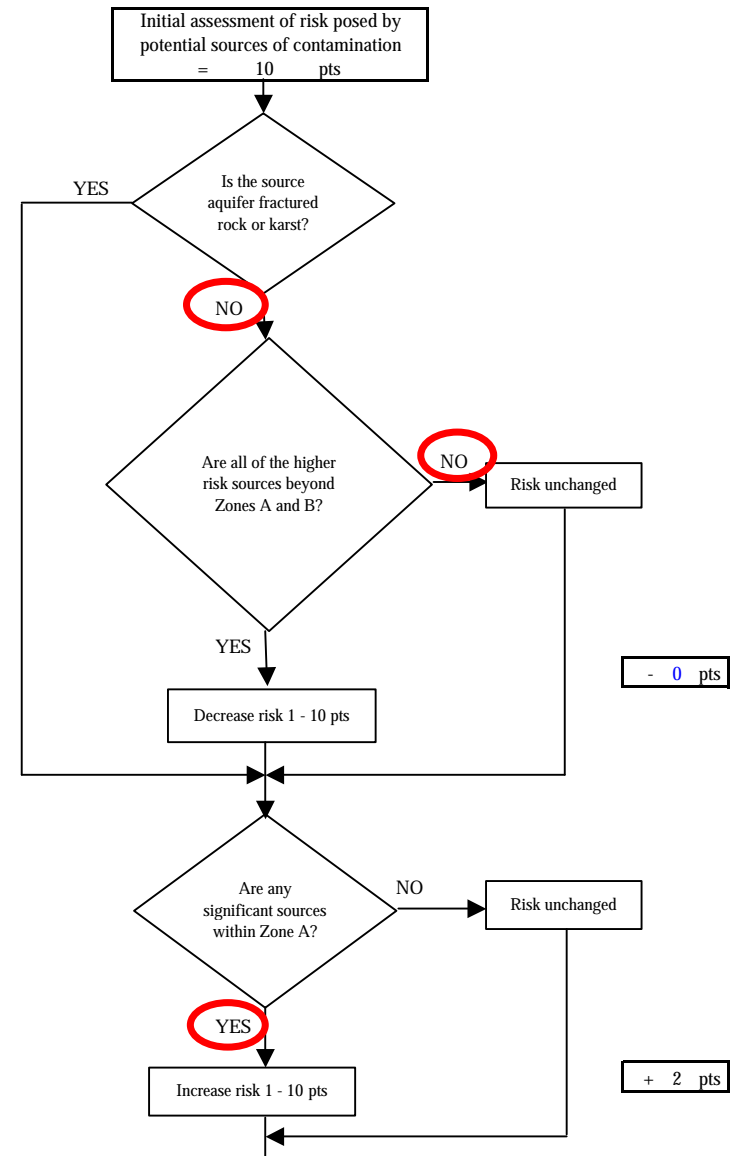
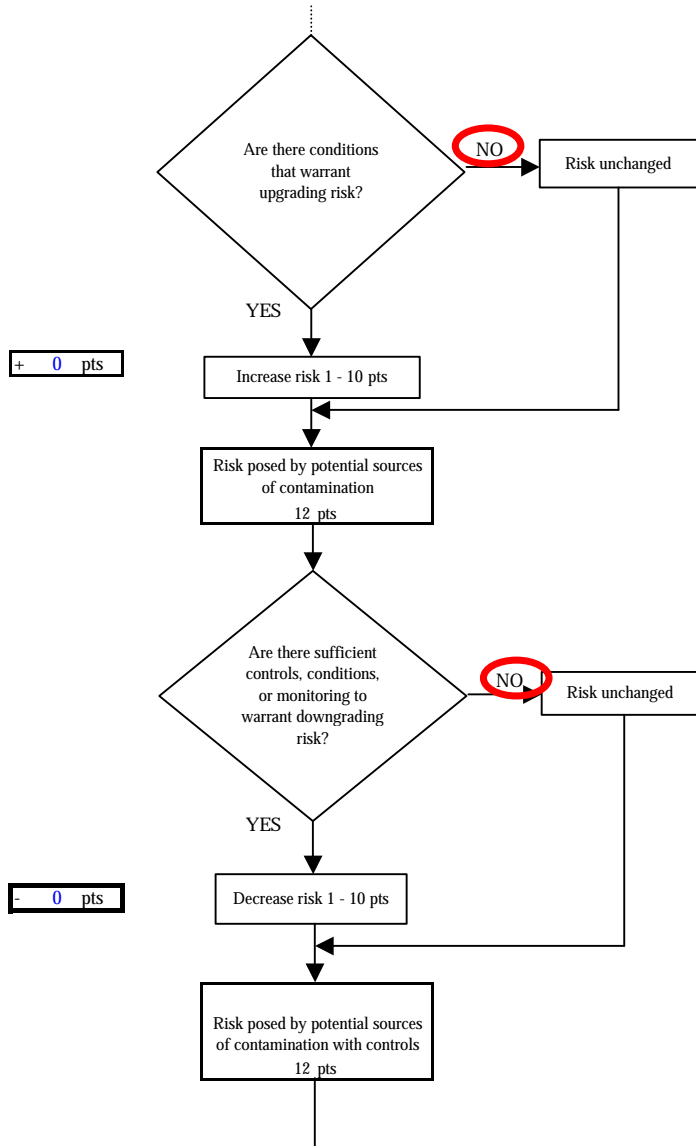
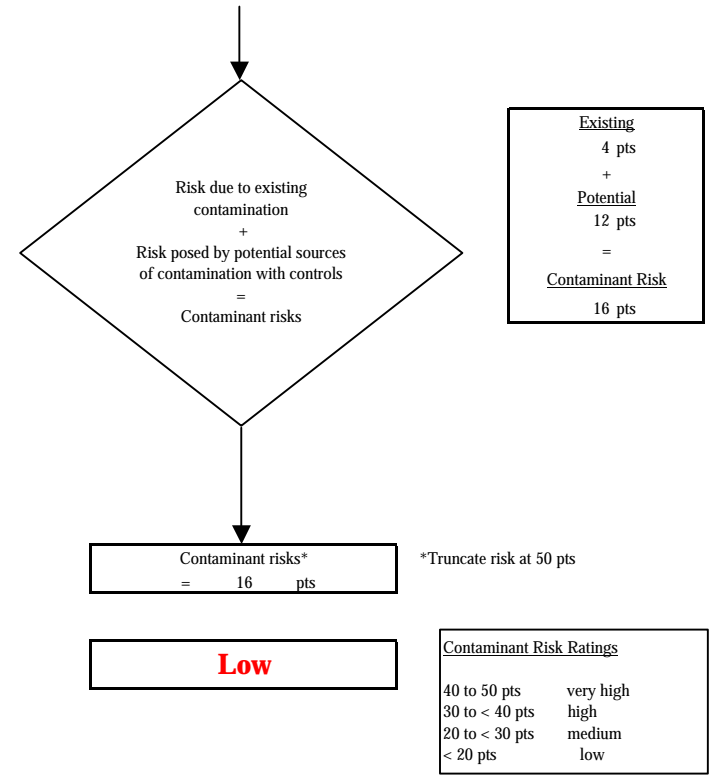
Chart 5. Contaminant risks for USFS Primrose Landing Campground (240286.001) - Nitrates and Nitrites

Sampling history for USFS Primrose Landing Campground well indicates that low concentrations of nitrate have been detected (See Chart 5 - Contaminant Risks for Nitrates and/or Nitrites in Appendix D). Existing nitrate concentration is approximately 0.8 mg/L or 8 % of the Maximum Contaminant Level (MCL) of 10mg/L. The MCL is the maximum level of contaminant that is allowed to exist in drinking water and still be consumed by humans without harmful health effects. Due to the high solubility and weak retention by soil, nitrates are very mobile, moving at approximately the same rate as water. Though existing nitrate contamination was detected at the site, concentrations remain at very safe levels with respect to human health.

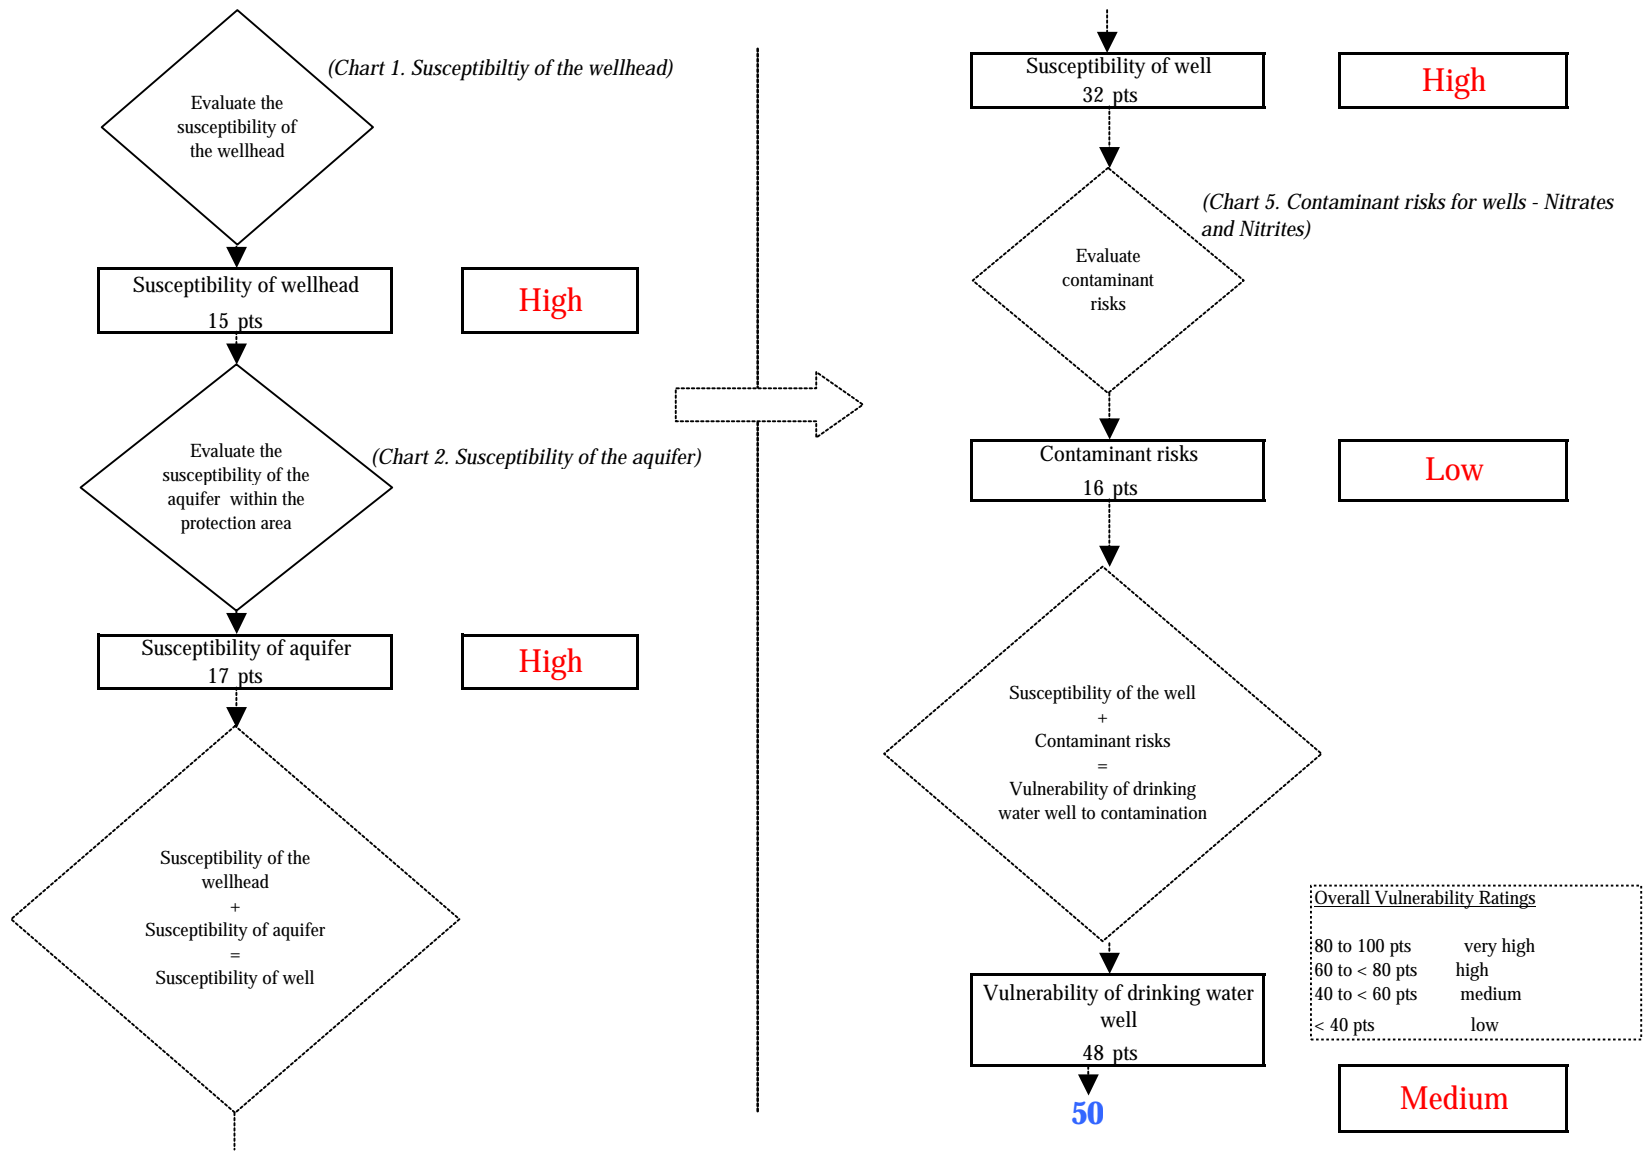
Chart 6. Vulnerability analysis for USFS Primrose Landing Campground (240286.001) - Nitrates and Nitrites

Appendix D contains eight charts, which together form the ‘Vulnerability Analysis’ for a source water assessment for a public drinking water source. Chart 1 analyzes the ‘Susceptibility of the Wellhead’ to contamination by looking at the construction of the well and its surrounding area. Chart 2 analyzes the ‘Susceptibility of the Aquifer’ to contamination by looking at the naturally occurring attributes of the water source and influences on the groundwater system that might lead to contamination. Chart 3 analyzes ‘Contaminant Risks’ for the drinking water source with respect to bacteria and viruses. The ‘Contaminant Risks’ portion of the analysis considers potential sources of contaminants as well as a review of contamination that has or may have occurred, but has not arrived or been detected at the well. Lastly, Chart 4 contains the ‘Vulnerability Analysis for Bacteria and Viruses’. Charts 5 through 8 contain the Contaminant Risks and Vulnerability Analyses for nitrates and nitrites and volatile organic chemicals, respectively.

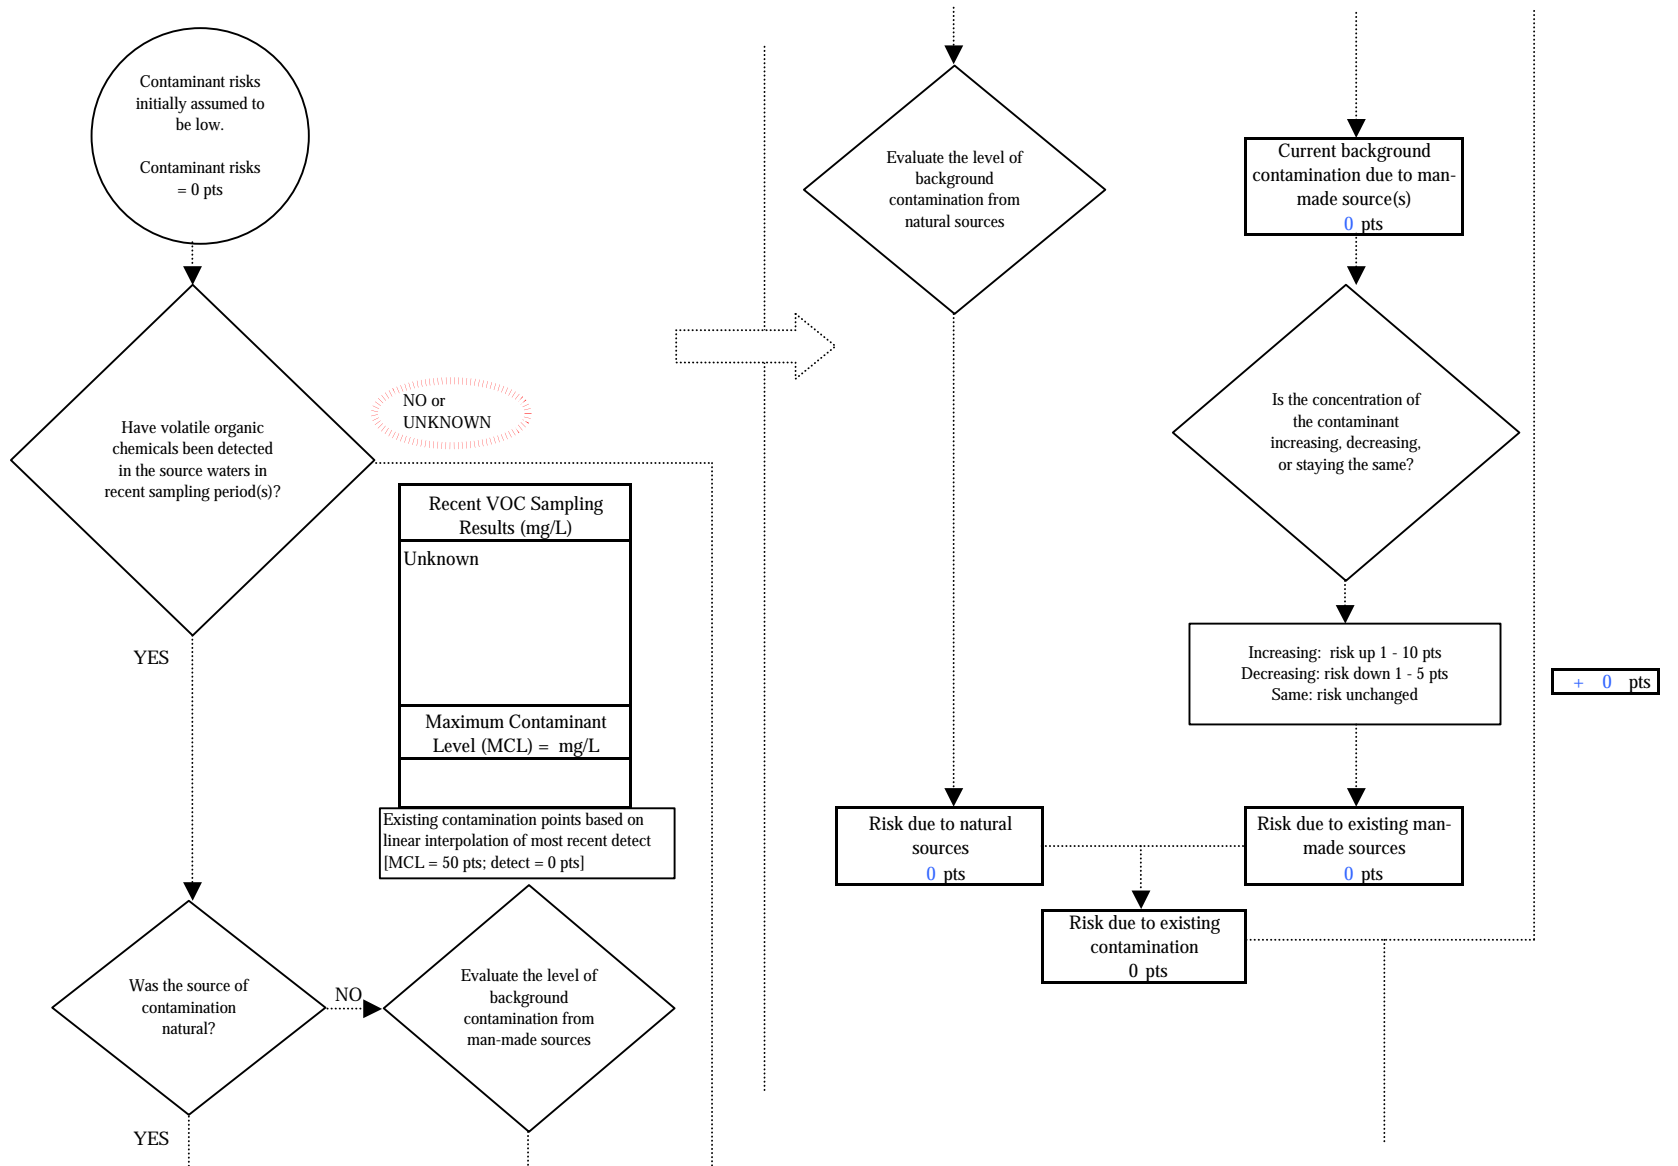
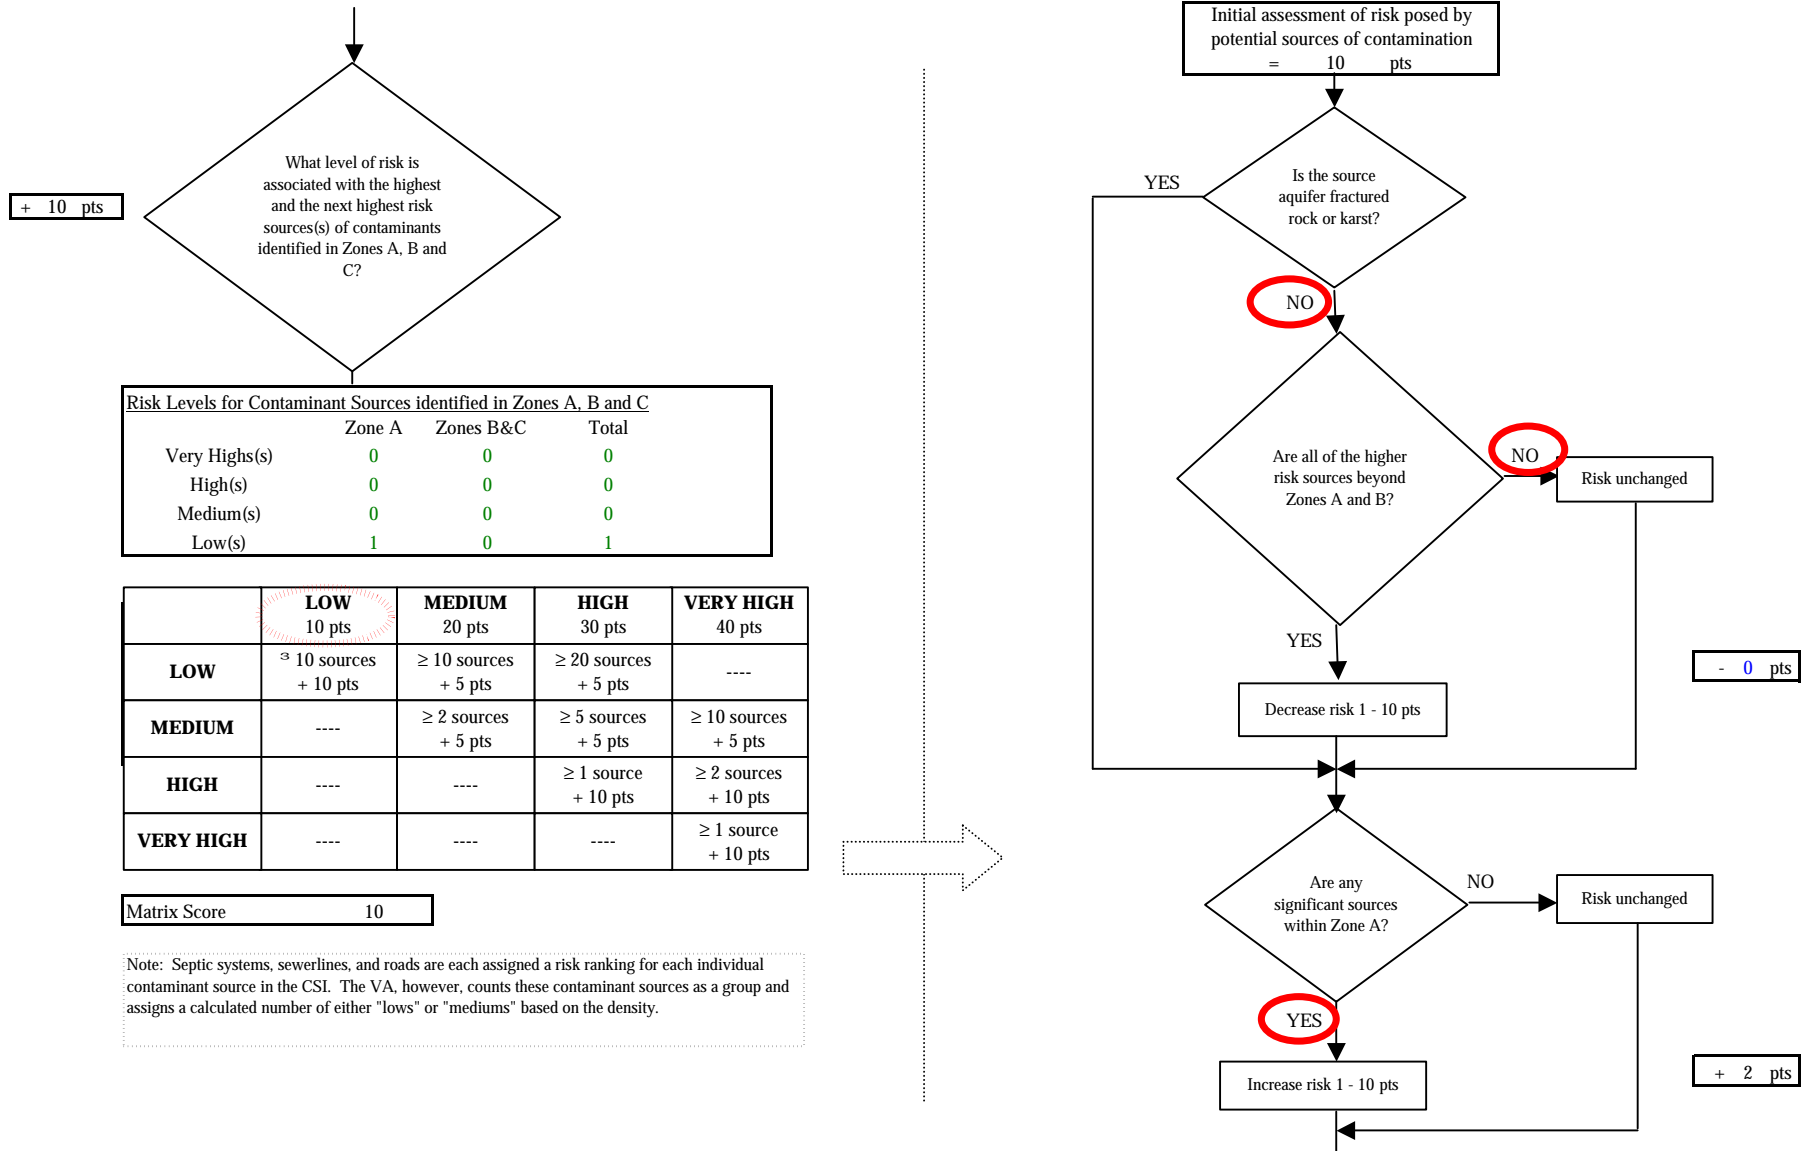
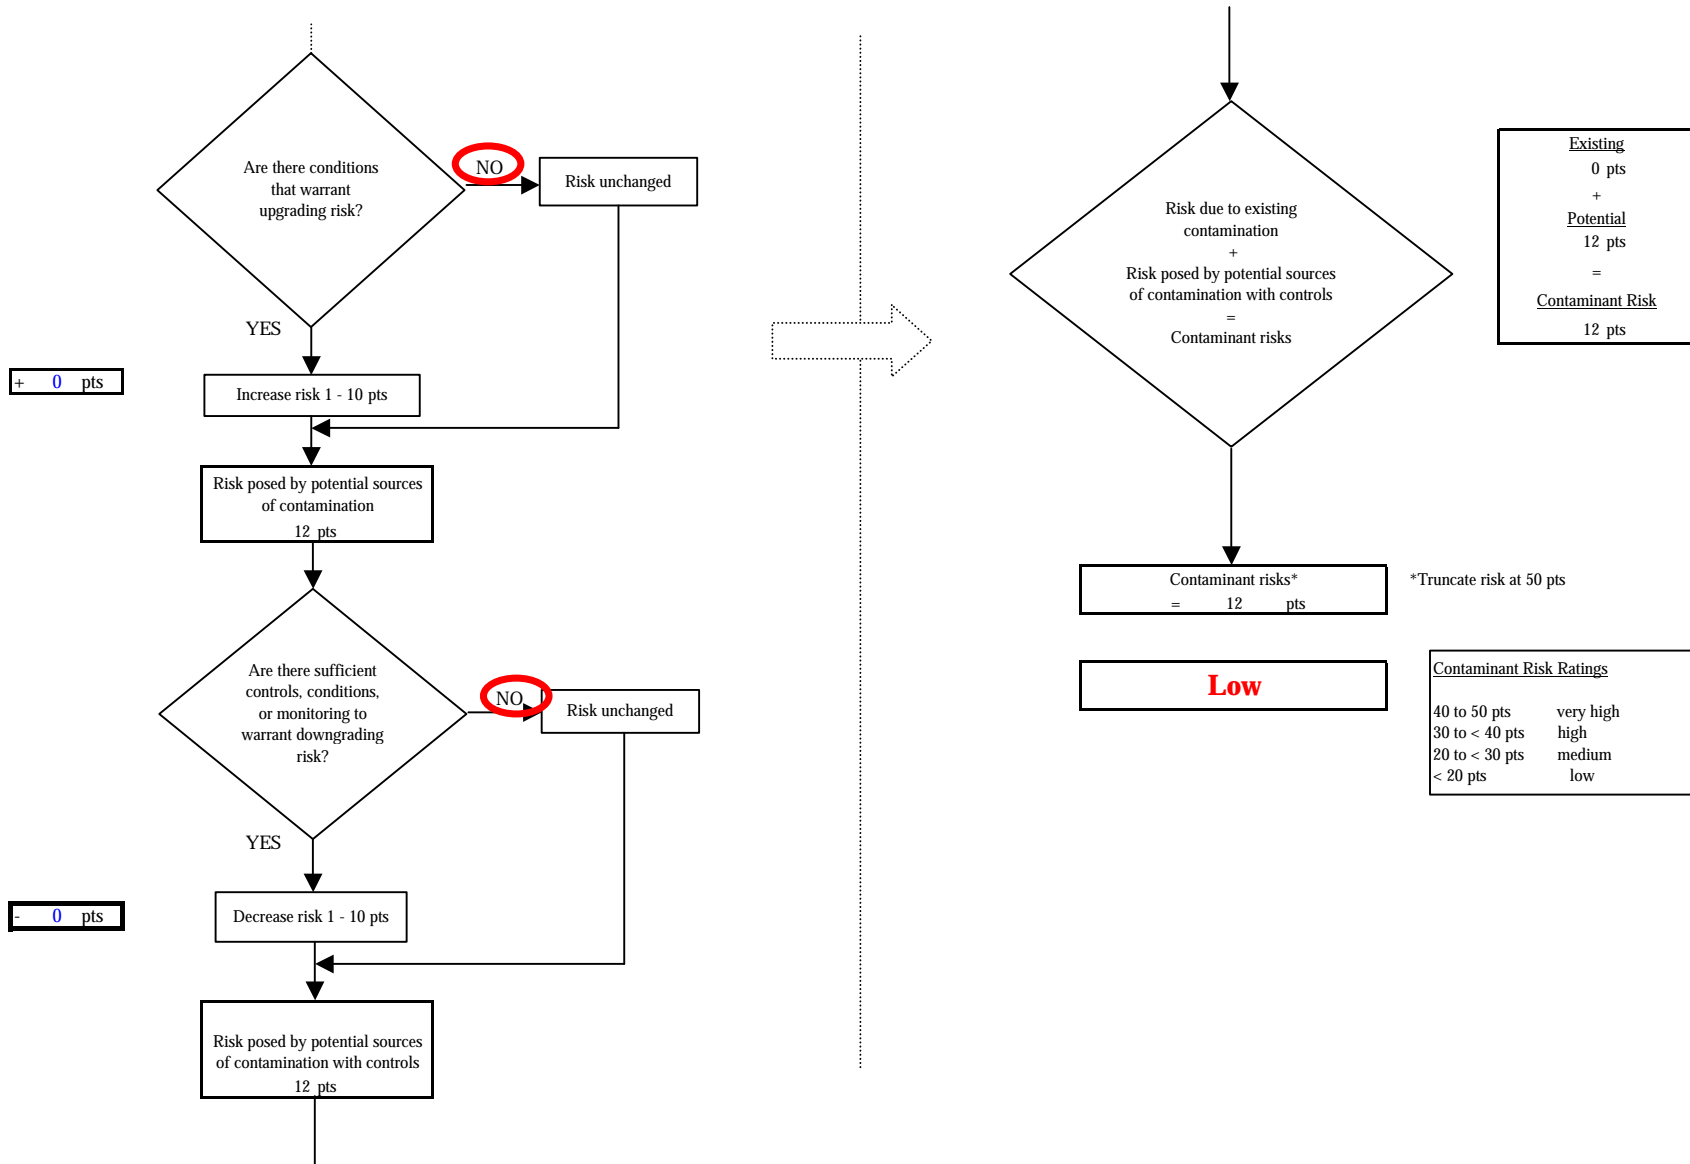
Chart 7. Contaminant risks for USFS Primrose Landing Campground (240286.001) - Volatile Organic Chemicals

Risk Levels for Contaminant Sources identified in Zones A, B and C			
	Zone A	Zones B&C	Total
Very High(s)	0	0	0
High(s)	0	0	0
Medium(s)	0	0	0
Low(s)	1	0	1

Matrix Score 10

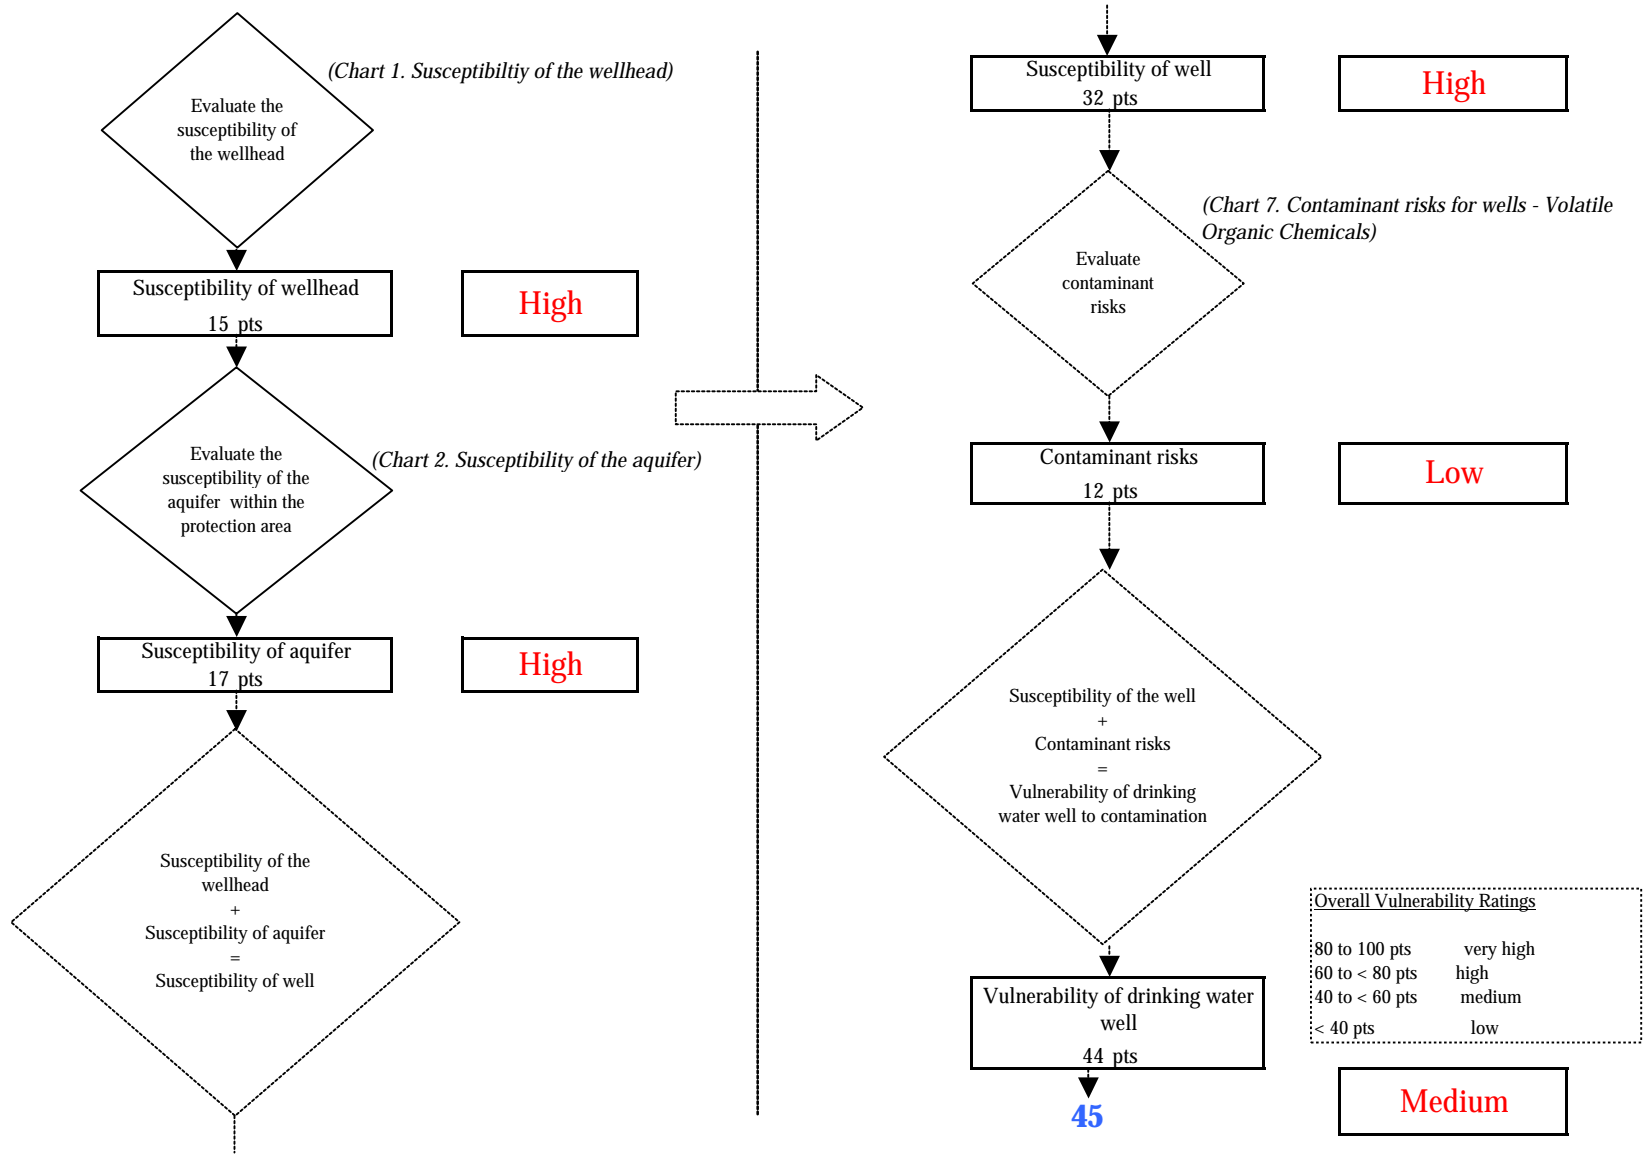
Chart 8. Vulnerability analysis for USFS Primrose Landing Campground (240286.001) - Volatile Organic Chemicals
