Source Water Assessment

Mecca Bar
Ketchikan, Alaska

PWSID # 120101.001

Drinking Water Protection Program Report #730
Alaska Department of Environmental Conservation

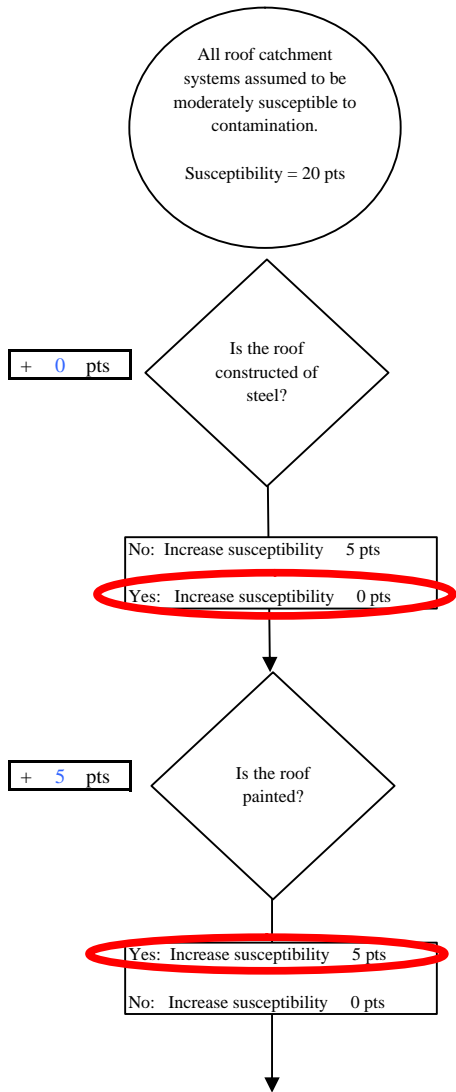
Chart 1. Susceptibility of the Roof Catchment - Mecca Bar

A score for the Susceptibility of the Roof Catchment is determined by considering the properties of the water intake and the surrounding area. The derivation of this information is presented below and the data for this source is shown in Chart 1 of Appendix B.

Score	Rating
Minimum Allowable Susceptibility	20	
Roof construction	0	
Roof painted	5	
Collection gutters screened	5	
Overhanging vegetation	0	
First flush collected	5	
Overall Susceptibility	35	High

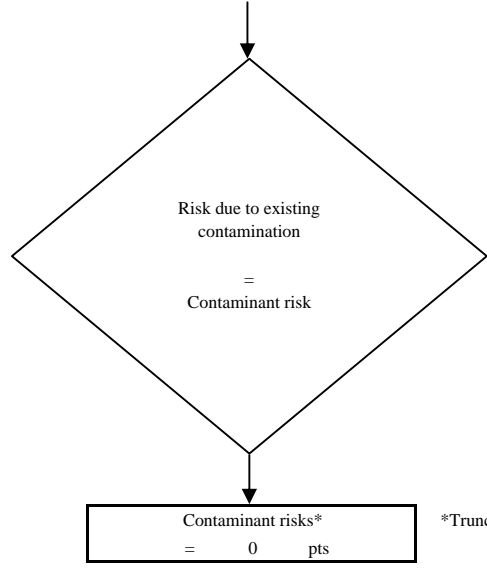
Chart 4. Contaminant risks for Mecca Bar - Nitrates and Nitrites

The contaminant risk for nitrates and nitrites is “**low**” (See Chart 4 - Contaminant Risks for Nitrates and/or Nitrites in Appendix B). Nitrates are very mobile, moving at approximately the same rate as water.

Sampling history for the water source indicates that nitrates were detected in sampling reviewed from 2002, but only in small amounts. Most recently (5/4/2002) at 0.1 milligrams per liter (milligrams per liter) or 1% of the Maximum Contaminant Level (MCL). The MCL for nitrates is 10 mg/L, and is the maximum level of contaminant that is allowed to exist in drinking water and still be consumed by humans without harmful health effects (EPA, 2003).

A possible source of nitrate/nitrites is the presence of animal (birds, squirrels, etc.) excrement on the roof.
