Source Water Assessment

A Hydrogeologic Susceptibility and
Vulnerability Assessment for
Moorcroft Bear Trail Lodge
Drinking Water System,
King Salmon, Alaska

PWSID # 263024.001

March 2004

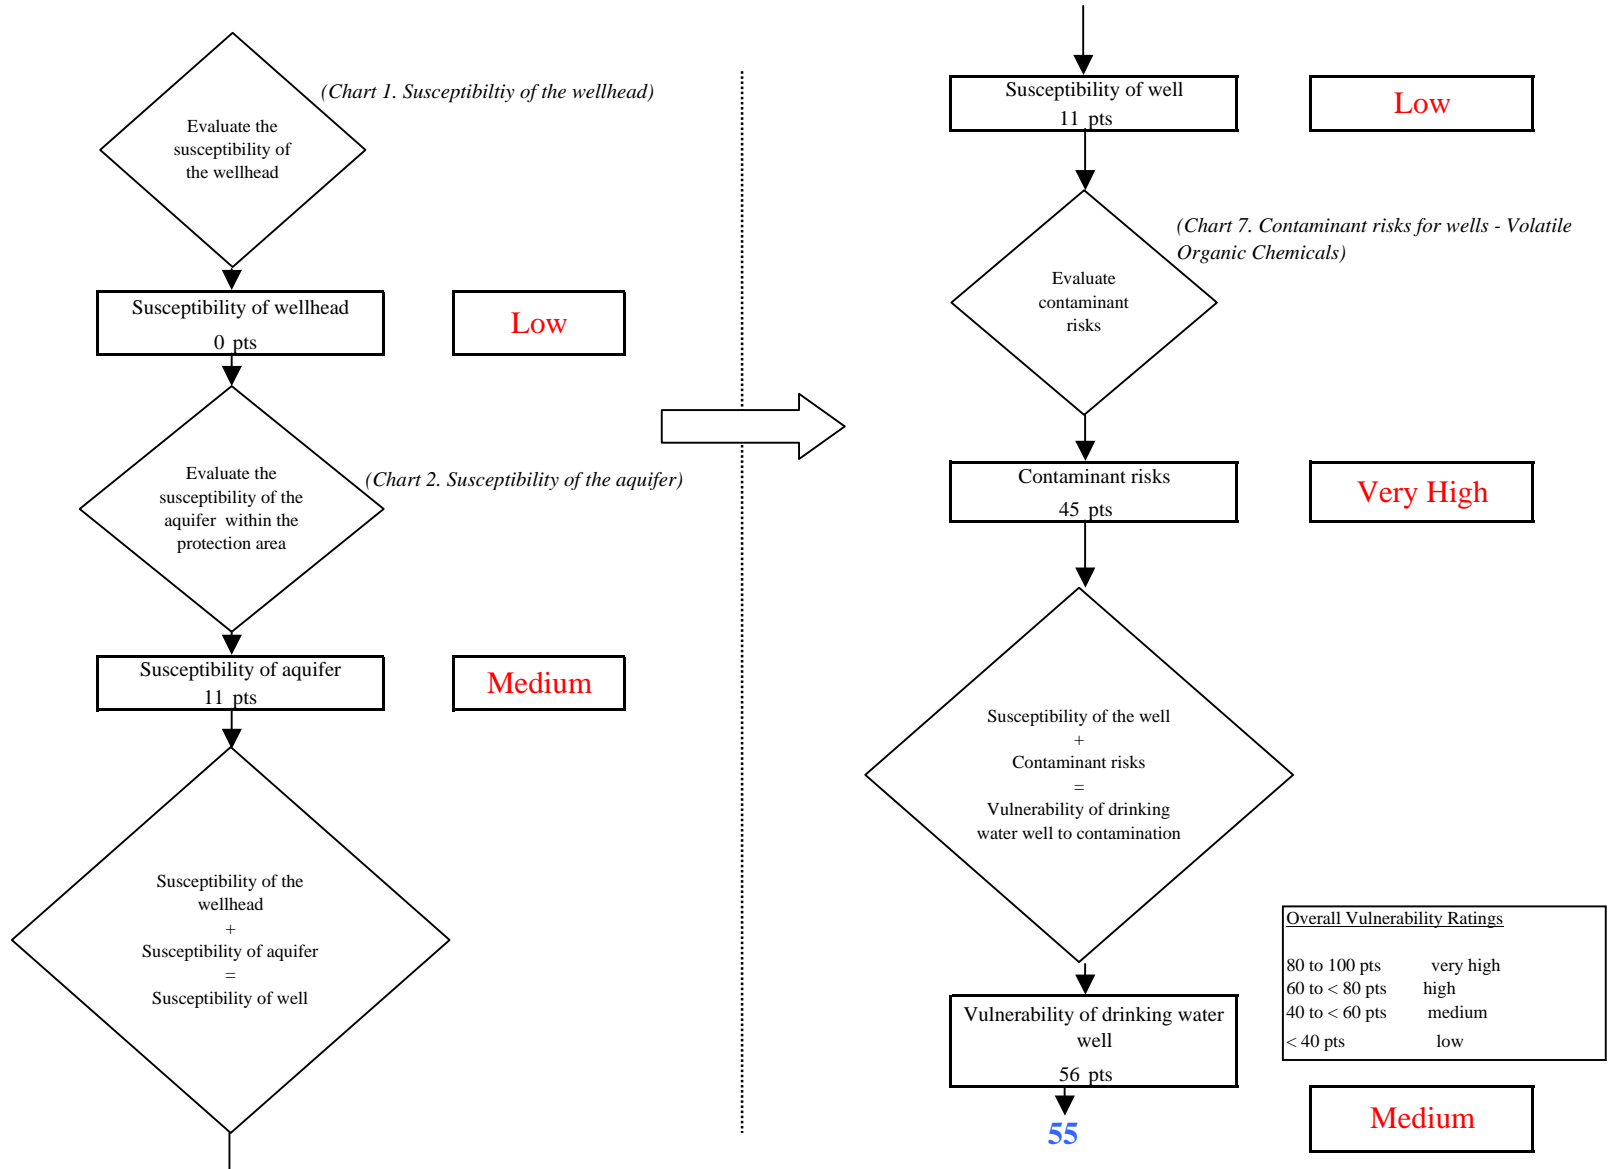
Chart 8. Vulnerability analysis for Moorcroft Bear Trail Lodge (263024.001) - Volatile Organic Chemicals

After combining the contaminant risk for volatile organic chemicals with the natural susceptibility of the well, the overall vulnerability of the well to contamination is **Medium**.
