Source Water Assessment

A Hydrogeologic Susceptibility and
Vulnerability Assessment for
Wolverine Lodge
Drinking Water System,
Lake Louise, Alaska
Wolverine Lodge #226478

DRINKING WATER PROTECTION PROGRAM REPORT 250
Alaska Department of Environmental Conservation

AUGUST 2002

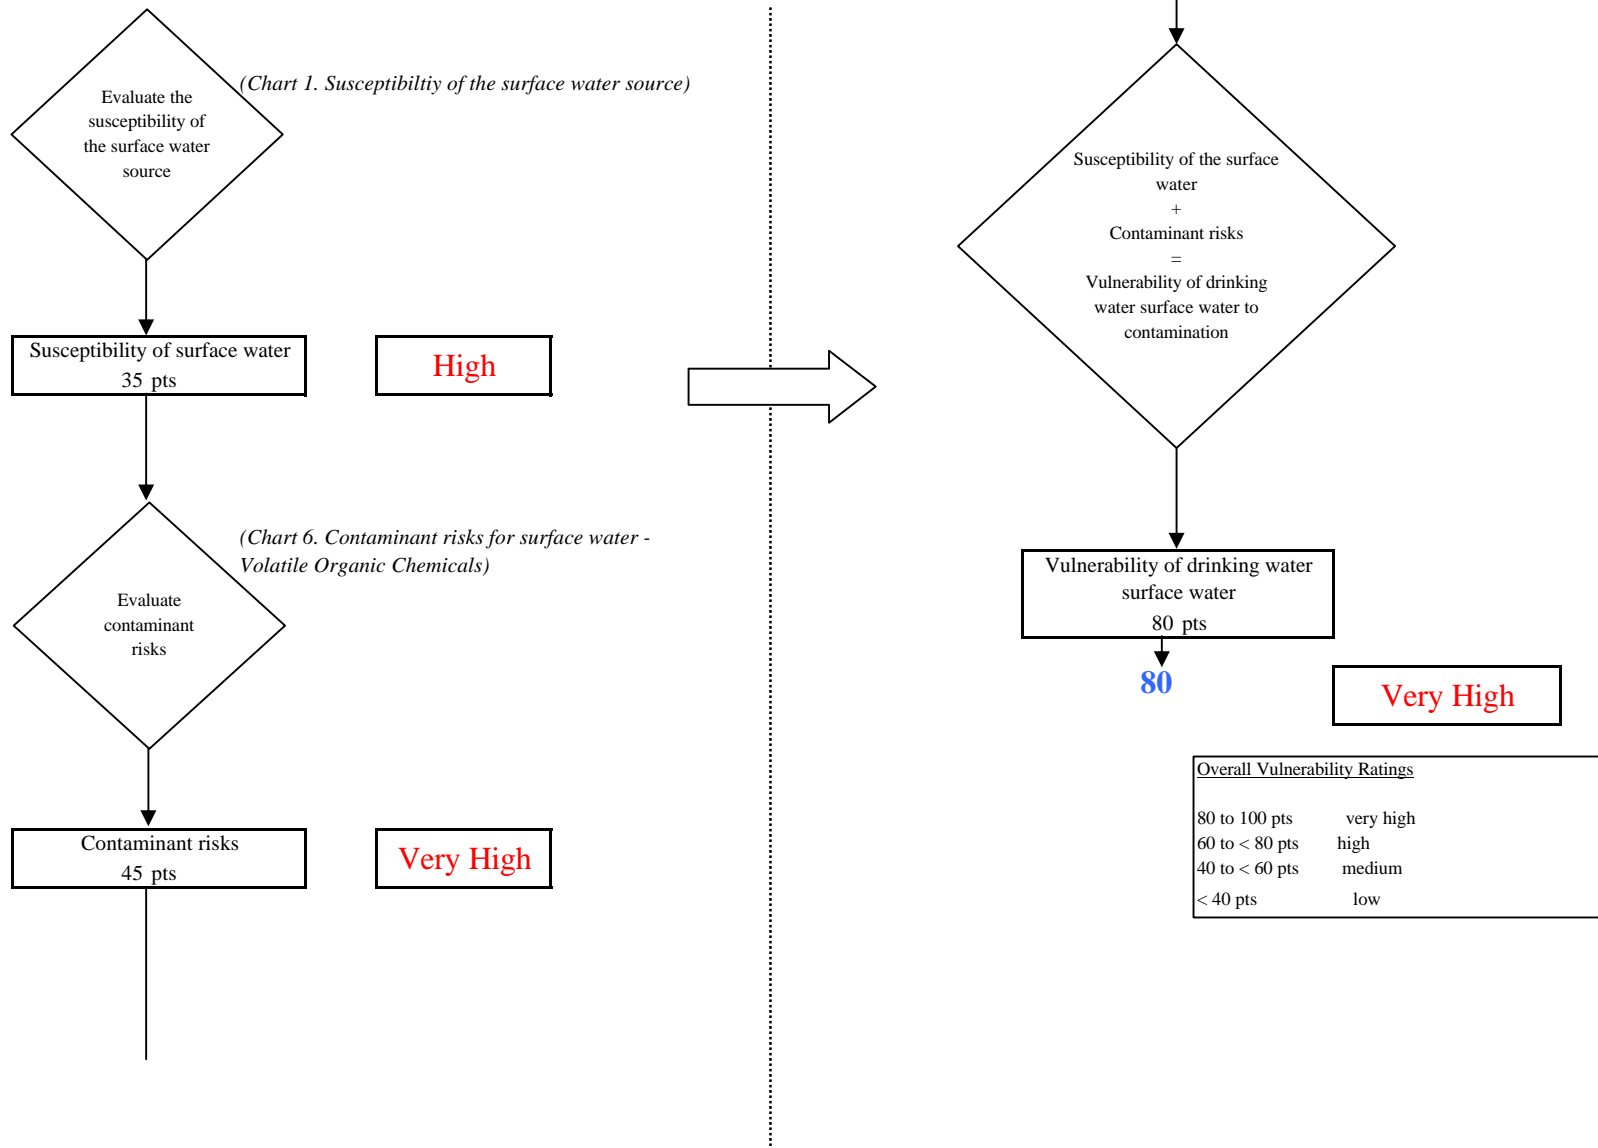
Chart 7. Vulnerability Analysis for Wolverine Lodge - Volatile Organic Chemicals
