# Source Water Assessment

A Hydrogeologic Susceptibility and  
Vulnerability Assessment for  
Carlo Creek Lodge  
Drinking Water System,  
McKinley Park, Alaska  
PWSID # 390196

DRINKING WATER PROTECTION PROGRAM REPORT # 294  
Alaska Department of Environmental Conservation

August 2002

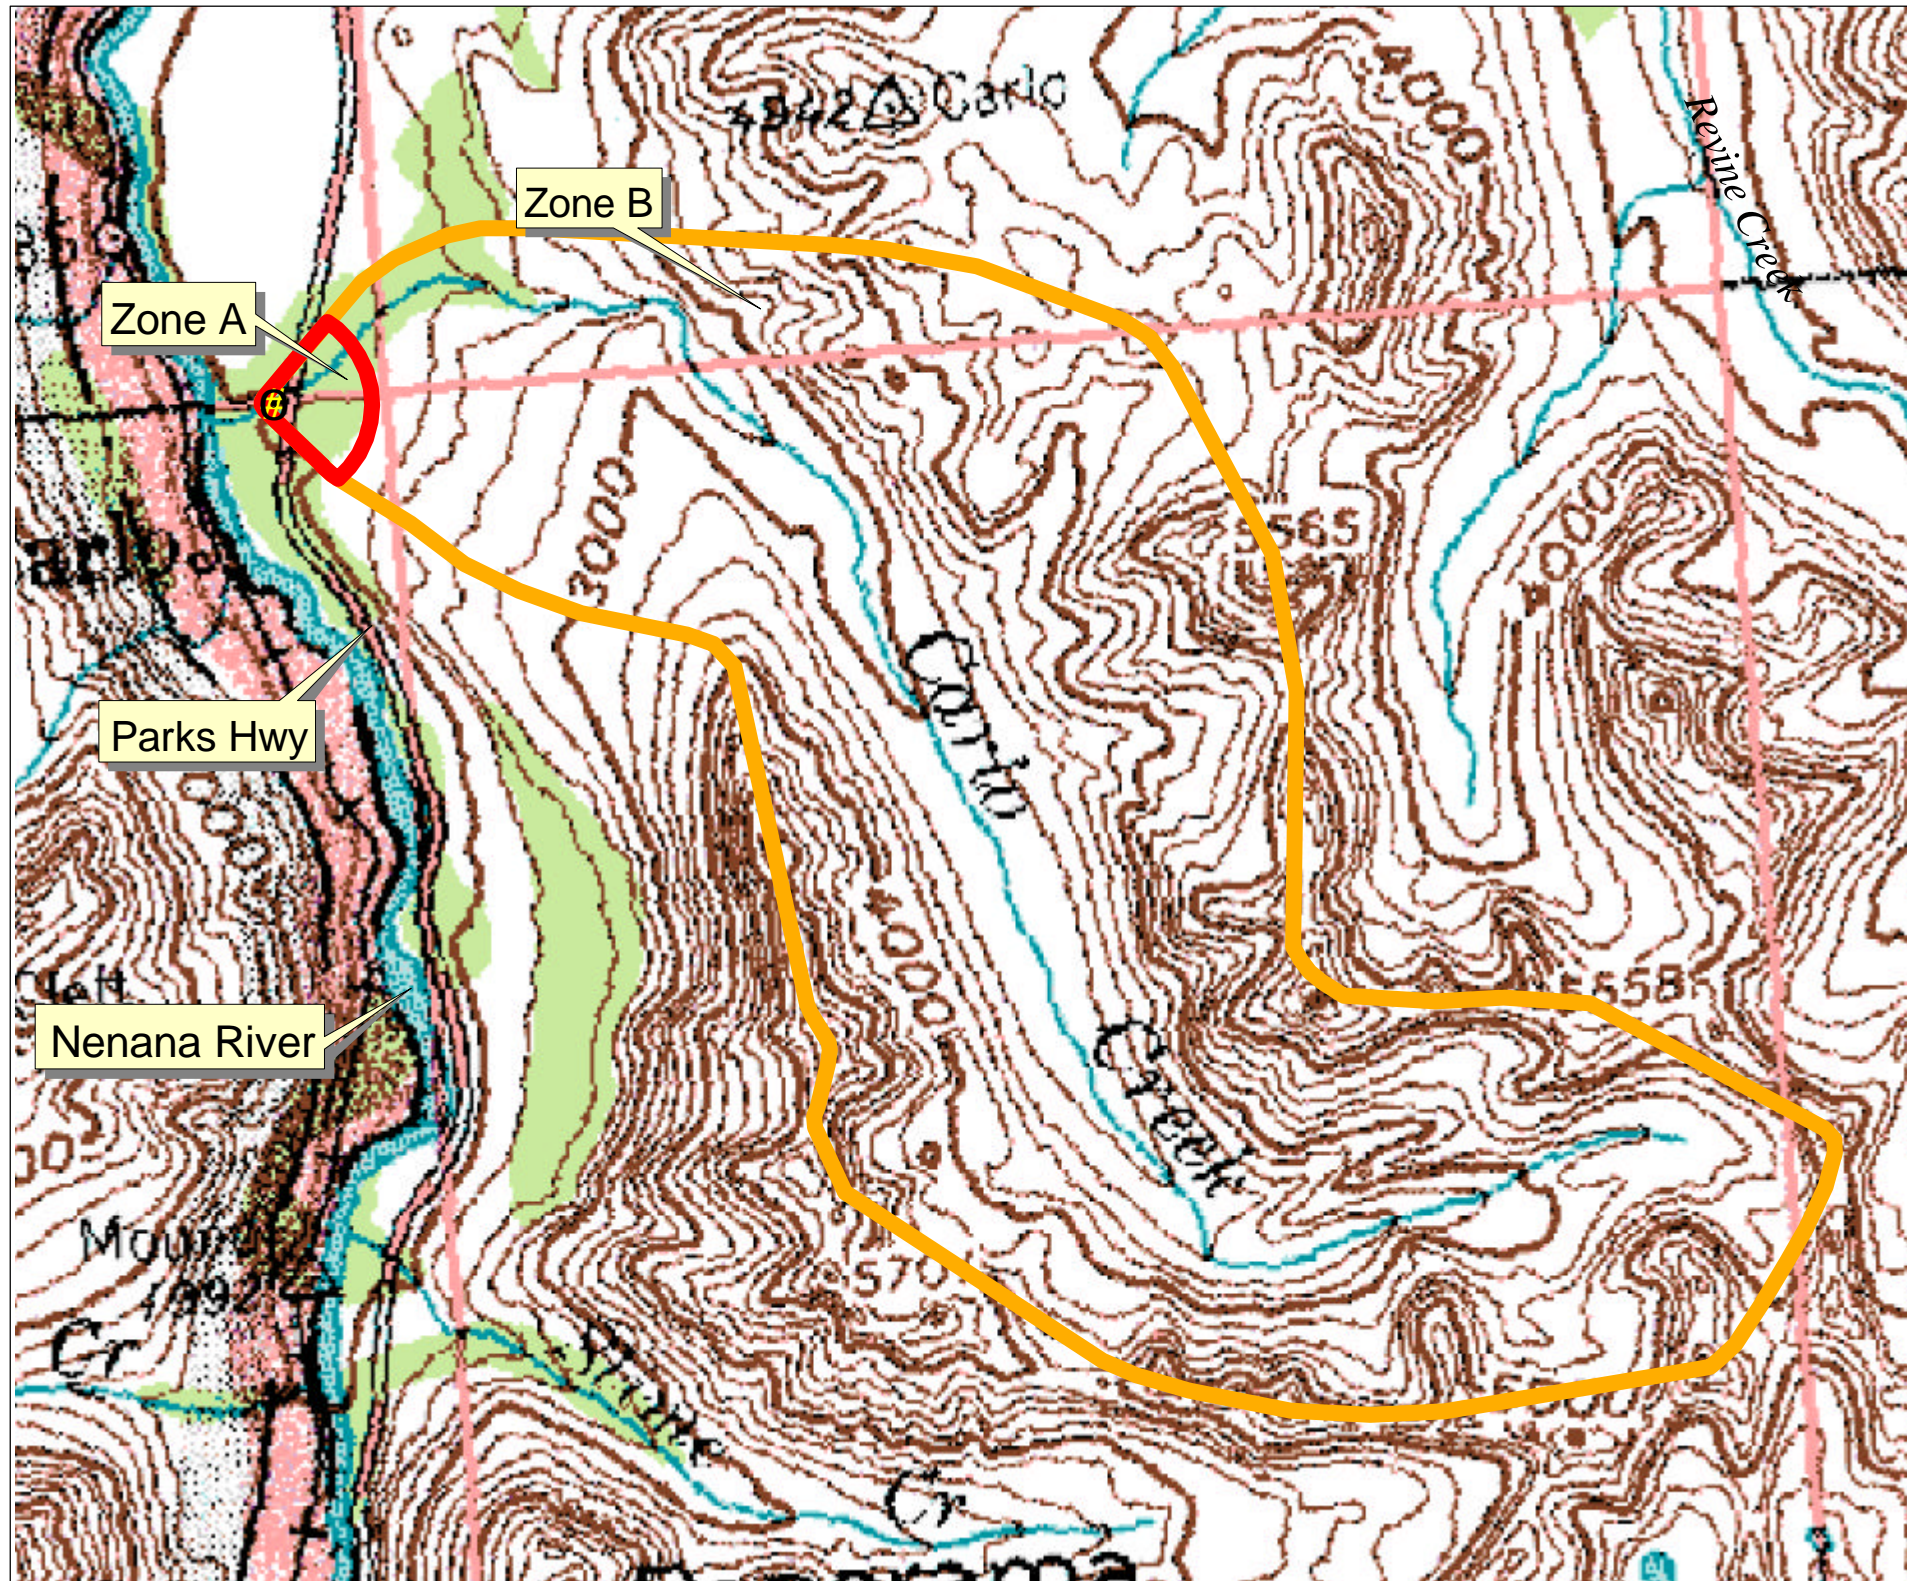
*Map 1*

### **Carlo Creek Lodge Drinking Water Protection Area (Map 1)**

- Carlo Creek Lodge Well
- Zone A (Few Months Travel Time)
- Zone B (Less Than 2 Years Travel Time)

The most probable area for contamination to reach the drinking water well is the area that contributes water to the well, the groundwater recharge area. This area is designated as the Drinking Water Protection Area (DWPA). Because a release of contaminants within the DWPA are most likely to impact the drinking water well, this area will serve as the focus for voluntary protection efforts.

The DWPAs established for wells by the ADEC are separated into four zones. These zones correspond to differences in the time-of-travel (TOT) of the water moving through the aquifer to the well. The time of travel for contaminants within the water varies and is dependent on the physical and chemical characteristics of each contaminant. The following is a summary of the four DWPA zones and the calculated time-of-travel for each:
