Source Water Assessment

A Hydrogeologic Susceptibility and
Vulnerability Assessment for
McKinley Creekside Cabins
Drinking Water System,
McKinley Park, Alaska

PWSID # 390447

DRINKING WATER PROTECTION PROGRAM REPORT # 283

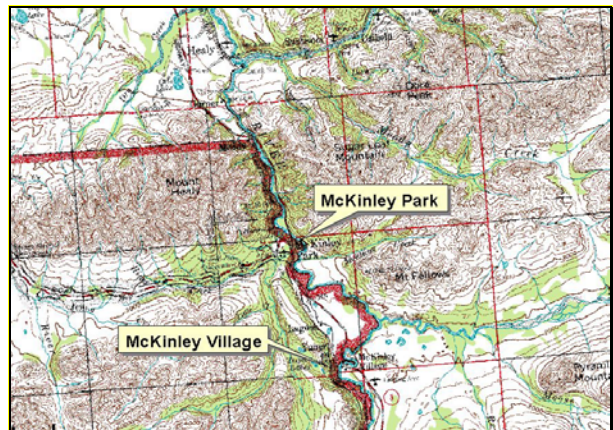
Figure 1

The McKinley Park area is located at the junction of the George Parks Highway and McKinley Park Road at mile 231 of the highway, at the entrance of Denali National Park. McKinley Village is located to the south, near the confluence of the Yanert Fork and the Nenana River (Figure 1).

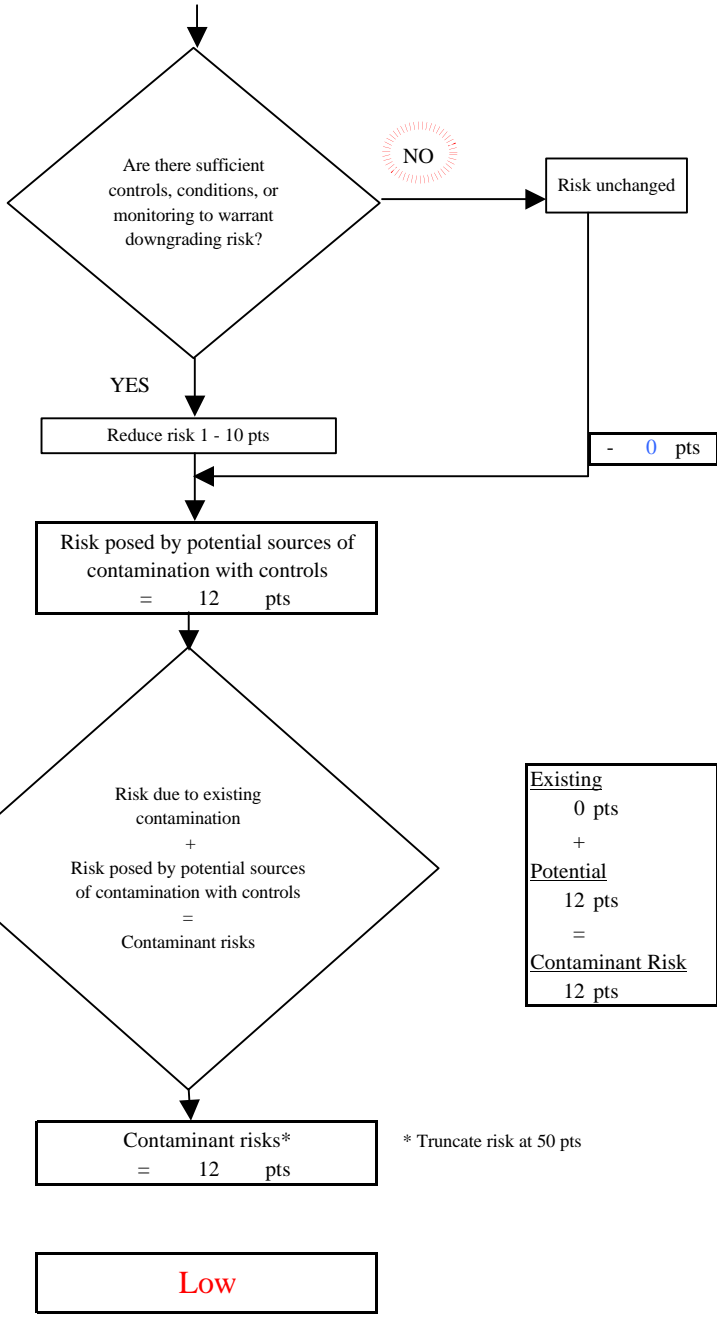
Chart 3. Contaminant risks for *McKinley Creekside Cabins- Bacteria & Viruses*

Risk Rankings for Contaminant Sources Identified in Zones A and B			
	Zone A	Zone B	Total
Very High(s)	0	0	0
High(s)	0	0	0
Medium(s)	0	0	0
Low(s)	2	0	2

Note: Septic systems, sewerlines, and roads are each assigned a risk ranking for each individual contaminant source in the CSI. The VA, however, counts these contaminant sources as a group and assigns a calculated number of either "lows" or "mediums" based on the density.

Existing	0 pts
+	
Potential	12 pts
=	
Contaminant Risk	12 pts

Only a small amount of bacteria and viruses are required to endanger public health. If bacteria and viruses have been detected during recent water sampling of the system at McKinley Creekside Cabins, the result is a maximum score on Chart 3.

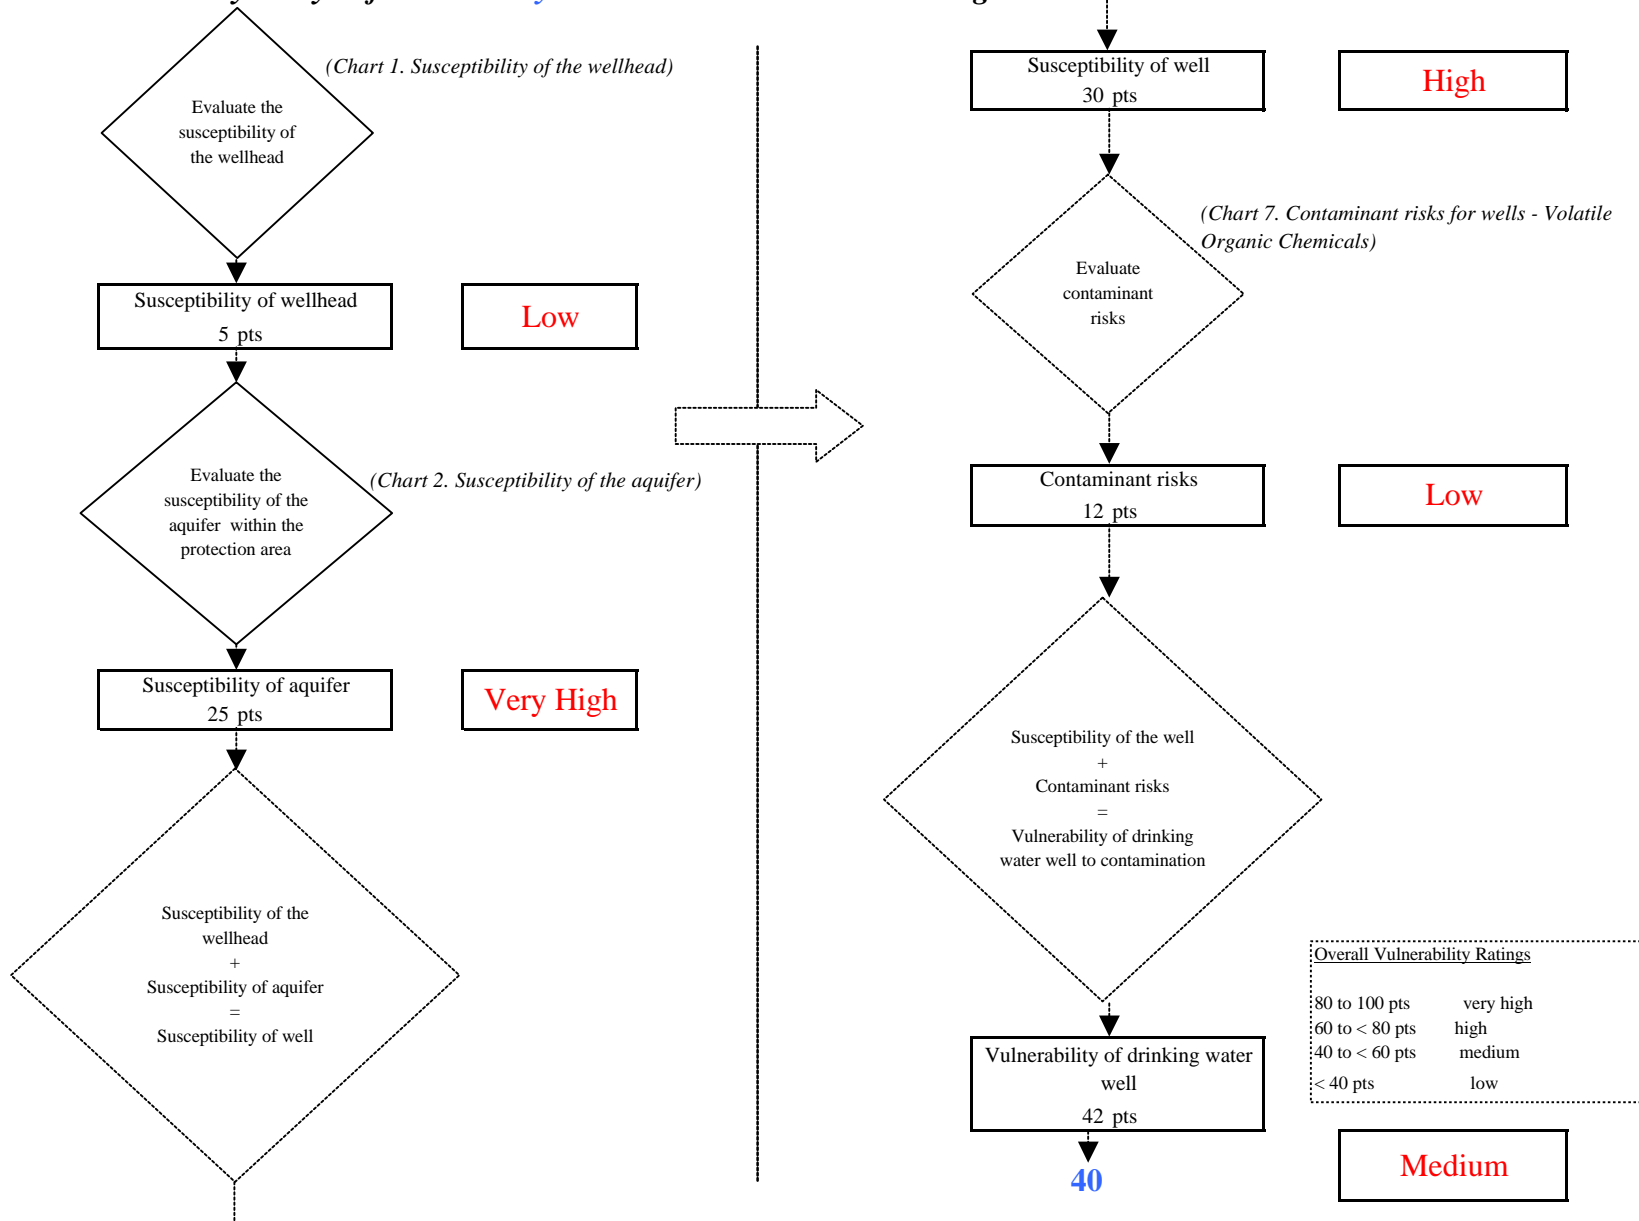
Chart 8. Vulnerability analysis for McKinley Creekside Cabins - Volatile Organic Chemicals

Table 4 contains the overall vulnerability scores (0 – 100) and ratings for each of the three categories of drinking water contaminants. Note: scores are rounded off to the nearest five (see Charts 4, 6, and 8).

Category	Score	Rating
Bacteria and Viruses	40	Medium
Nitrates and Nitrites	45	Medium
Volatile Organic Chemicals	40	Medium
