Source Water Assessment

A Hydrogeologic Susceptibility and Vulnerability Assessment for Mama C's Moose Creek Kitchen Drinking Water System, Moose Creek, Alaska PWSID 371621

January 2004

DRINKING WATER PROTECTION PROGRAM REPORT Report 1413
Alaska Department of Environmental Conservation

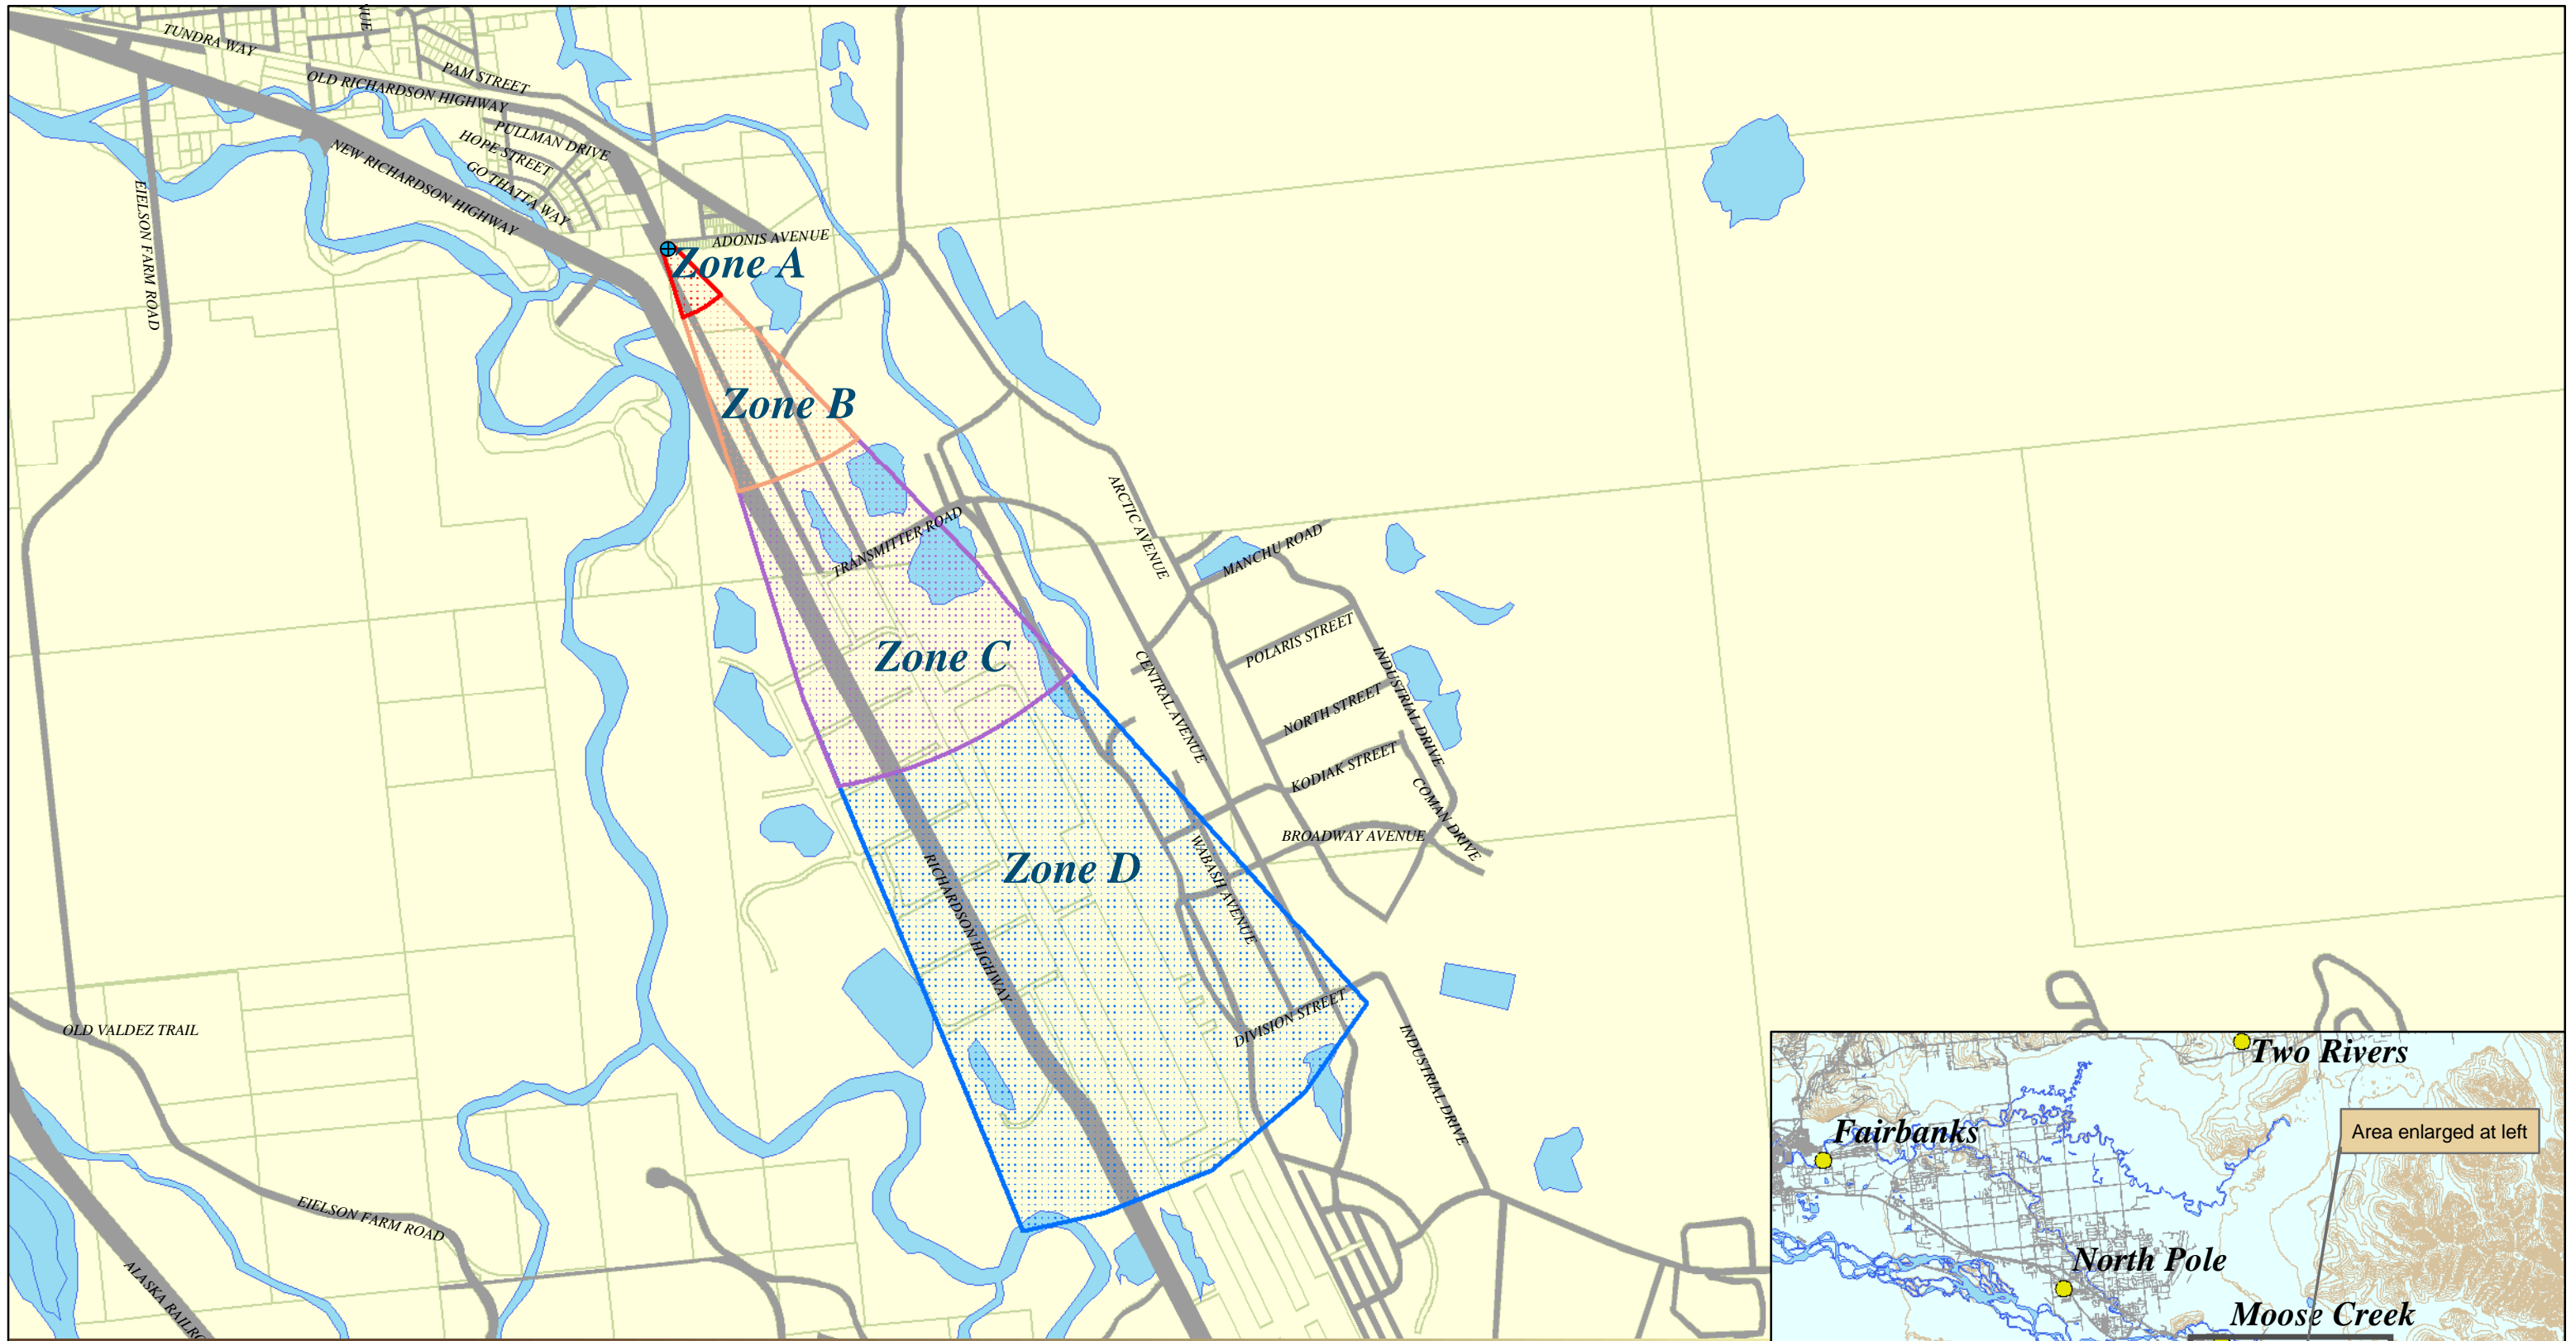
Map 1: Mama C's Moose Creek Kitchen Drinking Water Protection Areas

The protection areas established for wells are usually separated into four zones, limited by the watershed. These zones correspond to times-of-travel (TOT) of the water moving through the aquifer to the well (plus the factor of safety).

Zone	Definition
A	¼ the distance for the 2-yr. time-of-travel
B	Less than 2 years time-of-travel
C	Less than 5 years time-of-travel
D	Less than 10 years time-of-travel

The drinking water protection area outlined for the Mama C's Moose Creek Kitchen on Map 1 of Appendix A will serve as the focus for voluntary protection efforts.

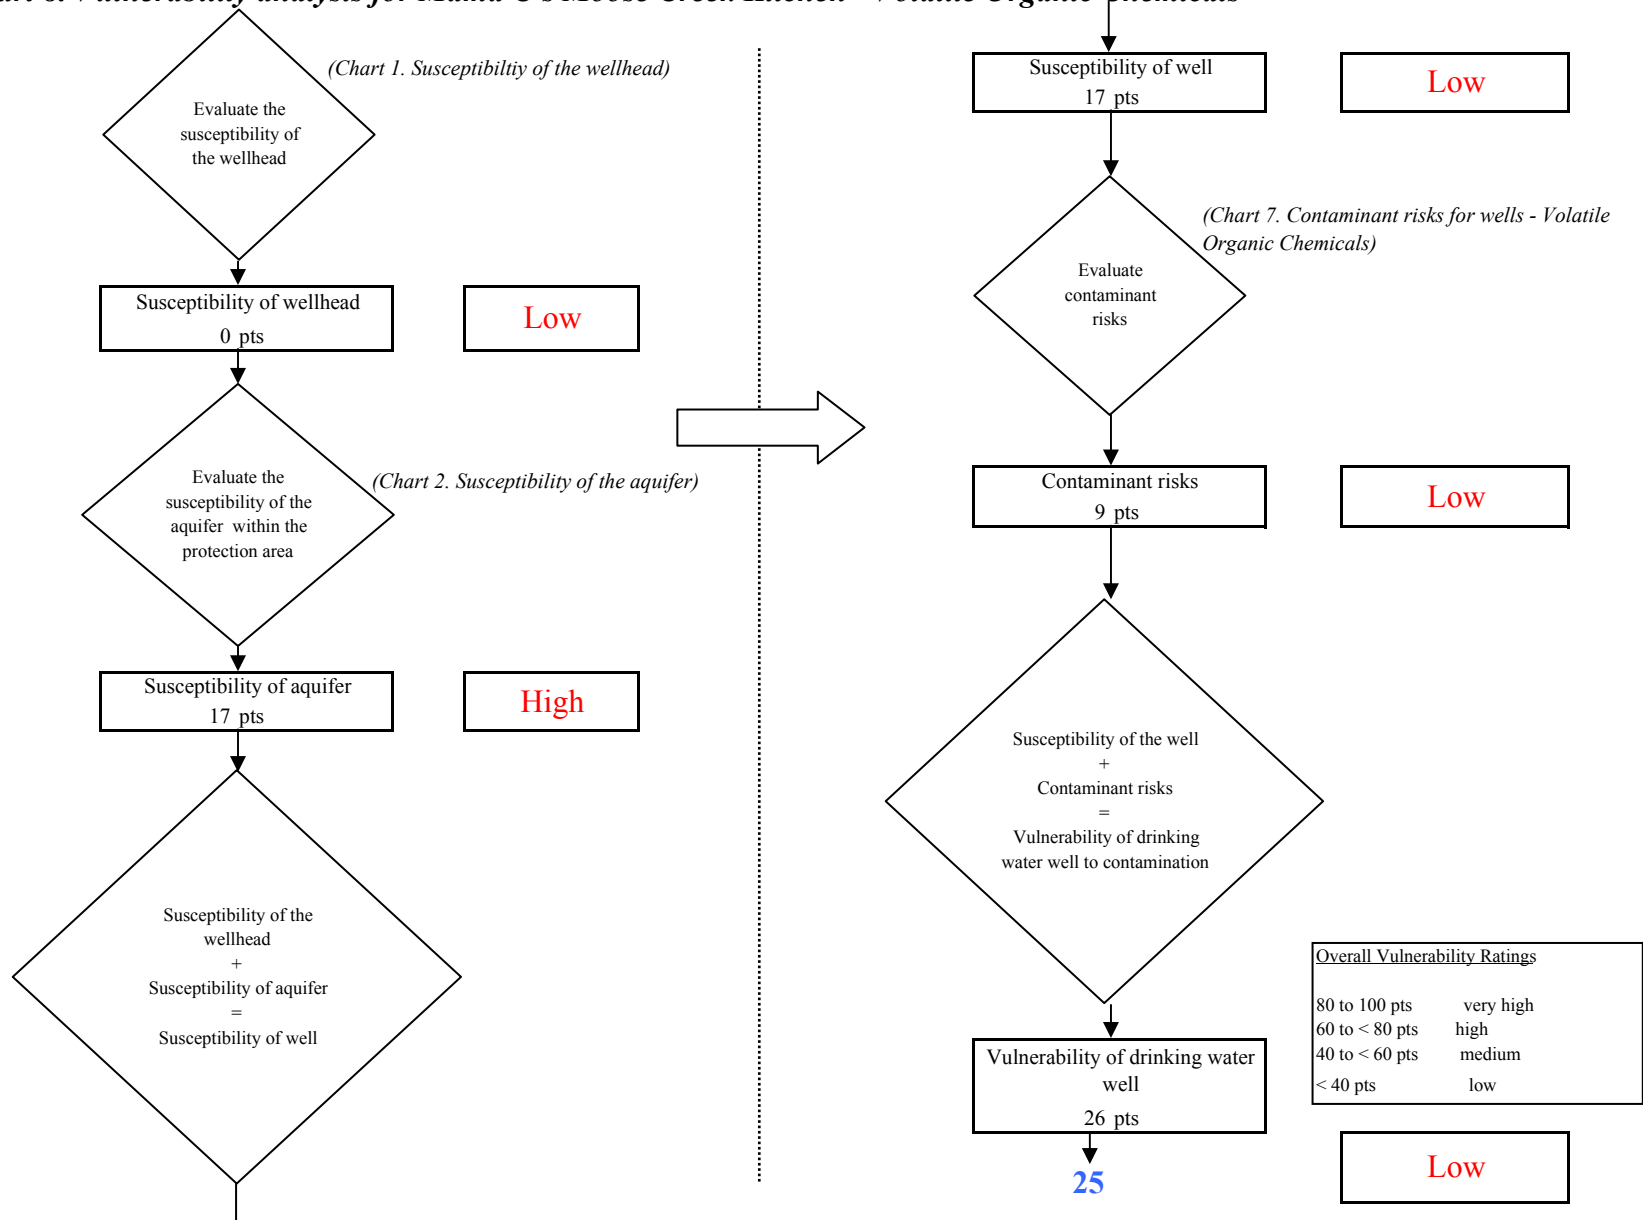
Chart 8. Vulnerability analysis for Mama C's Moose Creek Kitchen - Volatile Organic Chemicals

Volatile Organic Chemicals have not been sampled for in this water system. After combining the contaminant risk for volatile organic chemicals with the natural susceptibility of the well, the overall vulnerability of the well to contamination is low.
