Source Water Assessment

A Hydrogeologic Susceptibility and
Vulnerability Assessment for
North Pole Bible Baptist Church Drinking
Water System,
North Pole, Alaska
PWSID 372481

September 2003

DRINKING WATER PROTECTION PROGRAM REPORT Report 1242
Alaska Department of Environmental Conservation

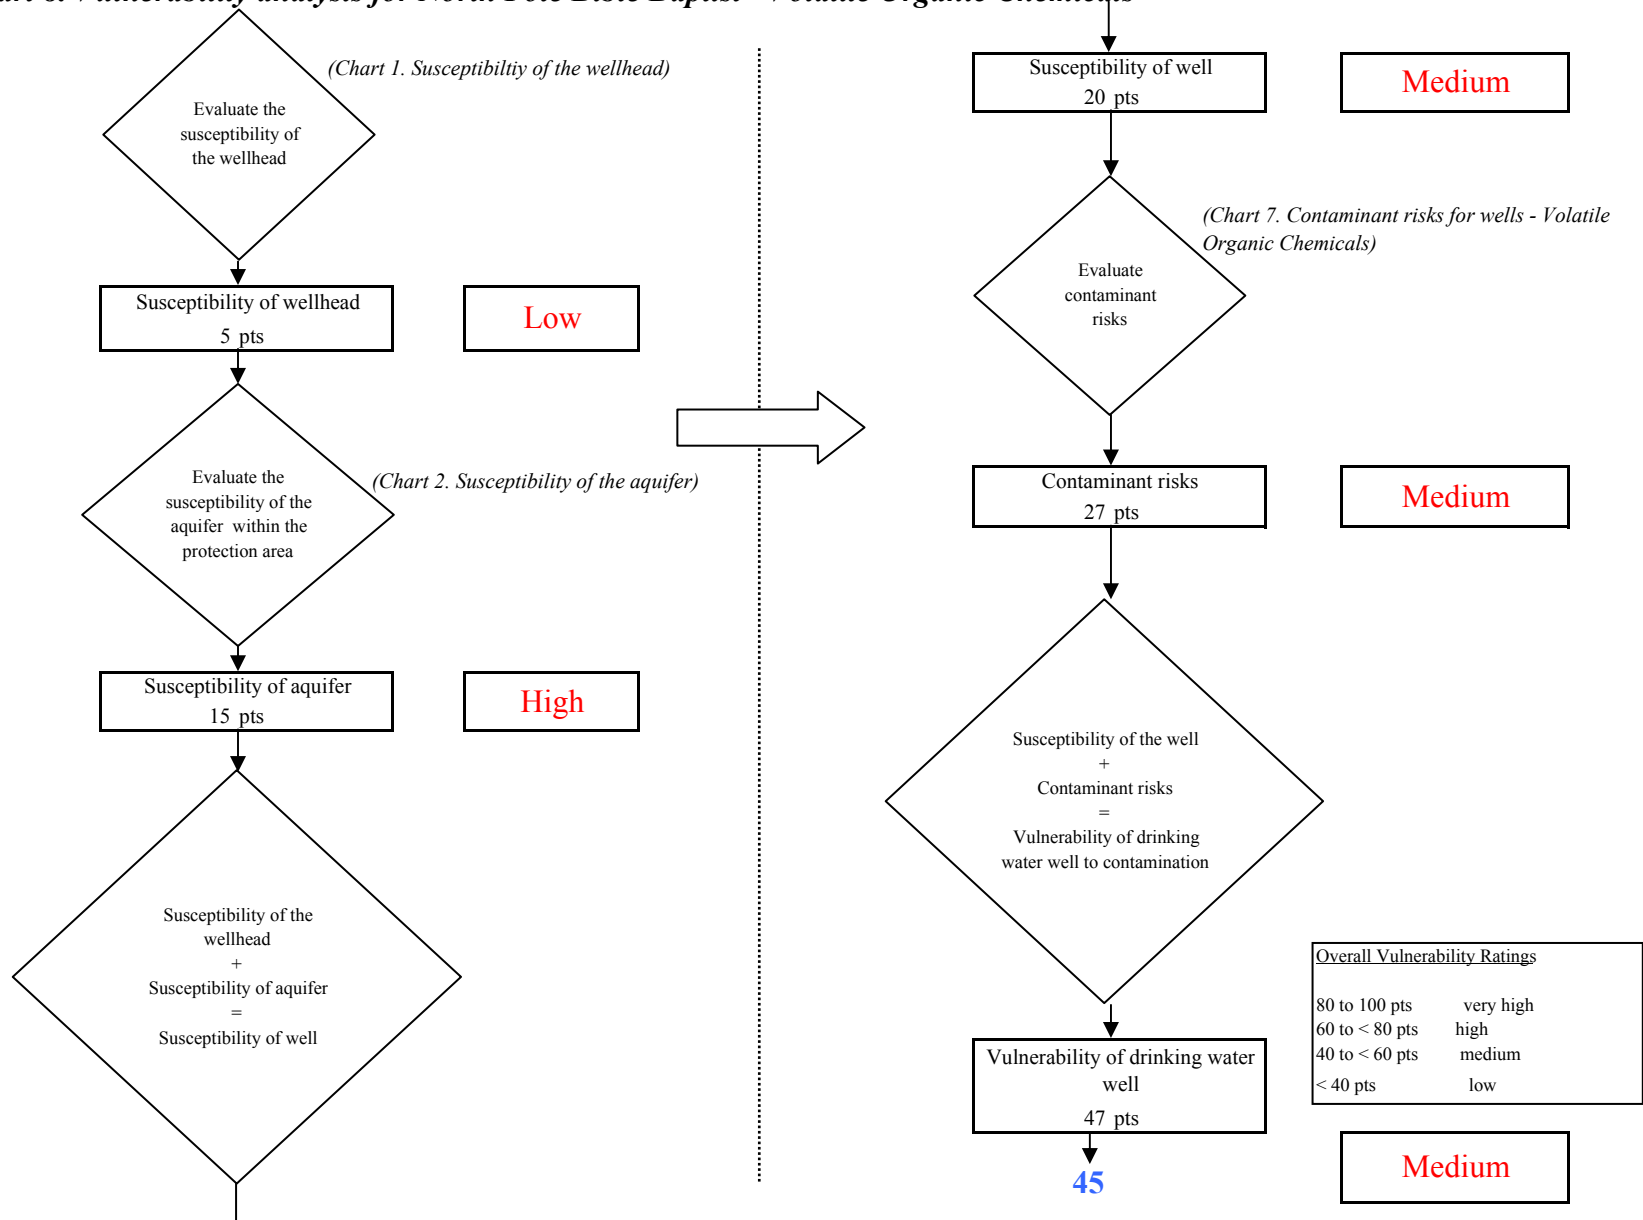
Chart 8. Vulnerability analysis for North Pole Bible Baptist - Volatile Organic Chemicals

Volatile Organic Chemicals have not been sampled for in this water system. After combining the contaminant risk for volatile organic chemicals with the natural susceptibility of the well, the overall vulnerability of the well to contamination is Medium.
