# Source Water Assessment

A Hydrogeologic Susceptibility and  
Vulnerability Assessment for  
Sourdough/Beaverbrook Station Drinking  
Water System,  
North Pole, Alaska  
PWSID 311710

December 2003

DRINKING WATER PROTECTION PROGRAM REPORT Report 1272  
Alaska Department of Environmental Conservation

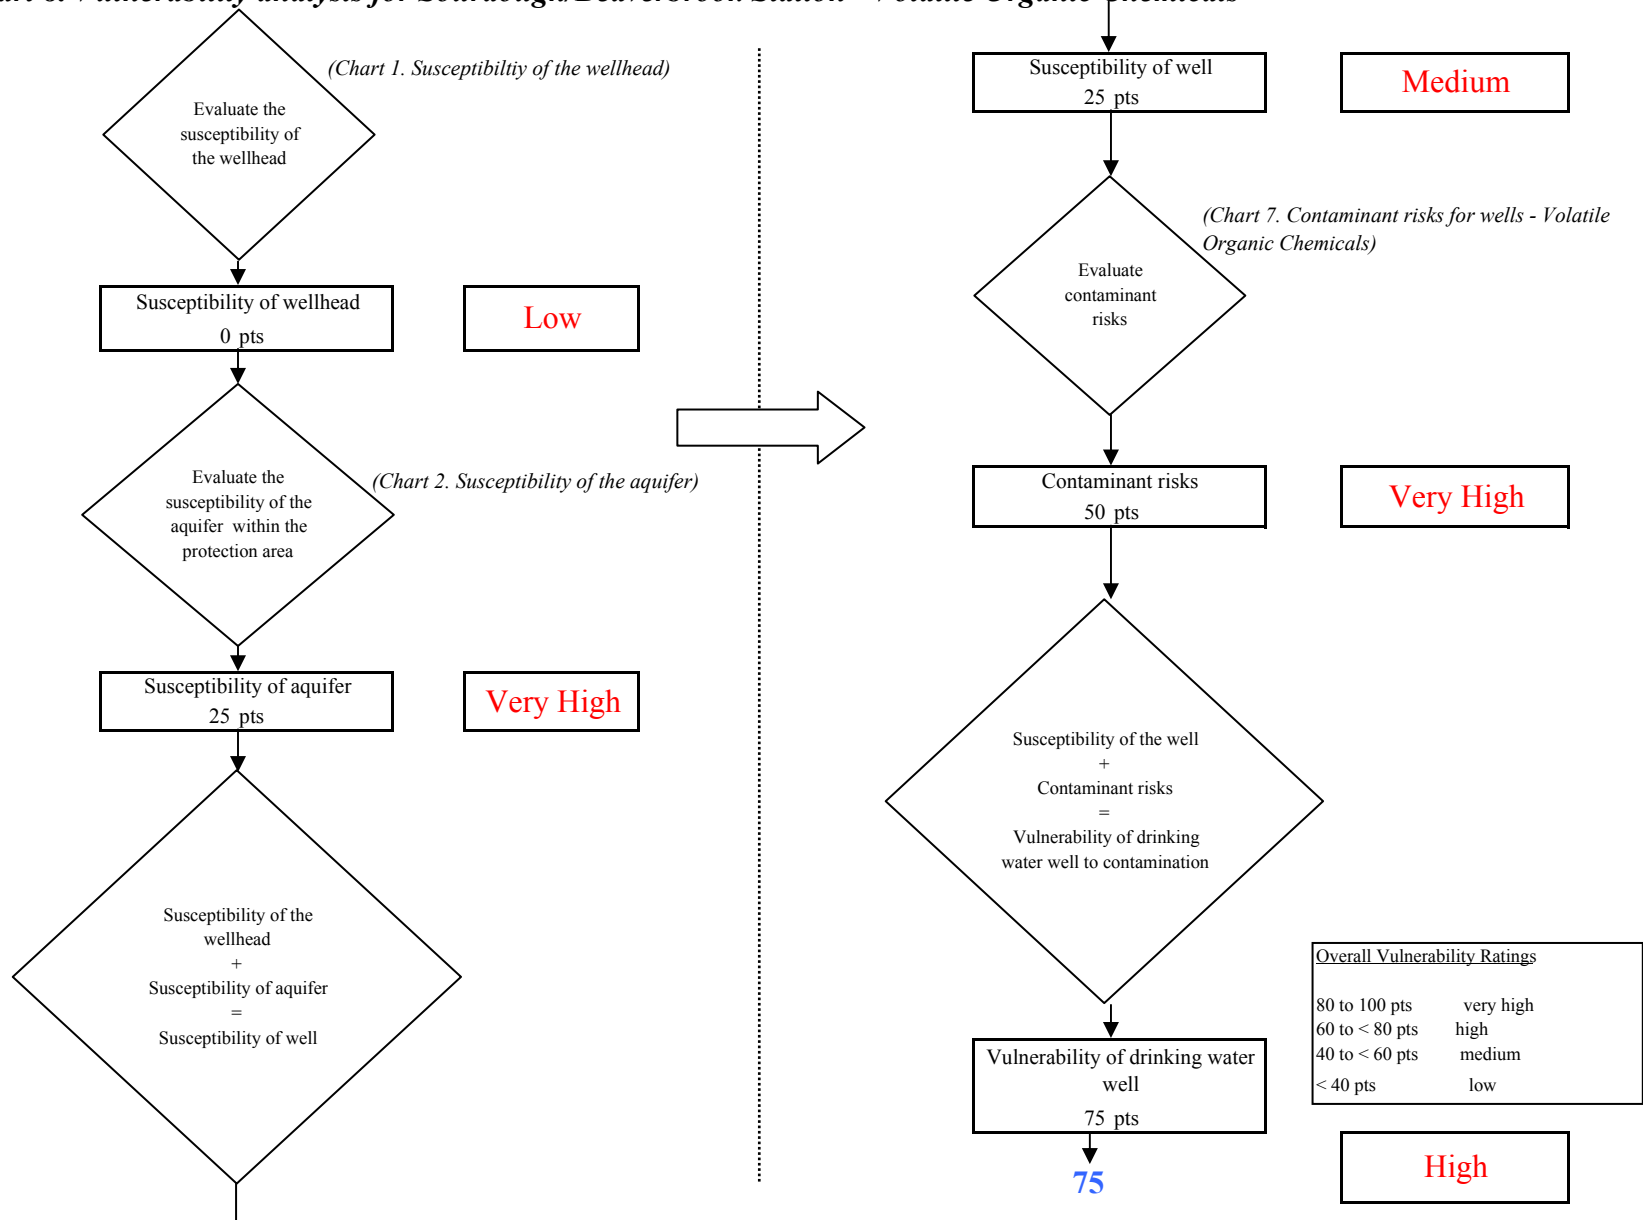
**Chart 8. Vulnerability analysis for Sourdough/Beaverbrook Station - Volatile Organic Chemicals**

Volatile Organic Chemicals have not been detected in during routine sampling of this water system. After combining the contaminant risk for volatile organic chemicals with the natural susceptibility of the well, the overall vulnerability of the well to contamination is high.
