Hydrogeologic Susceptibility and Vulnerability Assessment for Palmer Bus Facility Drinking Water Well, Palmer, Alaska

DRINKING WATER PROTECTION PROGRAM REPORT 114

September 2001

By Michael Baxter, B.E.S.T. Resource

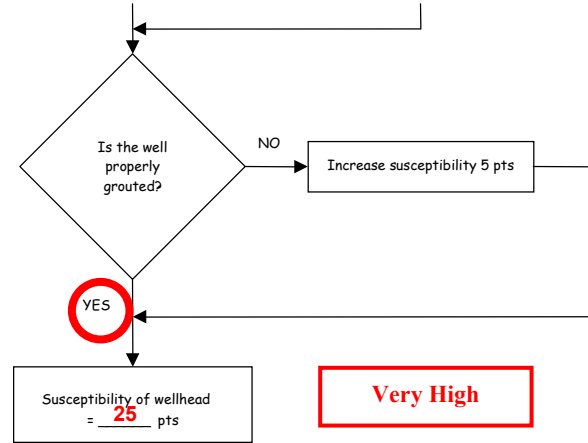
Chart 1. Susceptibility of the wellhead – Palmer Bus Facility

Palmer Bus Facility is completed in an unconfined aquifer setting. The well penetrates 200 feet of sand and gravel with one clayey layer. This layer, which is 115 to 200 feet thick, may provide somewhat of a protective barrier for the movement of contaminants in the subsurface. However, near the base of the Talkeetna Mountains, the clay and till layers tend to be discontinuous and thin toward the mountains. Therefore, contaminants that enter the subsurface near the base of the mountains may enter the confined aquifer uninhibited by the absence of any protective layer. This well appears to be properly grouted as indicated previously from information obtained from ADEC records. The absence of grouting can promote the transport of contaminants along the well casing. Combining the susceptibility of the wellhead and the aquifer to contamination leads to a score (0 – 50 points) and rating of overall Susceptibility (See Appendix D). Table 1 shows the overall Susceptibility score and rating for Palmer Bus Facility.

Susceptibility of wellhead = **25** pts

Very High

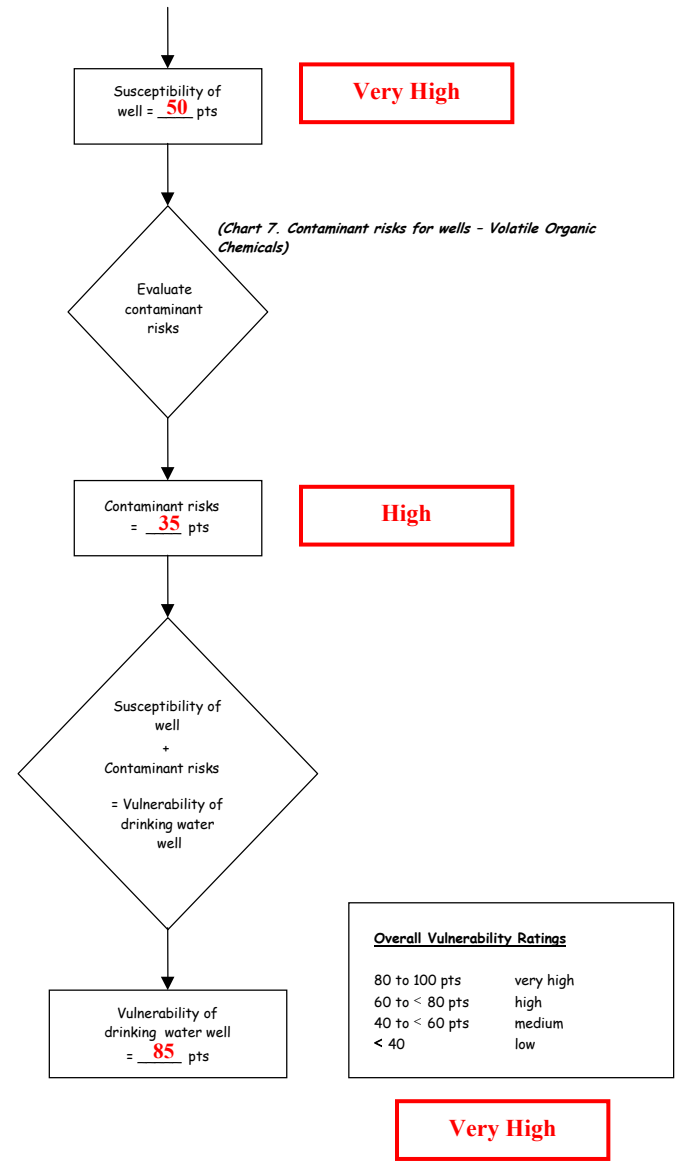
Chart 8. Vulnerability analysis for Palmer Bus Facility– Volatile Organic Chemicals

Volatile Organic Chemicals were not detected in the source waters of Palmer Bus Facility. Overall, a contaminant risk for the volatile organic chemicals category is very high due to the roads, animal barn, septic systems, residential acres and an air strip present up gradient from the well. Combining the contaminate risk with the susceptibility of the well yields an overall

very high vulnerability to contamination for Volatile Organic Chemicals.
