# Source Water Assessment

A Hydrogeologic Susceptibility and  
Vulnerability Assessment for  
Palmer Church of Christ  
Public Drinking Water System,  
Palmer, Alaska  
PWSID # 227563.001

DRINKING WATER PROTECTION REPORT 1695

Alaska Department of Environmental Conservation

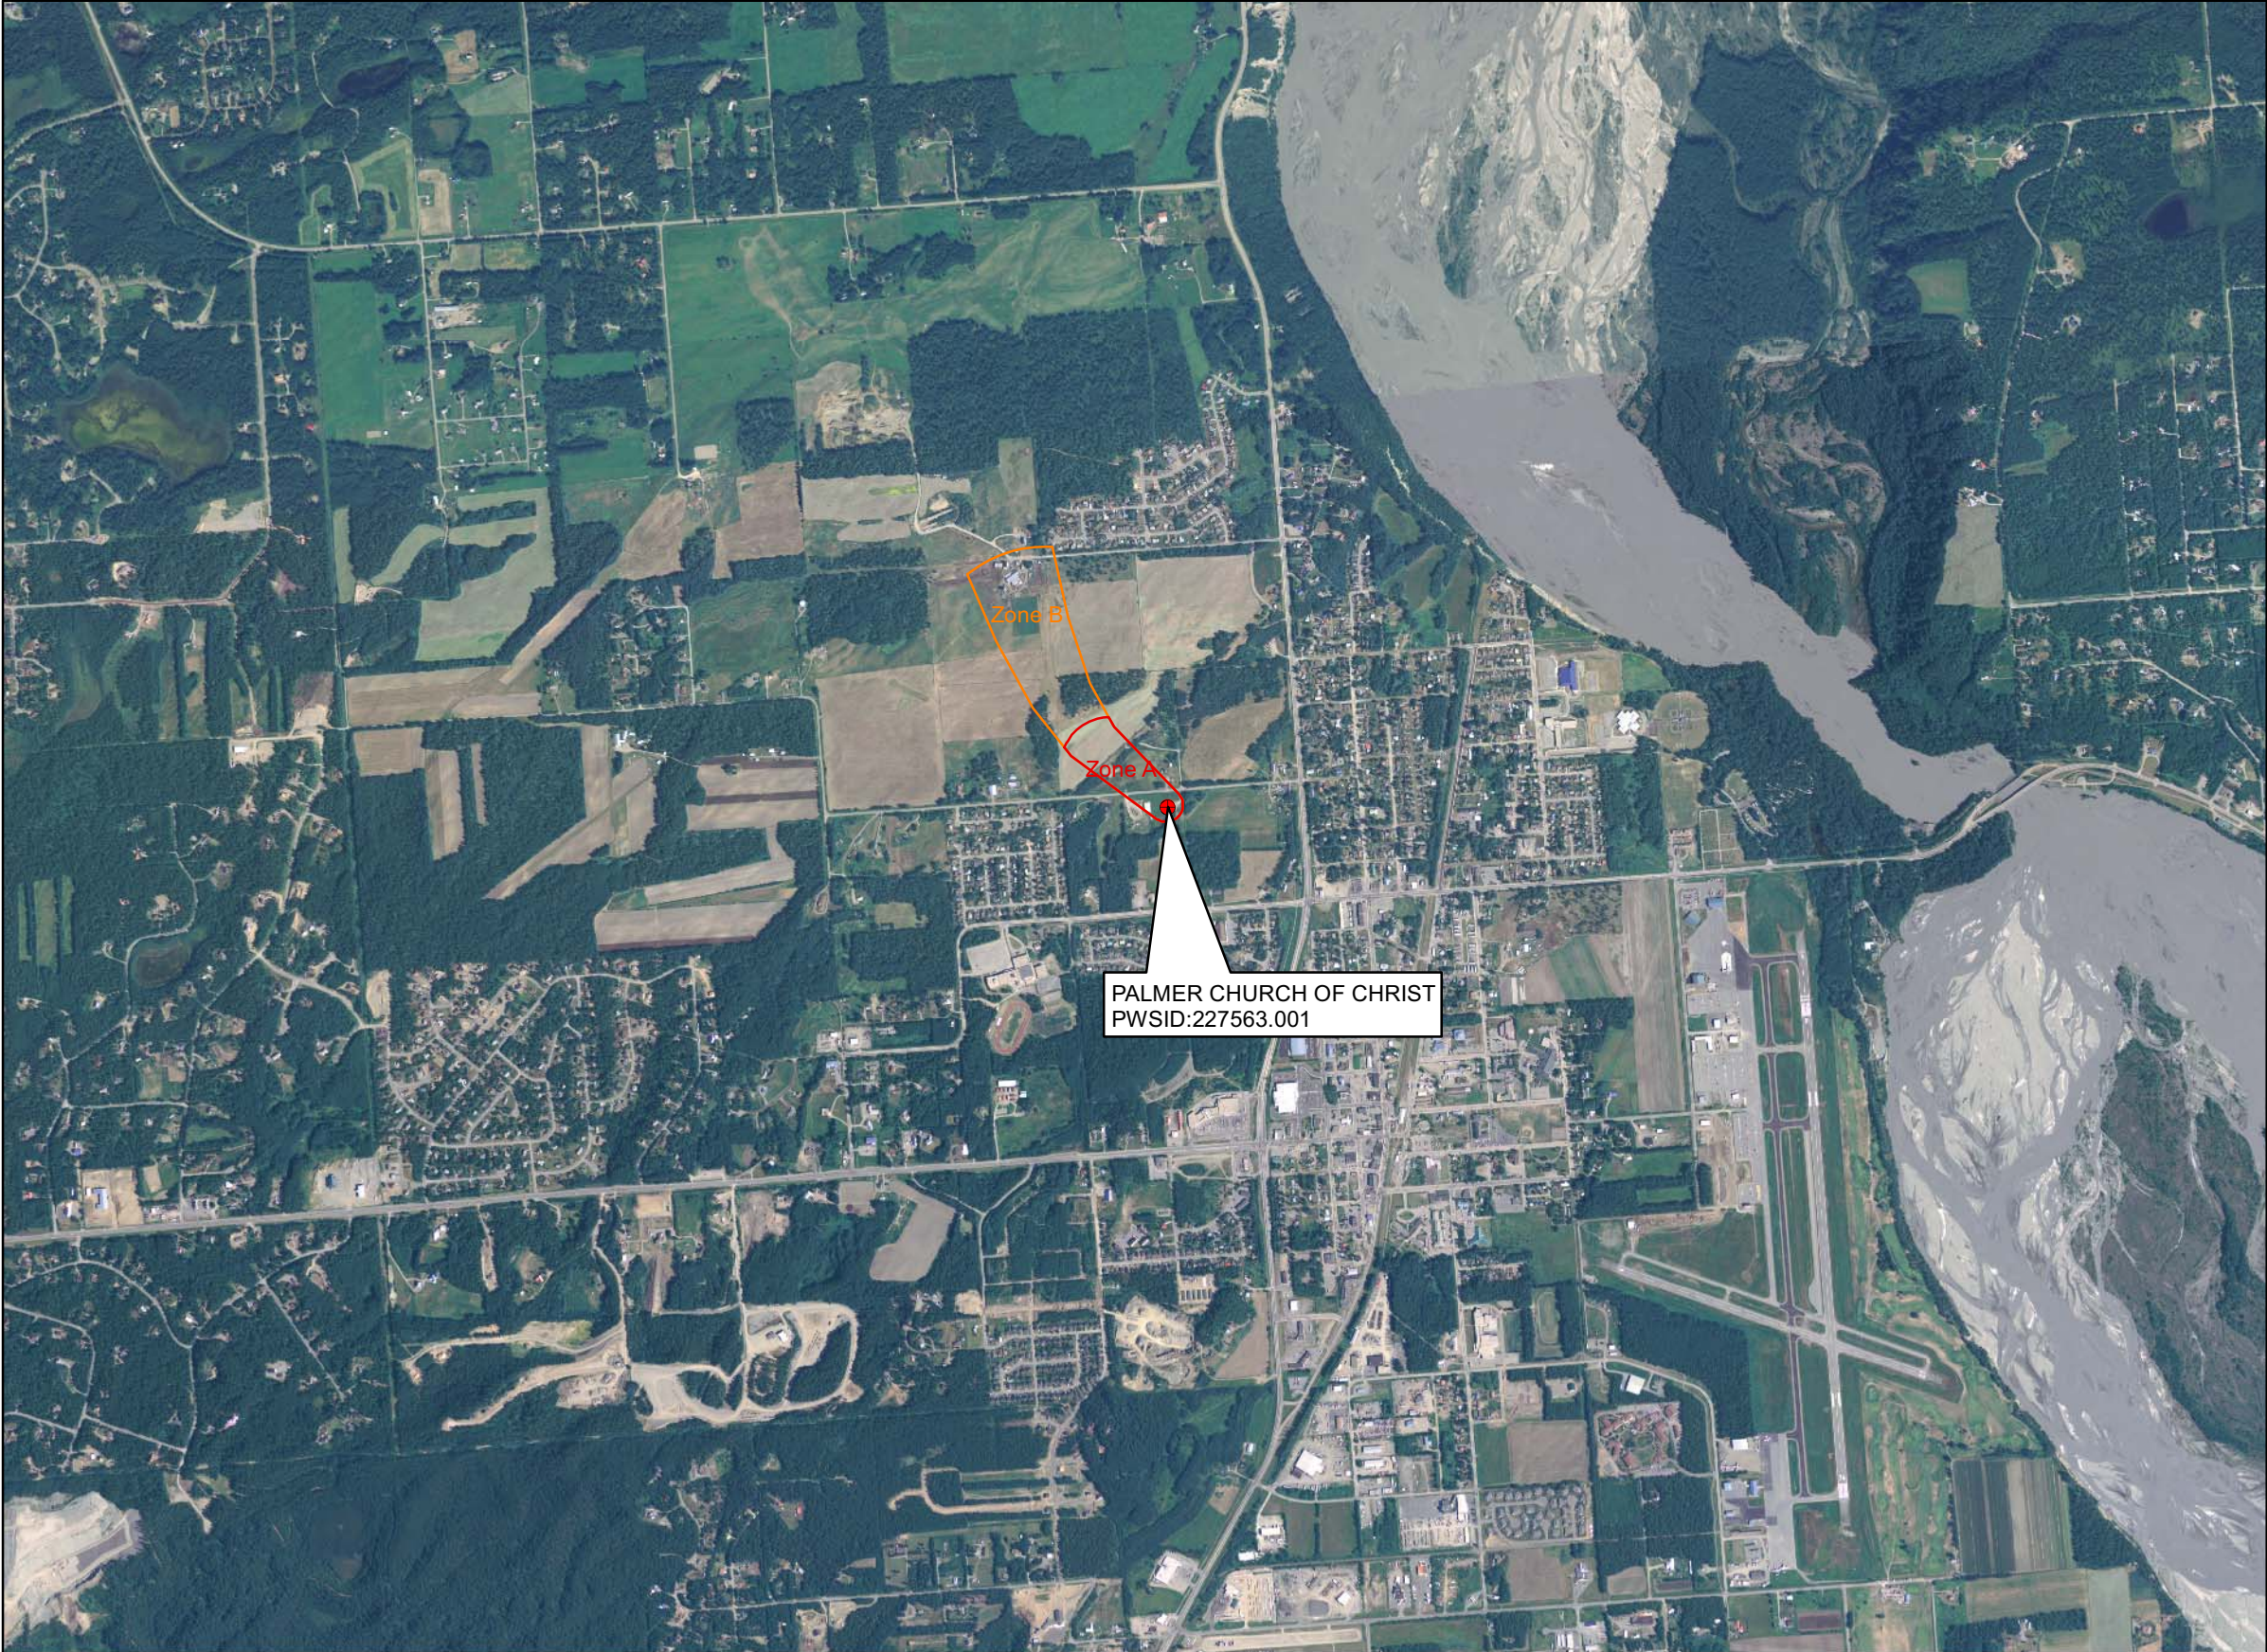
Palmer Church of Christ  
PWS 227563.001  
**Appendix A Map A**

The drinking water protection area for Palmer Church of Christ was determined using an analytical calculation and includes Zones A and B (See Map A of Appendix A).

Public Water Well System for PWS #227563.001 Palmer Church of Christ

The Palmer Church of Christ public water system is a Class B (transient/non-community) water system. The system consists of one well located on Scott Road in Palmer, Alaska (see Map A in Appendix A). Palmer is located on the Glenn Highway, approximately 42 miles northeast of Anchorage. Temperatures range from -36 to 51 in January and from 37 to 85 in July. Palmer receives an average of 16.5 inches of precipitation annually. The city has a population of 5,506 (ADCCED, 2009).

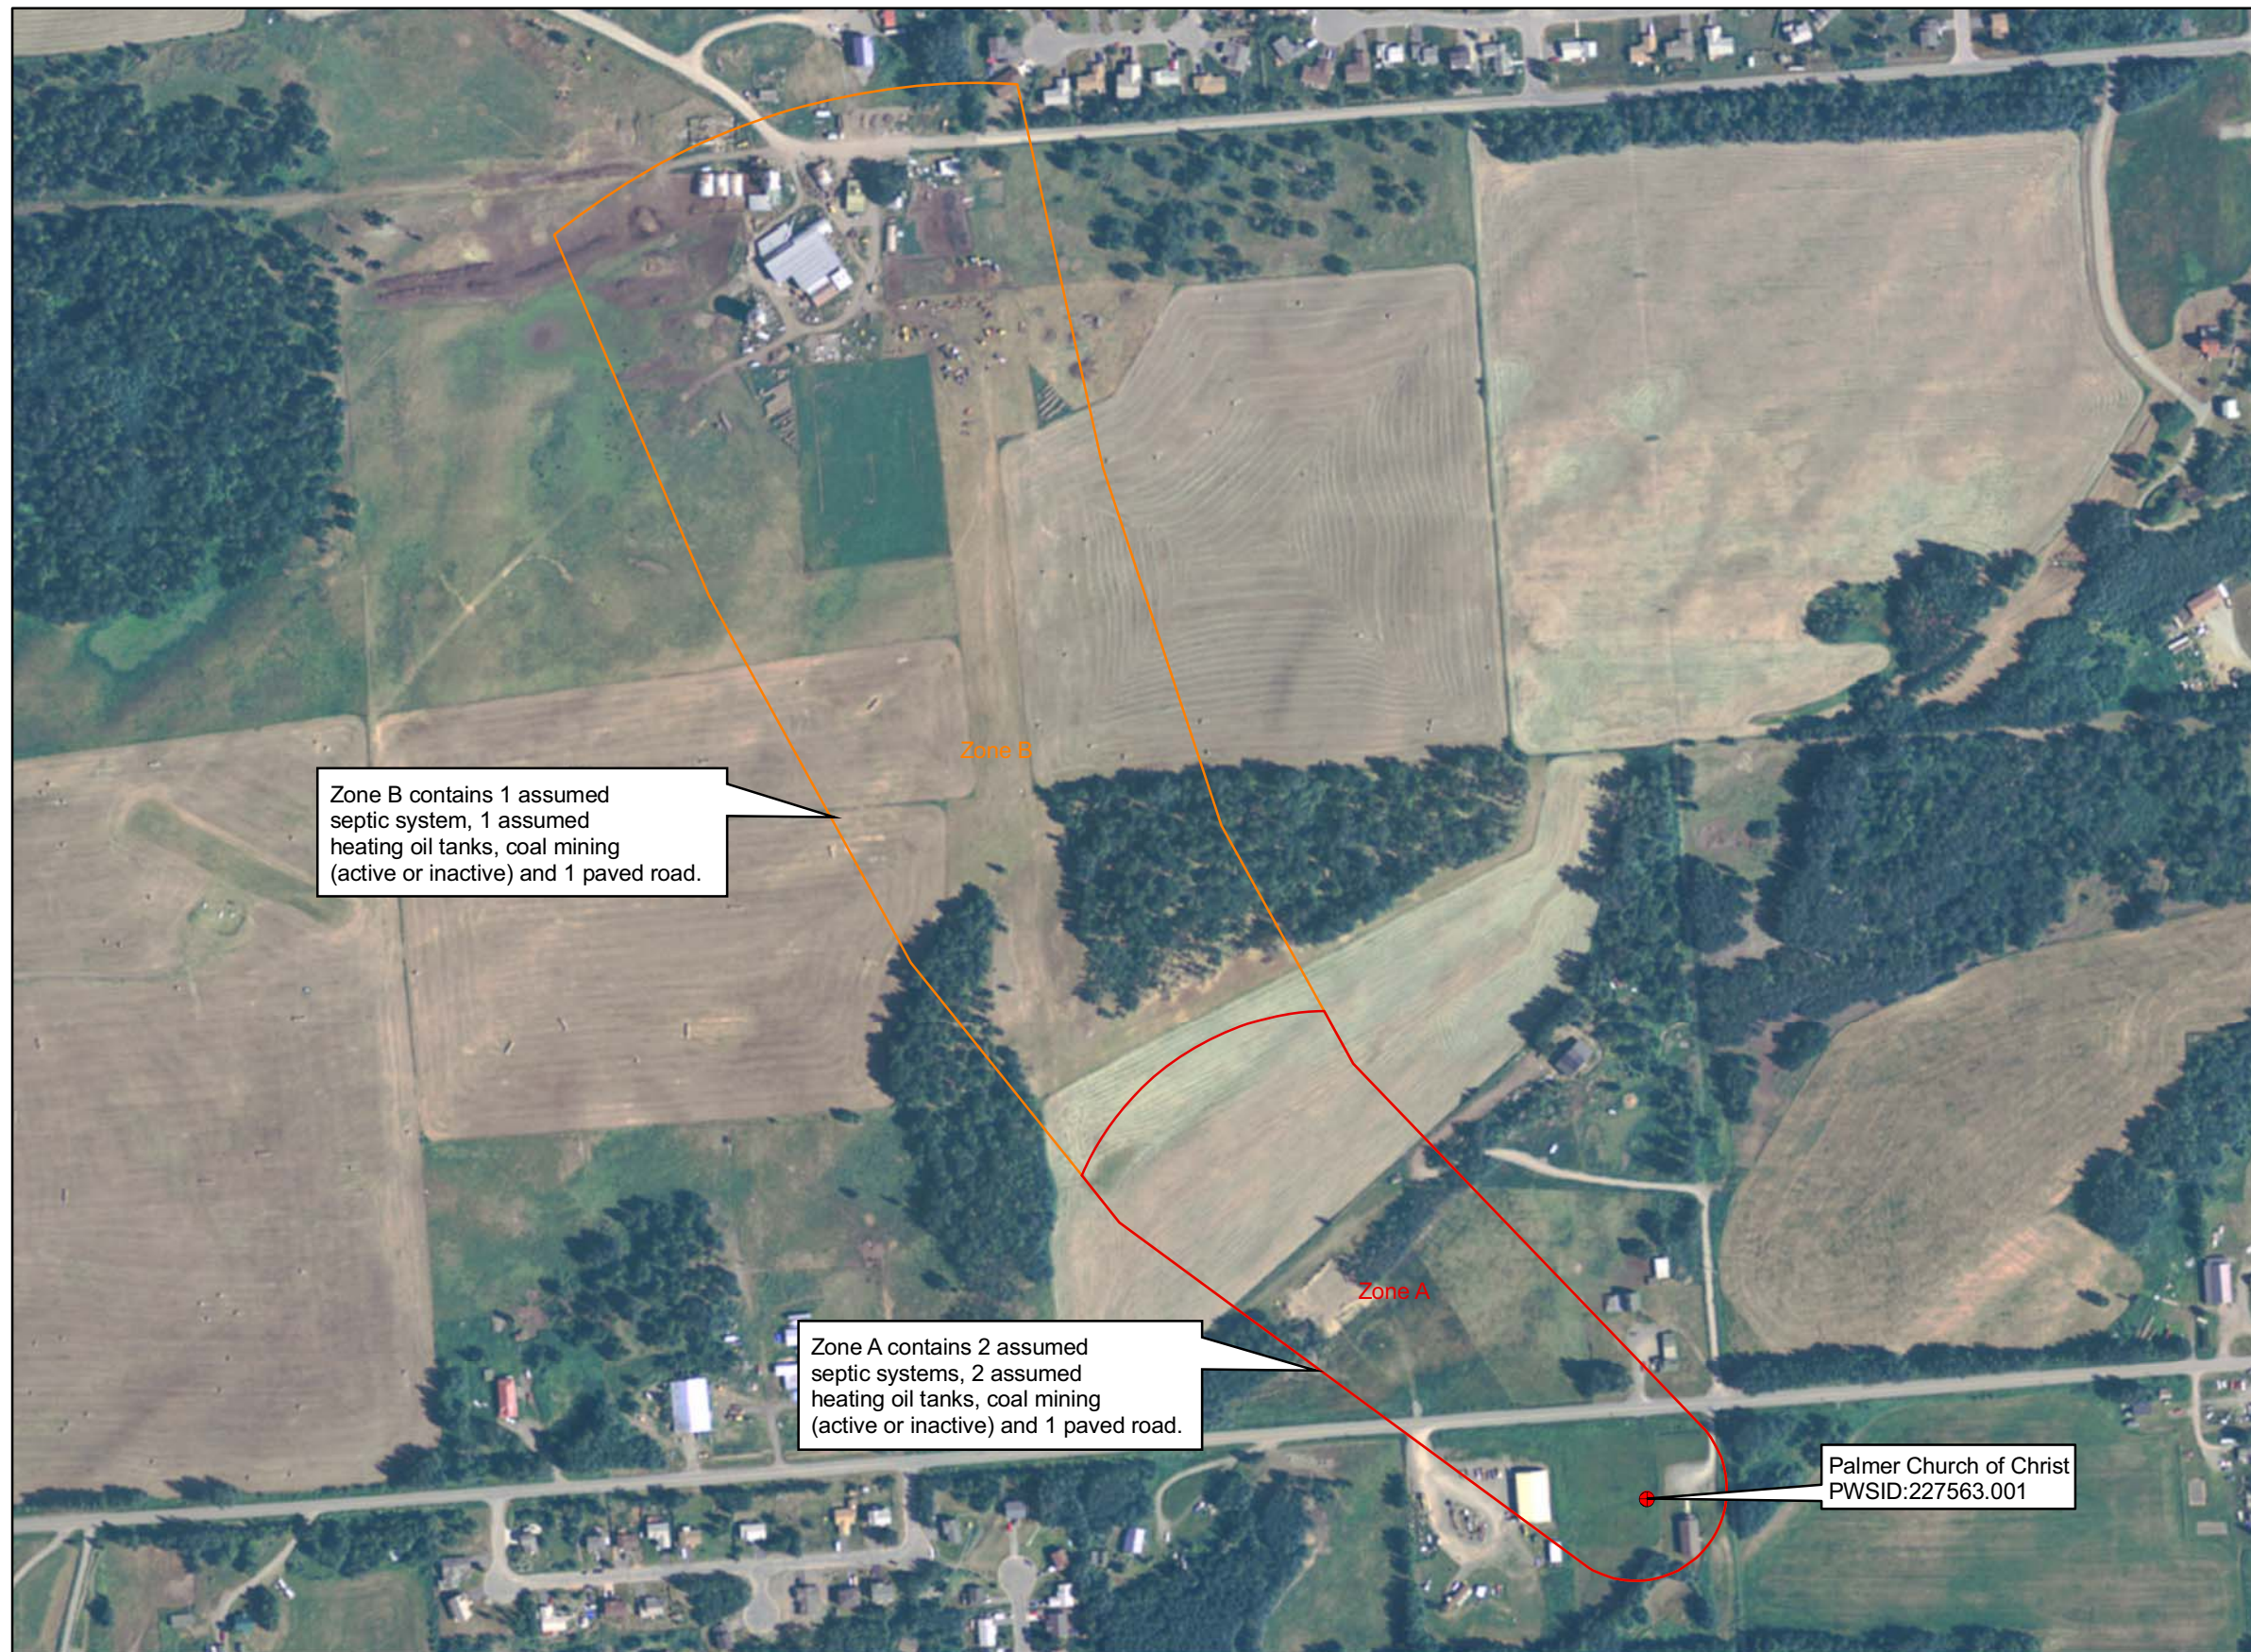
### **Palmer Church of Christ Drinking Water Protection Area and Potential and Existing Contaminant Sources (Map C)**

**Public Water Well System for PWS # 227563.001 Palmer Church of Christ  
Showing Potential and Existing Sources of Contamination**

The sources are displayed on Map C of Appendix C and summarized in Table 1 of Appendix B.
