Hydrogeologic Susceptibility and Vulnerability Assessment for Farm Loop Christian Center Drinking Water Well, Palmer, Alaska

DRINKING WATER PROTECTION PROGRAM REPORT 99

September 2001

By Catherine Baxter, B.E.S.T. Resource

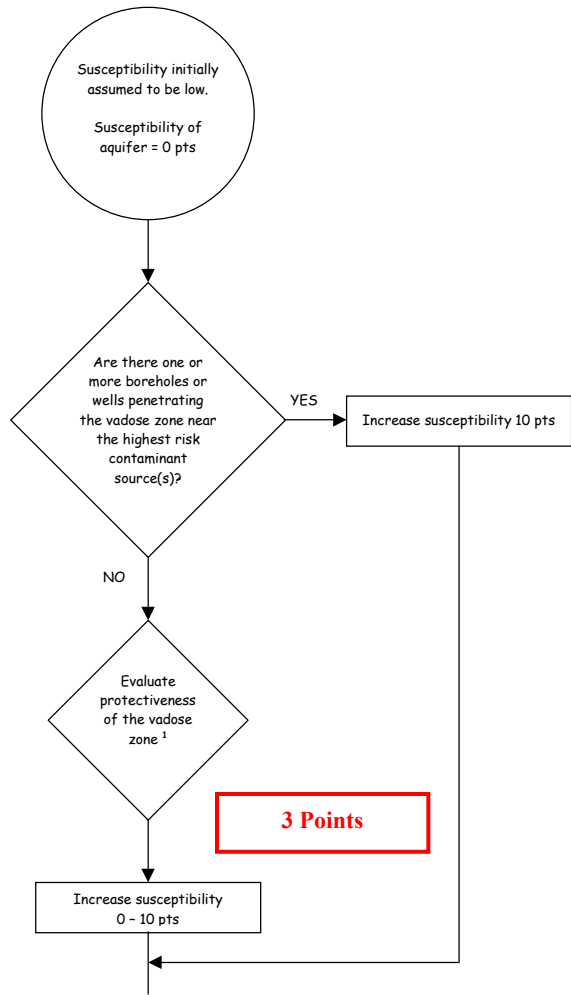
Chart 2. Susceptibility of the aquifer – Farm Loop Christian Center

Farm Loop Christian Center is completed in a confined aquifer setting. The well penetrates gravel and silty sand to 112 feet below the surface. From 15 to 40 feet till is present. Clay is present from 48 to 108 feet below the surface, which may provide a protective barrier from the movement of contaminants in the subsurface. However, near the base of the Talkeetna Mountains, the clay and till layers tend to be

discontinuous and thin toward the mountains. Therefore, contaminants that enter the subsurface near the base of the mountains may enter the confined aquifer uninhibited by any protective layer. This well appears to be properly grouted with surrounding concrete pad as indicated from ADEC records. Combining the susceptibilities of the wellhead and the aquifer to contamination leads to a score (0 – 50 points) and rating of overall Susceptibility (Appendix D). Table 1 shows the overall Susceptibility score and rating for Farm Loop Christian Center.

Recharge (16-20 inches per year, base of Talkeetna Mountains, and silty and clayey gravelly sand) 3/10 = 3 Points
 Depth to bottom of confining unit (100 feet) = 0 Points
 Protectiveness of the Vadose Zone Total = 3 Points

Confinement (100 feet of Sandy clayey gravel) 0/15 = 0 Points
 Density of boreholes/wells (high density in Zone C) 2/15 = 2 Points
 Degree of Confinement Total = 2 Points
