Source Water Assessment for Iris Circle Water Company

A Hydrogeologic Susceptibility and Vulnerability Assessment

DRINKING WATER PROTECTION PROGRAM REPORT 399
PWSID 226410.001

February 2002

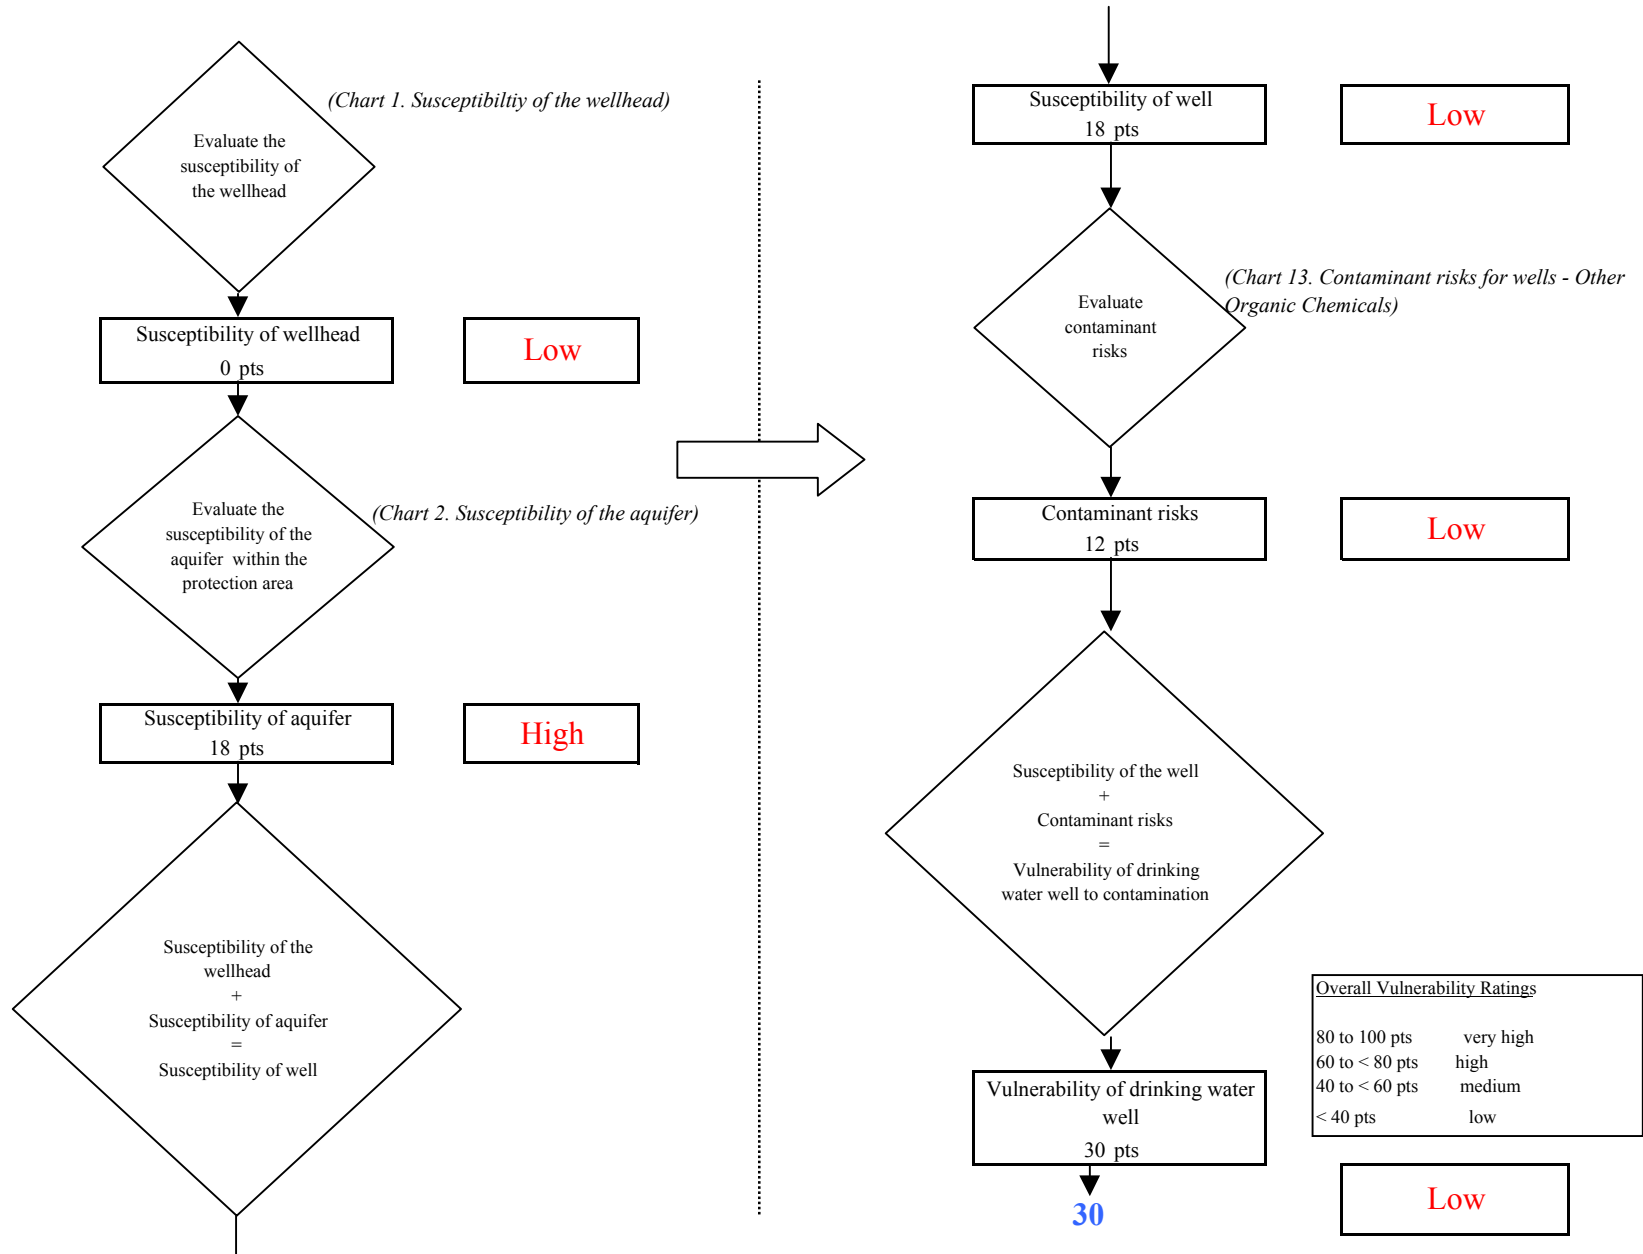
Chart 14. Vulnerability analysis for Iris Circle - Other Organic Chemicals
