Hydrogeologic Susceptibility and Vulnerability Assessment for Lazy Mountain Church Drinking Water Well, Palmer, Alaska

DRINKING WATER PROTECTION PROGRAM REPORT 108

September 2001

By Michael Baxter, B.E.S.T. Resource

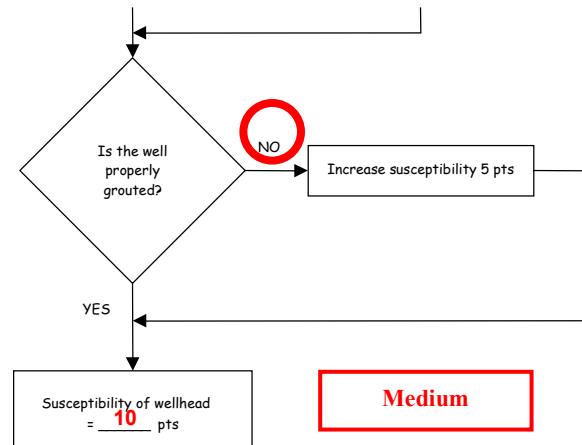
Chart 1. Susceptibility of the wellhead – Lazy Mountain Church

<u>Wellhead Susceptibility Ratings</u>	
20 to 25 pts	very high
15 to < 20 pts	high
10 to < 15 pts	medium
< 10	low

Lazy Mountain Church is completed in a confined or semi-confined aquifer setting. The well penetrates 181 feet of sand and gravel layered with four till and clay bearing layers. These till and clay layers encountered at 10 to 113 feet, 125 to 130, 132 to 141 and 155 to 175 feet below land surface, may provide somewhat of a protective barrier for the movement of contaminants in the subsurface. However, near the base of the Chugach and Talkeetna Mountains, the clay and till layers tend to be discontinuous and thin toward the mountains. Therefore, contaminants that enter the subsurface near the base of the mountains may enter the confined aquifer uninhibited by the absence of any protective layer. This well does not appear to be properly grouted as indicated previously from information obtained from Department records. The absence of grouting can promote the transport of contaminants along the well

casing. Combining the susceptibility of the wellhead and the aquifer to contamination leads to a score (0 – 50 points) and rating of overall Susceptibility (See Appendix D). Table 1 shows the overall Susceptibility score and rating for Lazy Mountain Church.

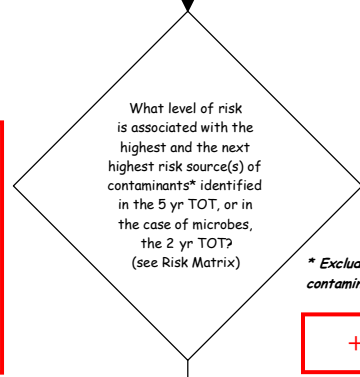
Chart 3. Contaminant risks for Lazy Mountain Church – Bacteria & Viruses

Zone A contains:
 19 septic systems = 19 Lows
 27 residential acres = 1 Low
 4 gravel roads = 1 Low
Zone B contains:
 3 gravel roads = 1 Low
Total = 22 Lows

Appendix D contains eight charts, which together form the ‘Vulnerability Analysis’ for a source water assessment for a public drinking water source. Chart 1 analyzes the ‘Susceptibility of the Wellhead’ to contamination by looking at the construction of the well and its surrounding area. Chart 2 analyzes the ‘Susceptibility of the Aquifer’ to contamination by looking at the naturally occurring attributes of the water source and influences on the groundwater system that might lead to contamination. Chart 3 analyzes ‘Contaminant Risks’ for the drinking water source with respect to bacteria and viruses. The ‘Contaminant

Overall, contaminant risk for the bacteria and viruses category is medium. Bacteria and Viruses were not detected in the source waters of Lazy Mountain Church. Taking the sampling history into account and combining the contaminate risk from bacteria and viruses with the susceptibility of the well yields an overall medium vulnerability to contamination from bacteria and viruses.
