Hydrogeologic Susceptibility and Vulnerability Assessment for Matanuska Assembly of God Church Drinking Water Well, Palmer, Alaska

DRINKING WATER PROTECTION PROGRAM REPORT 95

September 2001

By Michael Baxter, B.E.S.T. Resource

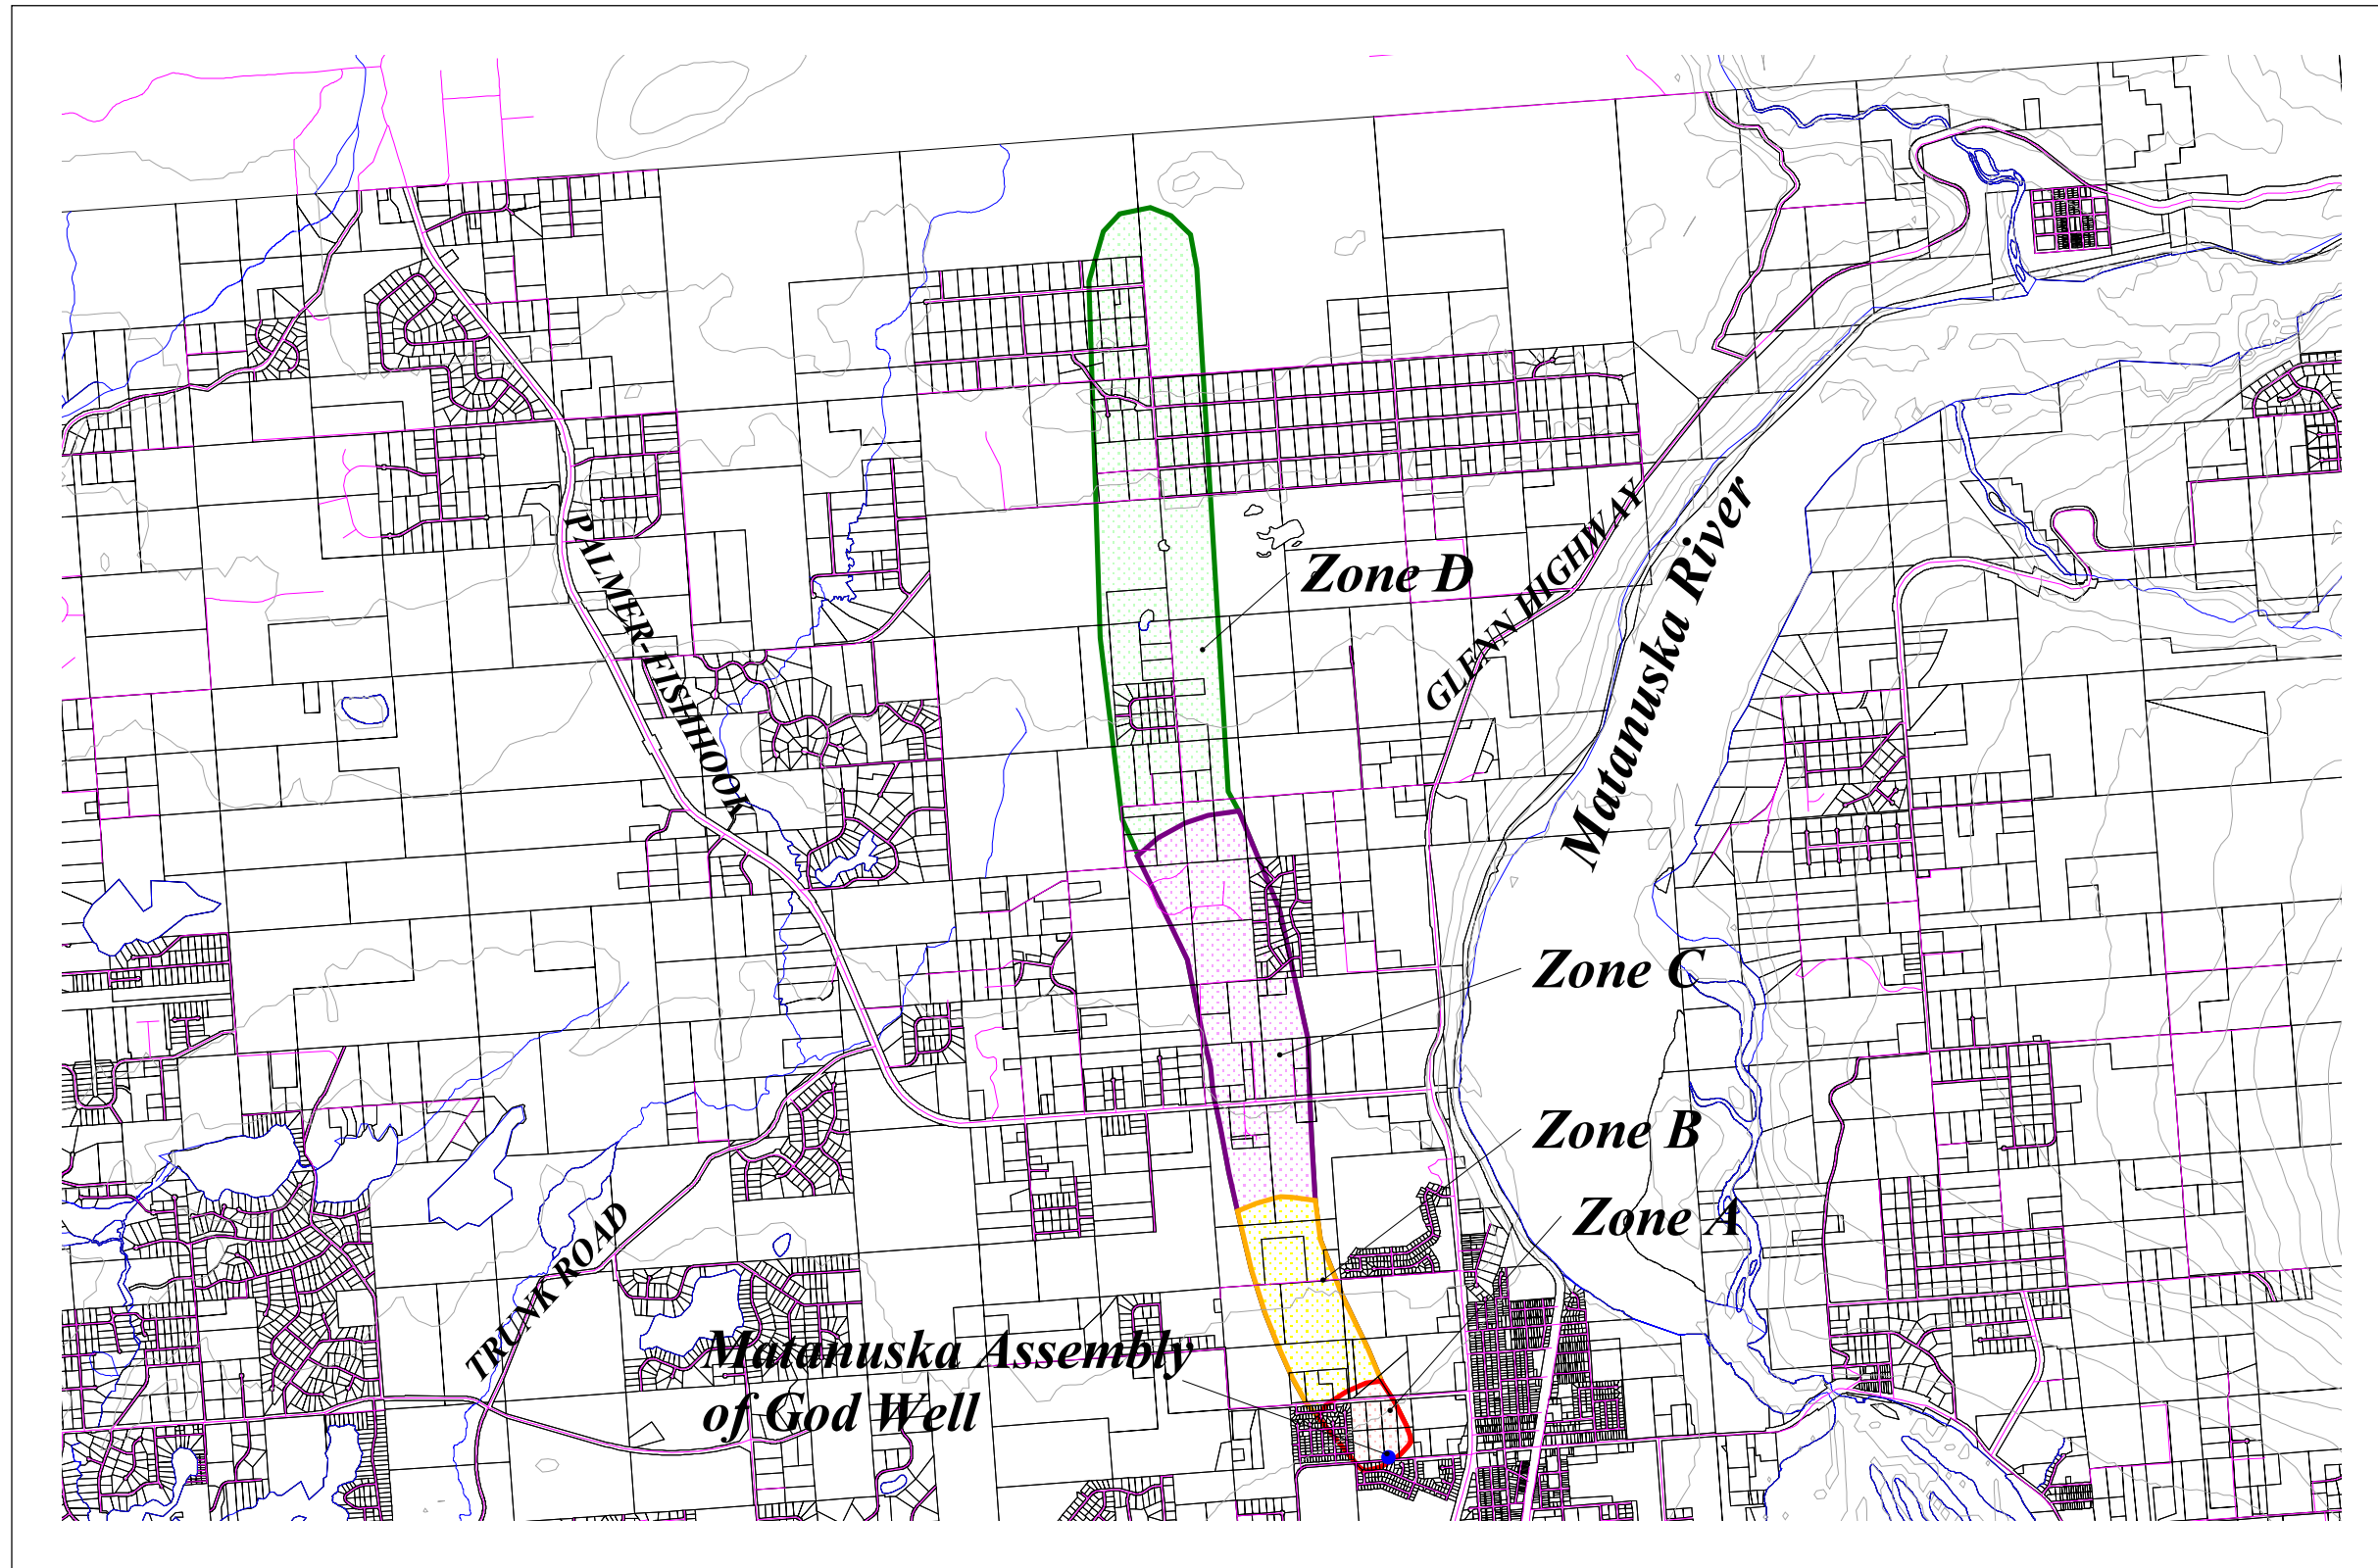
The Drinking Water Protection Areas established for wells by the Alaska Department of Environmental Conservation are separated into zones. These zones correspond to a time-of-travel. Time-of-travel is the time required for water to move in the saturated zone of the ground from a specific point to the well. The Drinking Water Protection Areas for Matanuska Assembly of God contain three zones, Zone A, Zone B, and Zone C (See Map 1 in Appendix A). Zone A corresponds to the area between the well and the distance equal to $\frac{1}{4}$ of the distance of the 2-year time-of-travel. Depending on where a contaminant source is located within Zone A, travel time for a contaminant to the well may be on the order of several days to several hours. Zone A also extends down gradient from the well to take into account the area of the aquifer that is influenced by pumping of the well.

The Zone B protection area for Matanuska Assembly of God corresponds to a time-of-travel of less than two years and extends toward to base of the Talkeetna Mountains. Lastly, the Zone C protection area extends

from Zone B to the top of the watershed divide of the Chugach Mountains.

Matanuska Assembly of God (PWSID 226135) Drinking Water Protection Areas

The Drinking Water Protection and Assessment Area that has been established for Matanuska Assembly of God in the area that is most sensitive to contamination. This area has served as a basis for assessing the risk of the drinking water source to contamination. This zone around the drinking water source is the most critical area for the preservation of the quality of the drinking water for this source. For simplicity, this area will be known as your Drinking Water Protection Area and will serve as the area of focus for voluntary protection efforts.

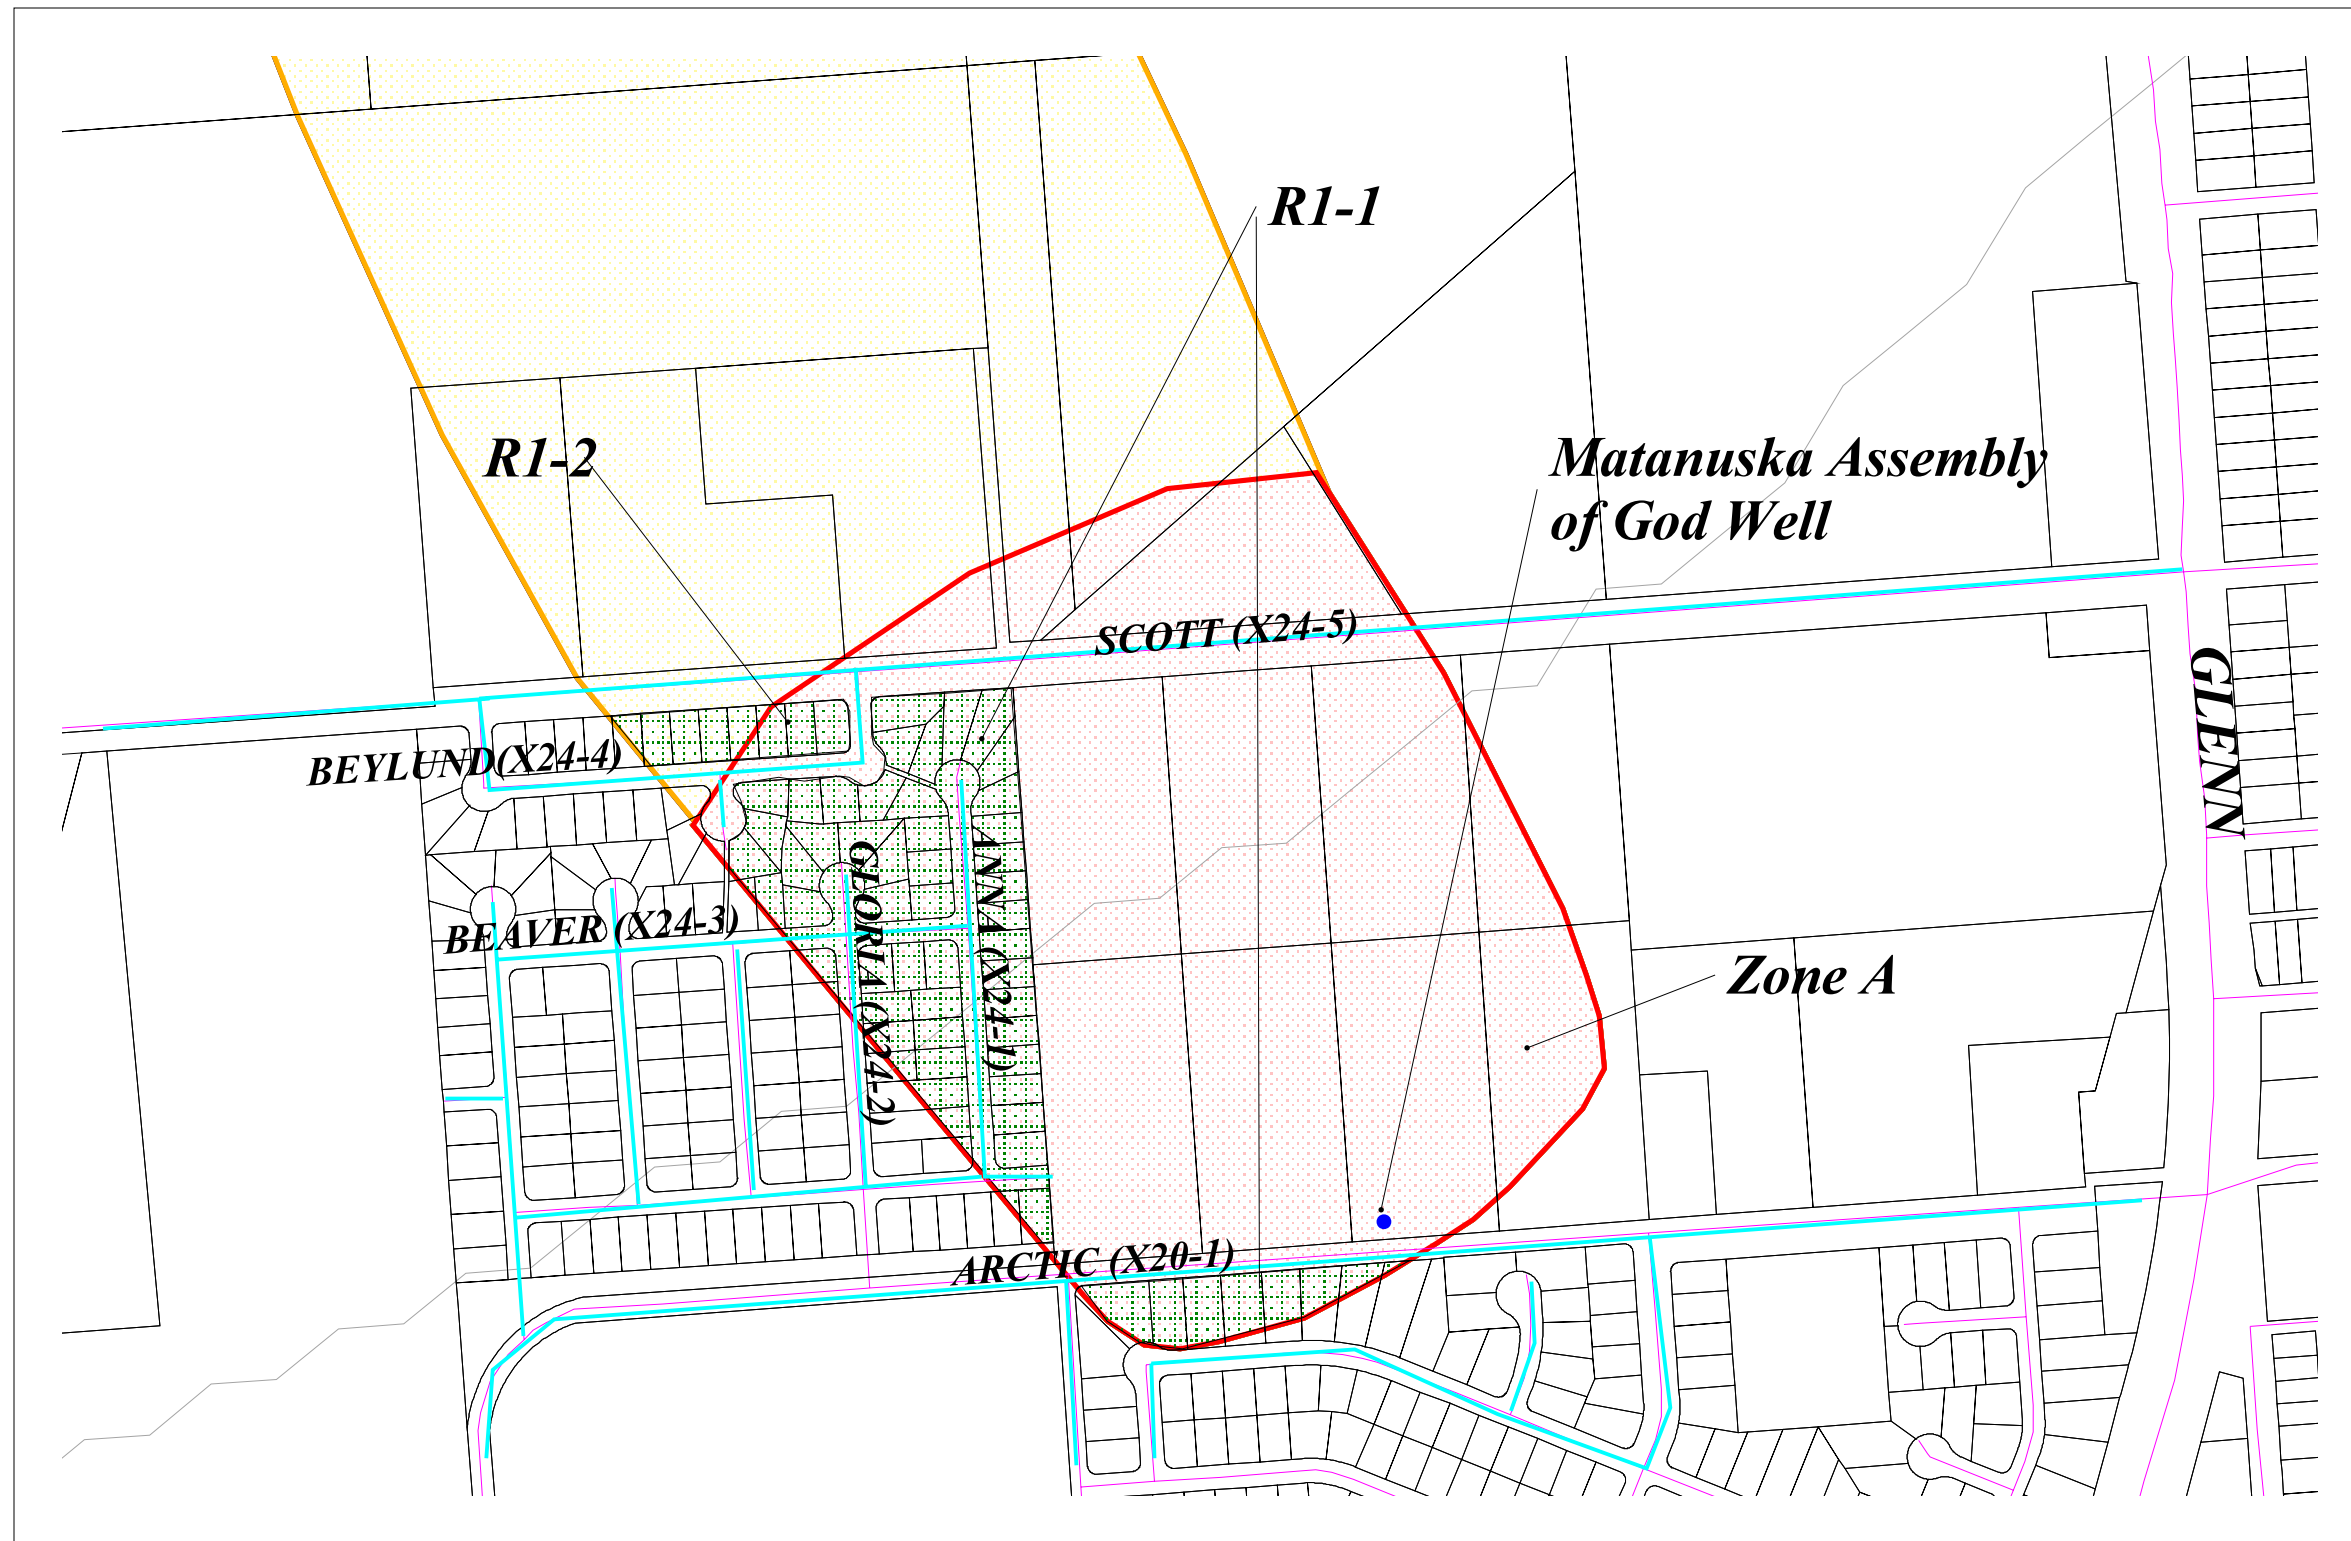
Matanuska Assembly of God Drinking Water Protection Area and Potential & Existing Contaminant Sources

Drinking Water Protection Areas Potential & Existing Sources of Contamination for Matanuska Assembly of God

Map 1 in Appendix C depicts the Contaminant Source Inventory for Matanuska Assembly of God.

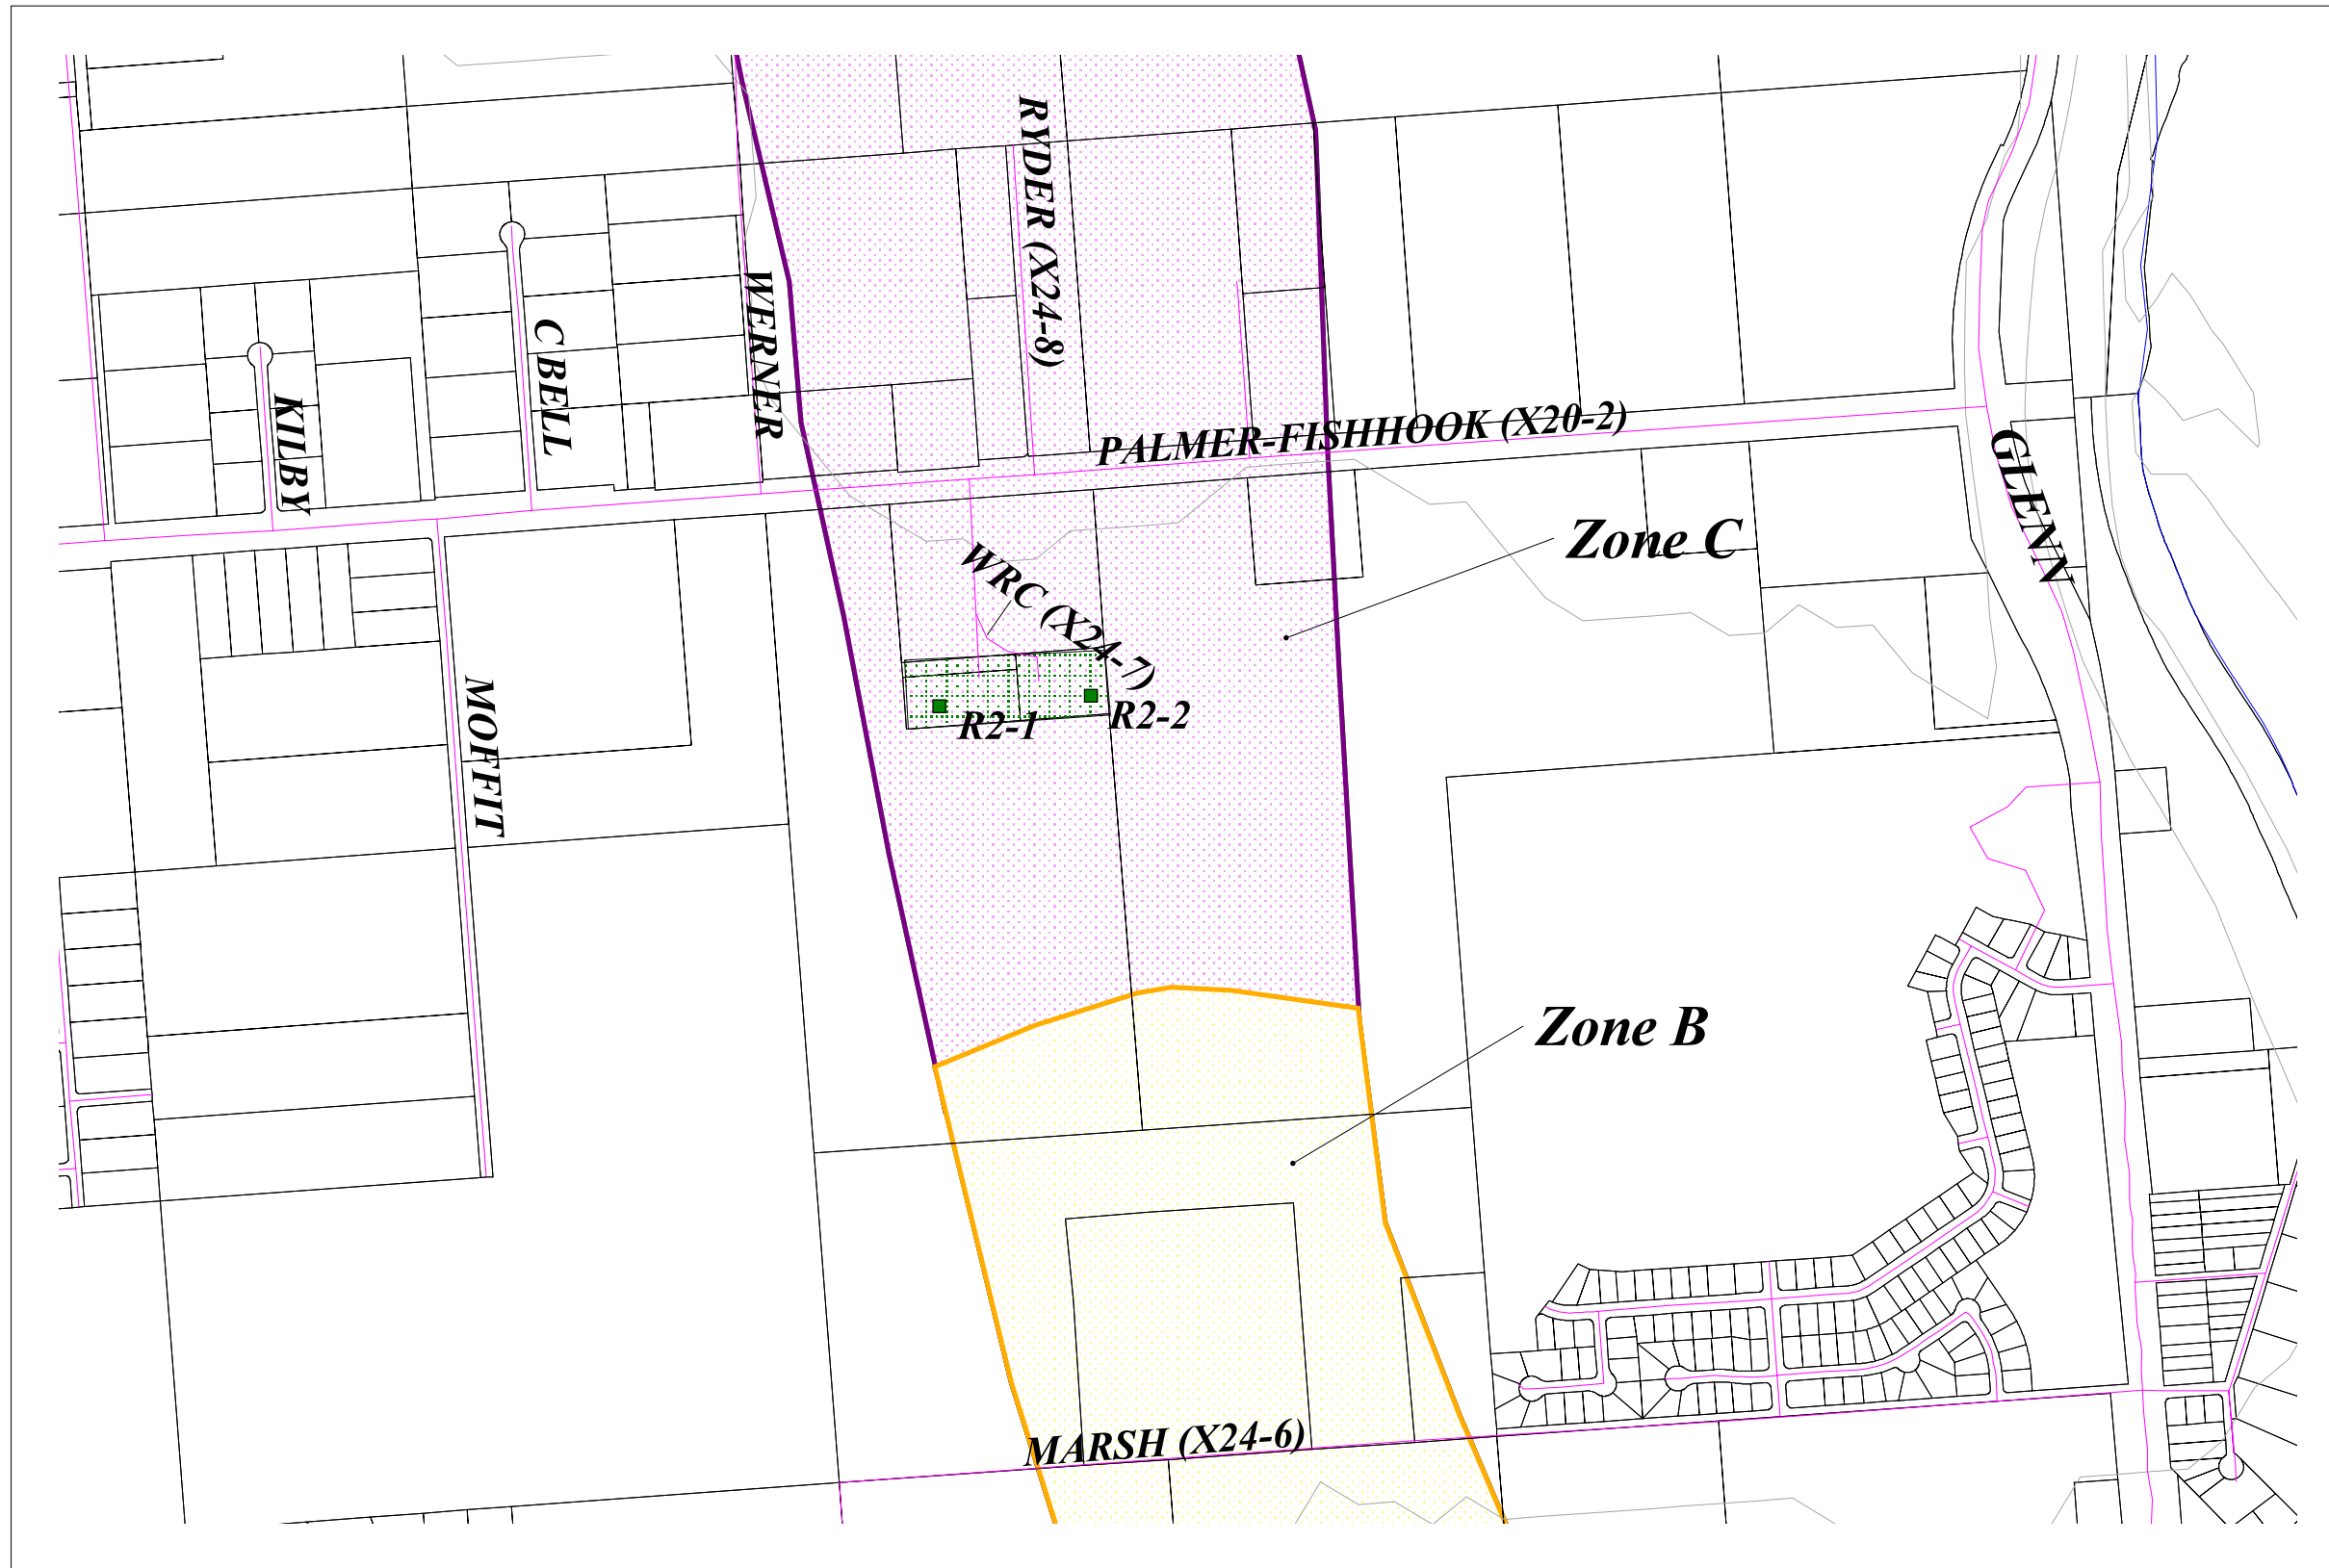
Drinking Water Protection Area and Potential & Existing Sources of Contamination for Matanuska Assembly of God

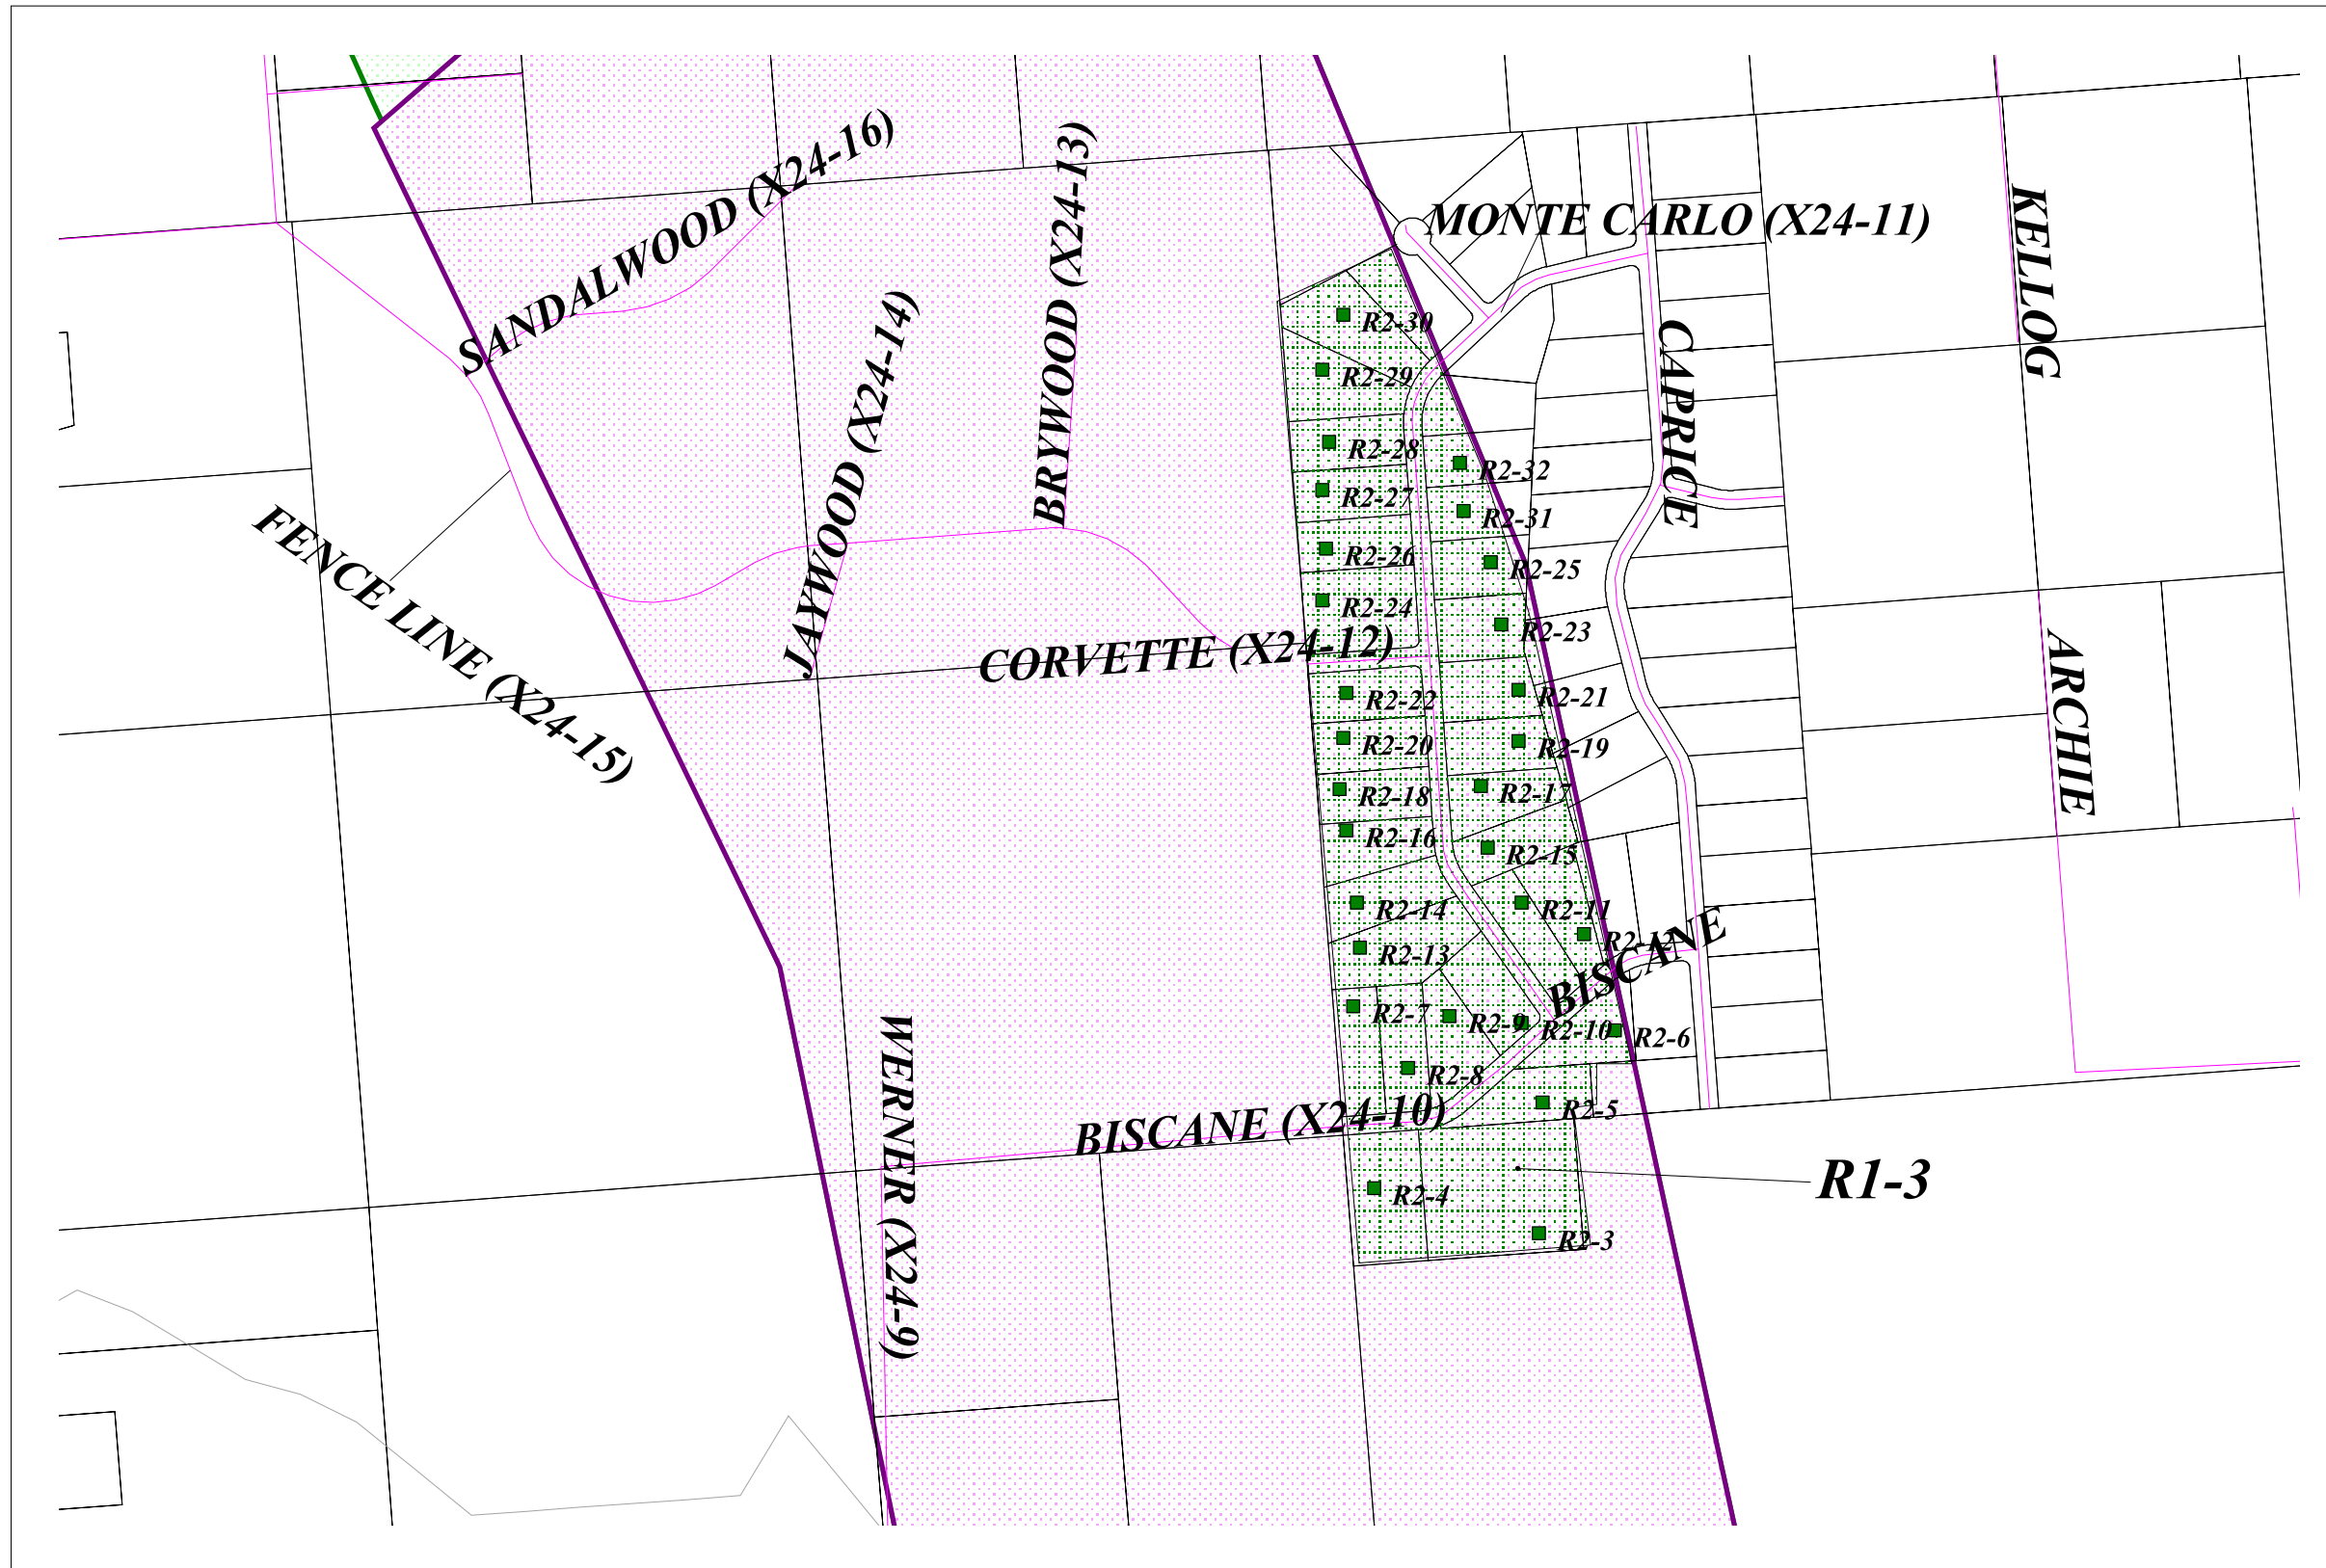
Drinking Water Protection Area and Potential & Existing Sources of Contamination for Matanuska Assembly of God

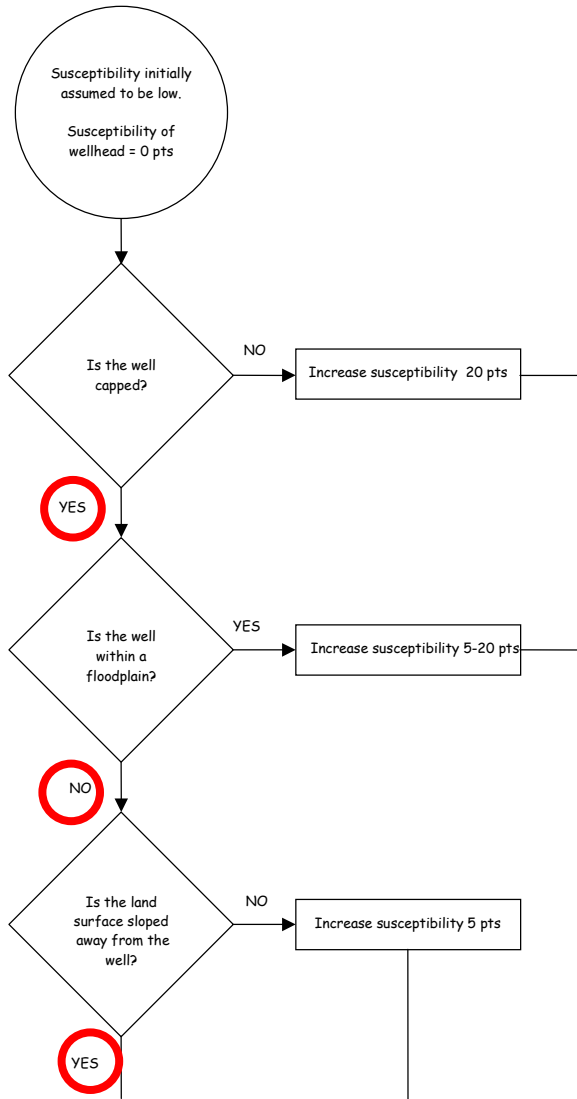
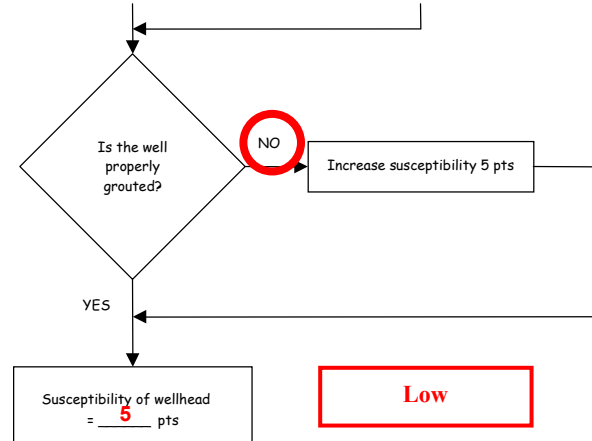
Chart 1. Susceptibility of the wellhead – Matanuska Assembly of God

<u>Wellhead Susceptibility Ratings</u>	
20 to 25 pts	very high
15 to < 20 pts	high
10 to < 15 pts	medium
< 10	low

Appendix D contains eight charts, which together form the ‘Vulnerability Analysis’ for a source water assessment for a public drinking water source. Chart 1 analyzes the ‘Susceptibility of the Wellhead’ to contamination by looking at the construction of the well and its surrounding area. Chart 2 analyzes the ‘Susceptibility of the Aquifer’ to contamination by looking at the naturally occurring attributes of the water source and influences on the groundwater system that might lead to contamination. Chart 3 analyzes ‘Contaminant Risks’ for the drinking water source with respect to bacteria and viruses. The ‘Contaminant Risks’ portion of the analysis considers potential sources of contaminants as well as a review of

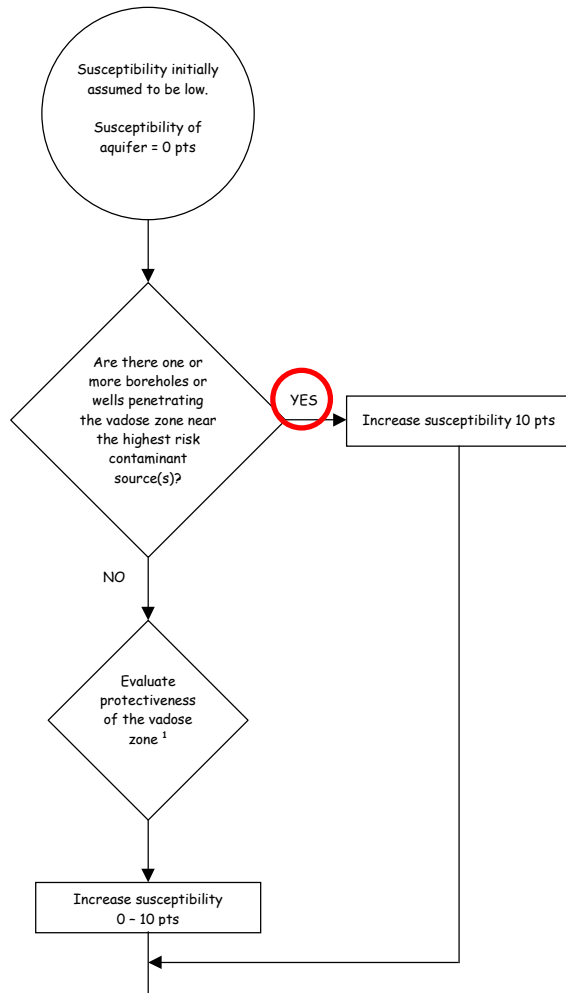
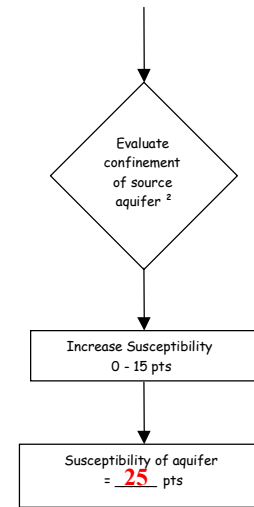
Chart 2. Susceptibility of the aquifer – Matanuska Assembly of God

Recharge (16-20 inches per year, base of Chugach Mountains, and silty gravelly sand)
8/10 = 4 Points
Depth to static water level (40 feet) 4/10 = 2 Point
Protectiveness of the Vadose Zone Total = **6/10 Points**

Unconfined aquifer
15/15 = **10 Points**
Density of boreholes/wells
15/15 = **5 Point**
Degree of Confinement
Total = **15/15 Points**

Matanuska Assembly of God is completed in a confined or semi-confined aquifer setting. The well penetrates fifty feet of silt, sand and gravel layers. This till material may provide somewhat of a protective barrier for the movement of contaminants in the subsurface. However, near the base of the Talkeetna Mountains, the clay and till layers tend to be discontinuous and thin toward the mountains. Therefore, contaminants that enter the subsurface near the base of the mountains may enter the confined aquifer uninhibited by the absence of any protective layer. This well does not appear to be properly grouted as indicated previously from information obtained from (ADEC) records. The absence of grouting can promote the transport of contaminants along the well casing. Combining the susceptibility of the wellhead and the aquifer to contamination leads to a score (0 – 50 points) and rating of overall Susceptibility (See Appendix D). Table 1
