Hydrogeologic Susceptibility and Vulnerability Assessment for Matanuska Assembly of God Church Drinking Water Well, Palmer, Alaska

DRINKING WATER PROTECTION PROGRAM REPORT 95

September 2001

By Michael Baxter, B.E.S.T. Resource

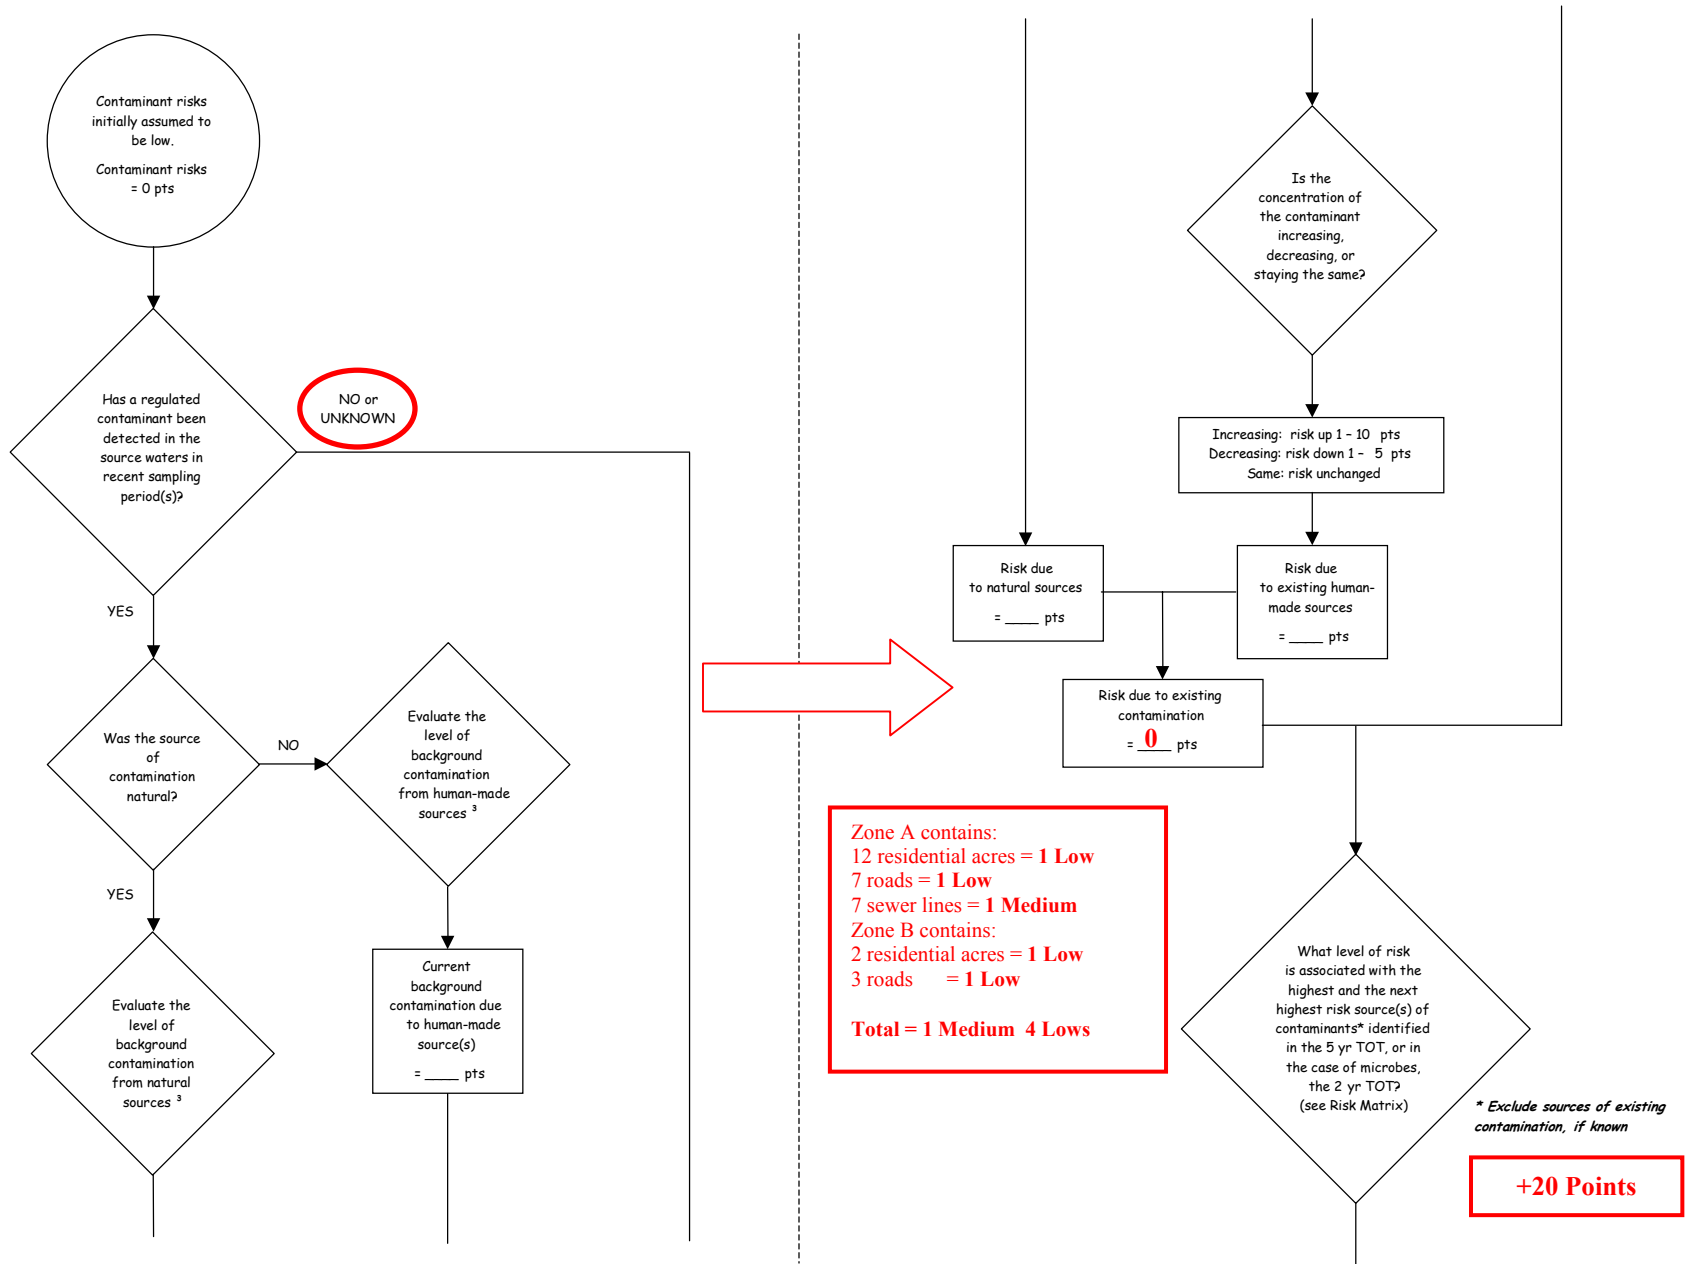
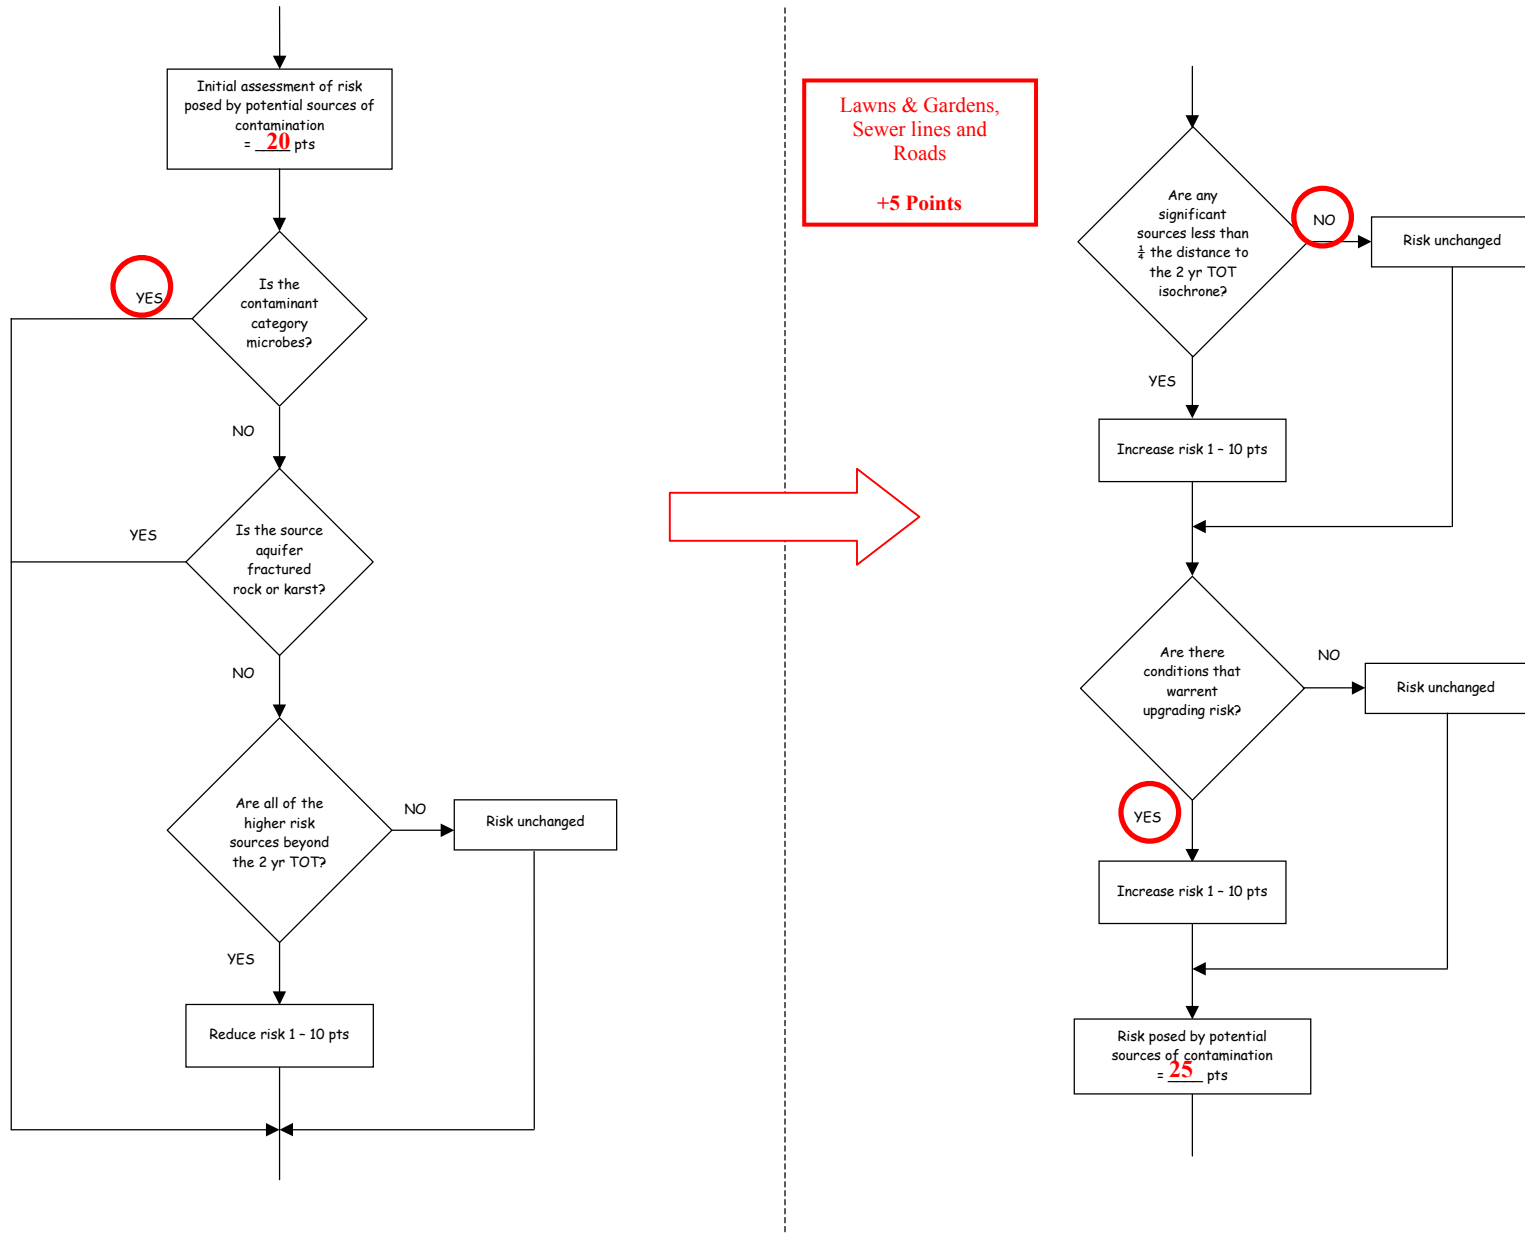
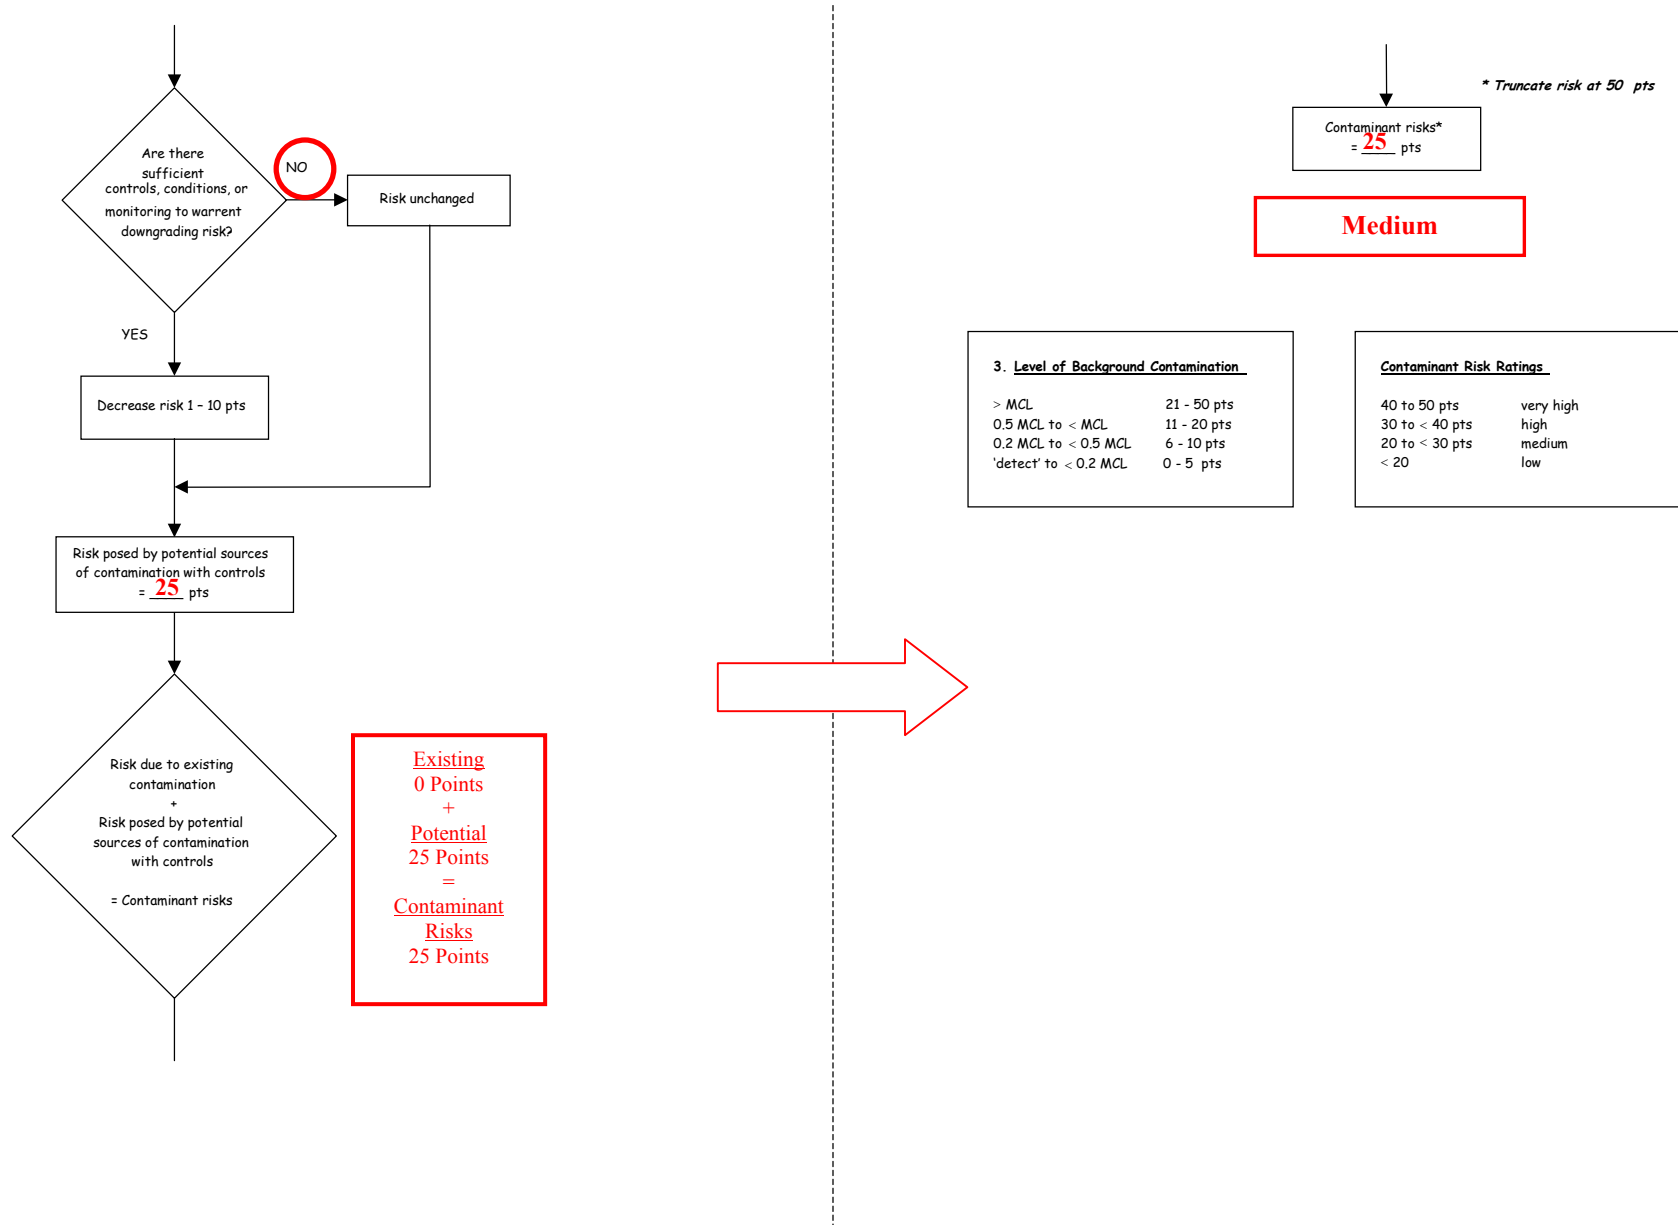
Chart 3. Contaminant risks for Matanuska Assembly of God – Bacteria & Viruses

Appendix D contains eight charts, which together form the ‘Vulnerability Analysis’ for a source water assessment for a public drinking water source. Chart 1 analyzes the ‘Susceptibility of the Wellhead’ to contamination by looking at the construction of the well and its surrounding area. Chart 2 analyzes the ‘Susceptibility of the Aquifer’ to contamination by looking at the naturally occurring attributes of the water source and influences on the groundwater system that might lead to contamination. Chart 3 analyzes ‘Contaminant Risks’ for the drinking water source with respect to bacteria and viruses. The ‘Contaminant Risks’ portion of the analysis considers potential sources of contaminants as well as a review of

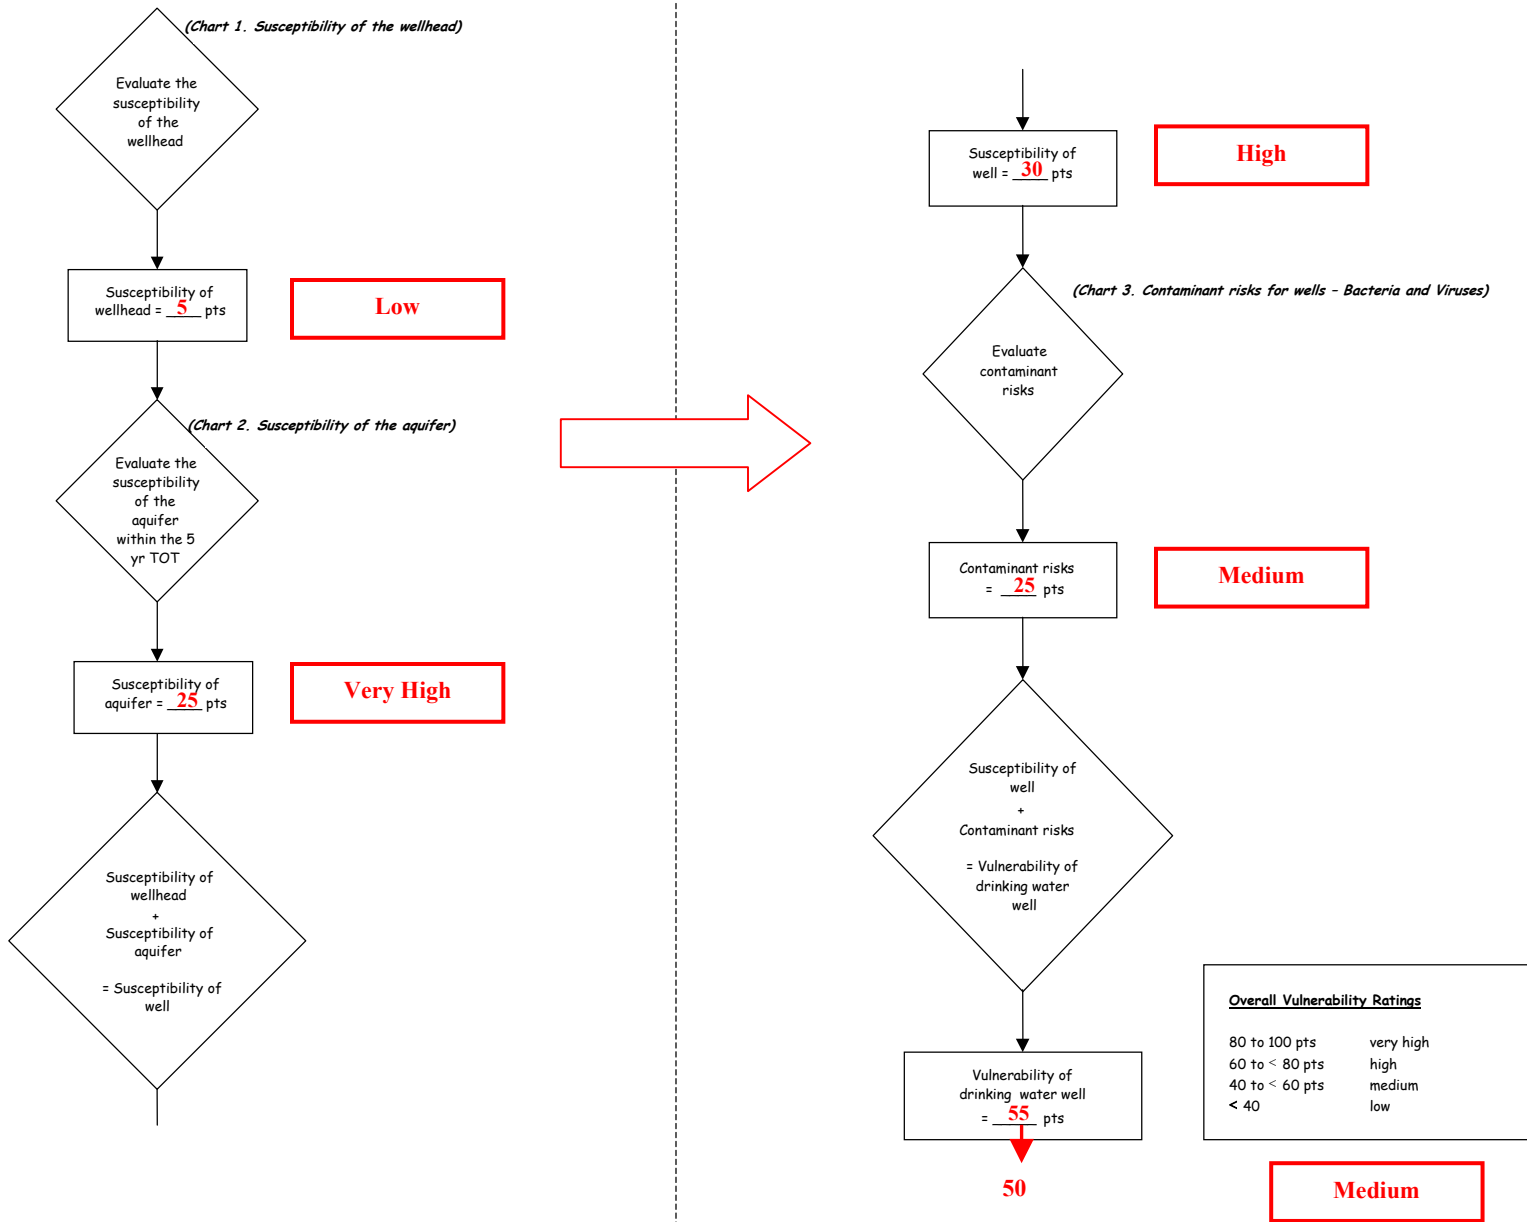
Chart 4. Vulnerability analysis for Matanuska Assembly of God – Bacteria & Viruses

Overall, contaminant risk for the bacteria and viruses category is medium. Bacteria and Viruses were not detected in the source waters of Matanuska Assembly of God. The contaminate risk from bacteria and viruses with the susceptibility of the well yields an overall medium vulnerability to contamination from bacteria and viruses.

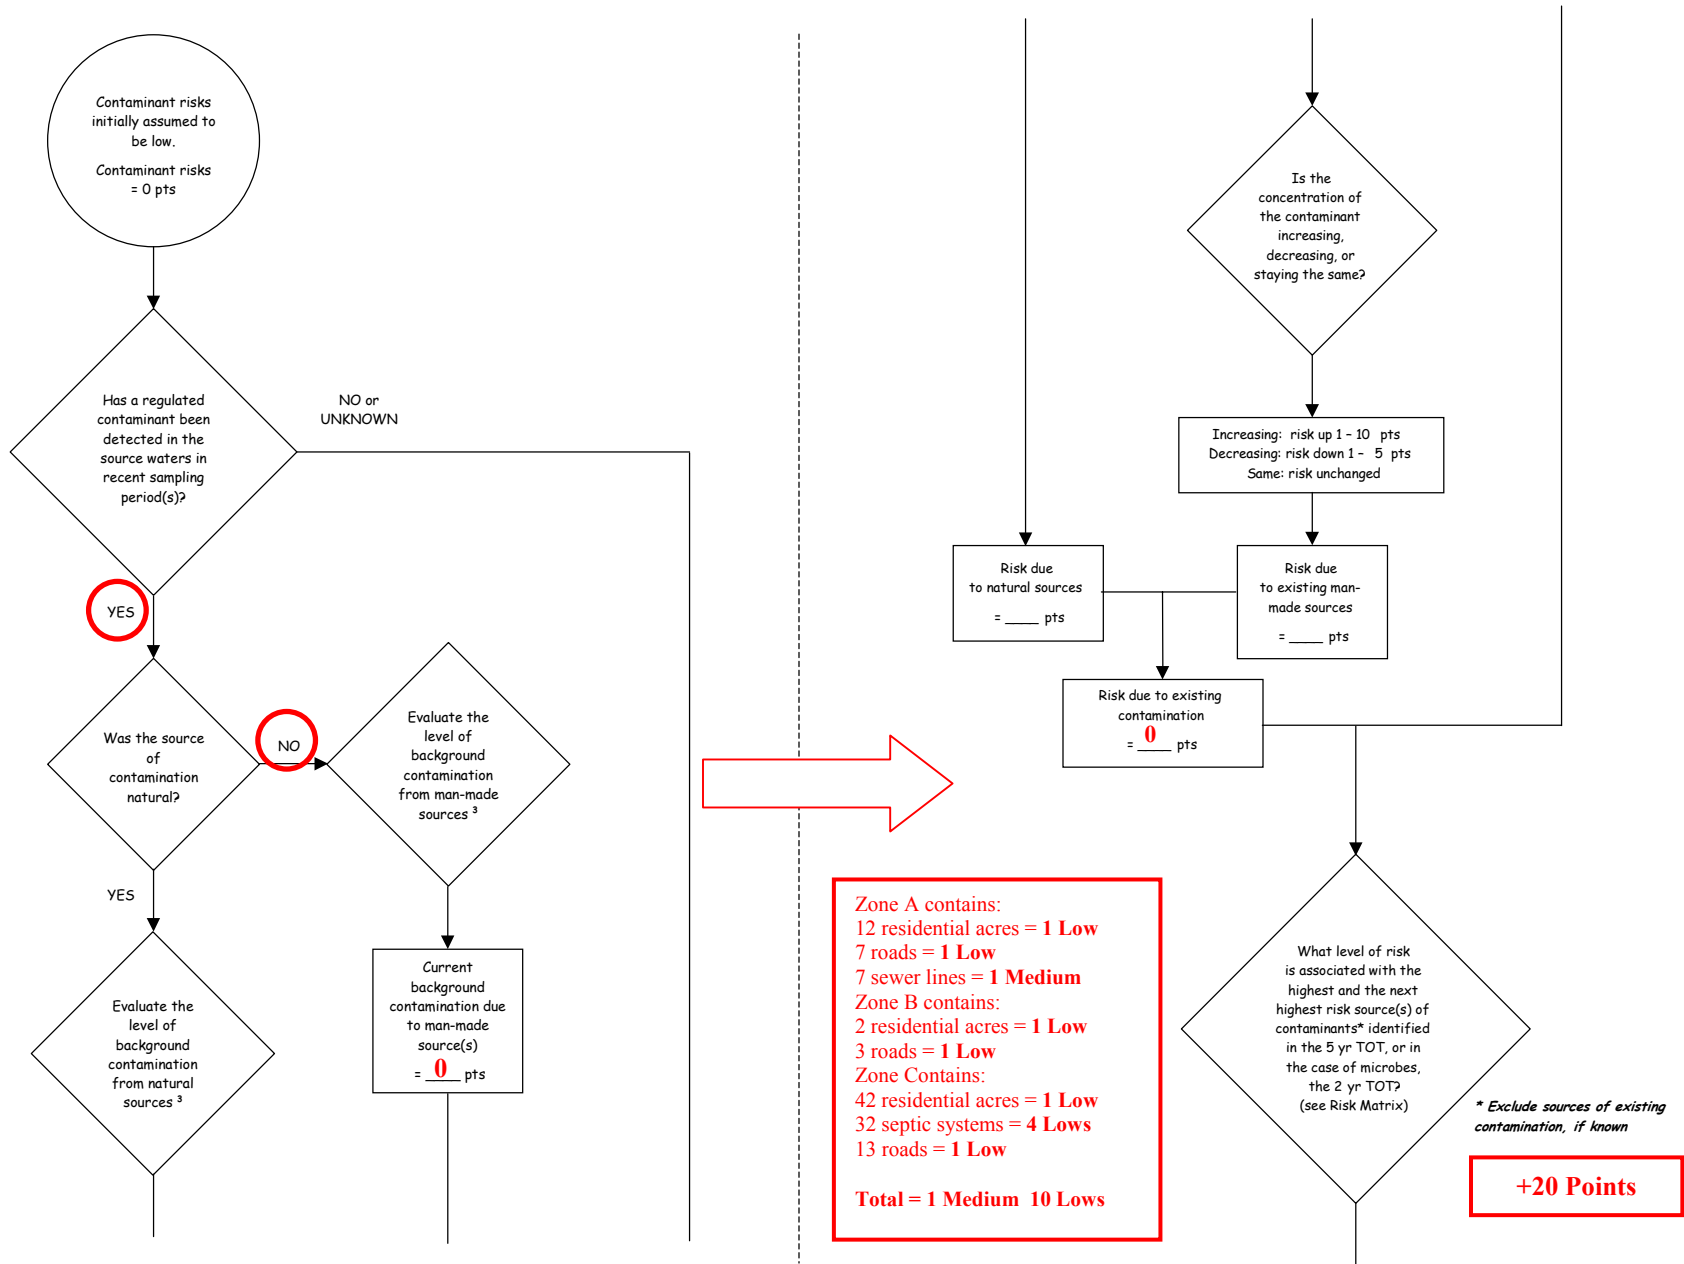
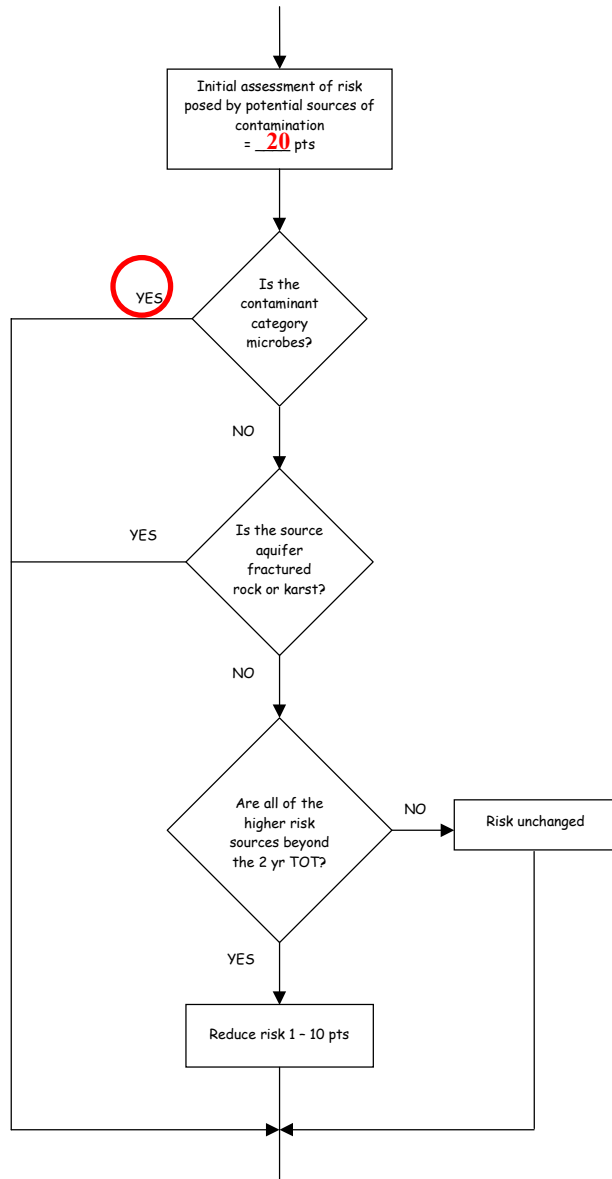
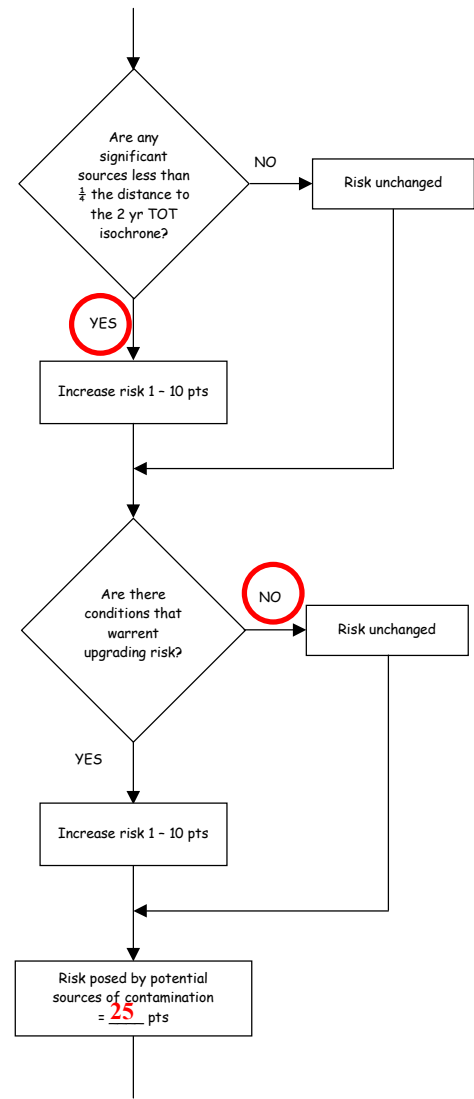
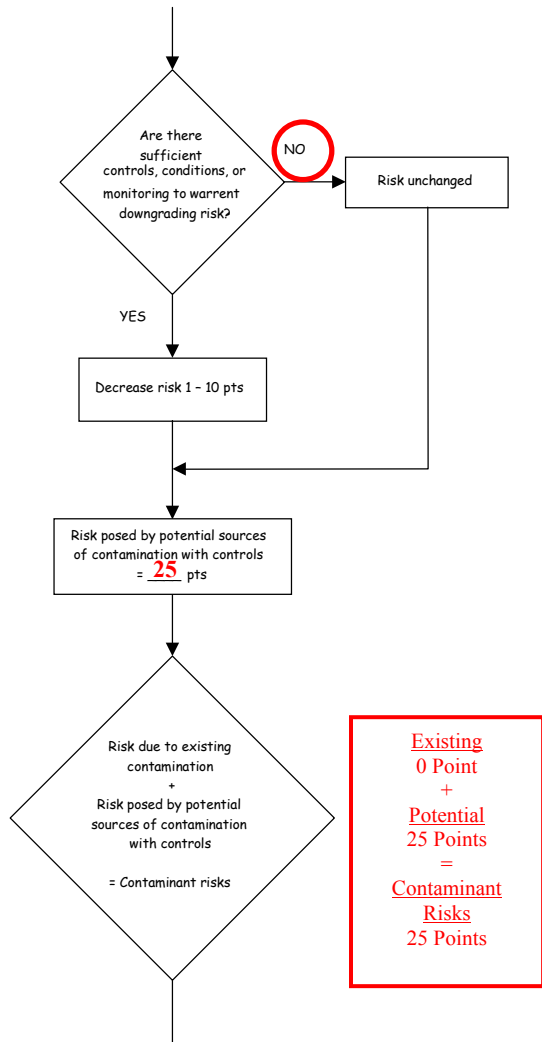
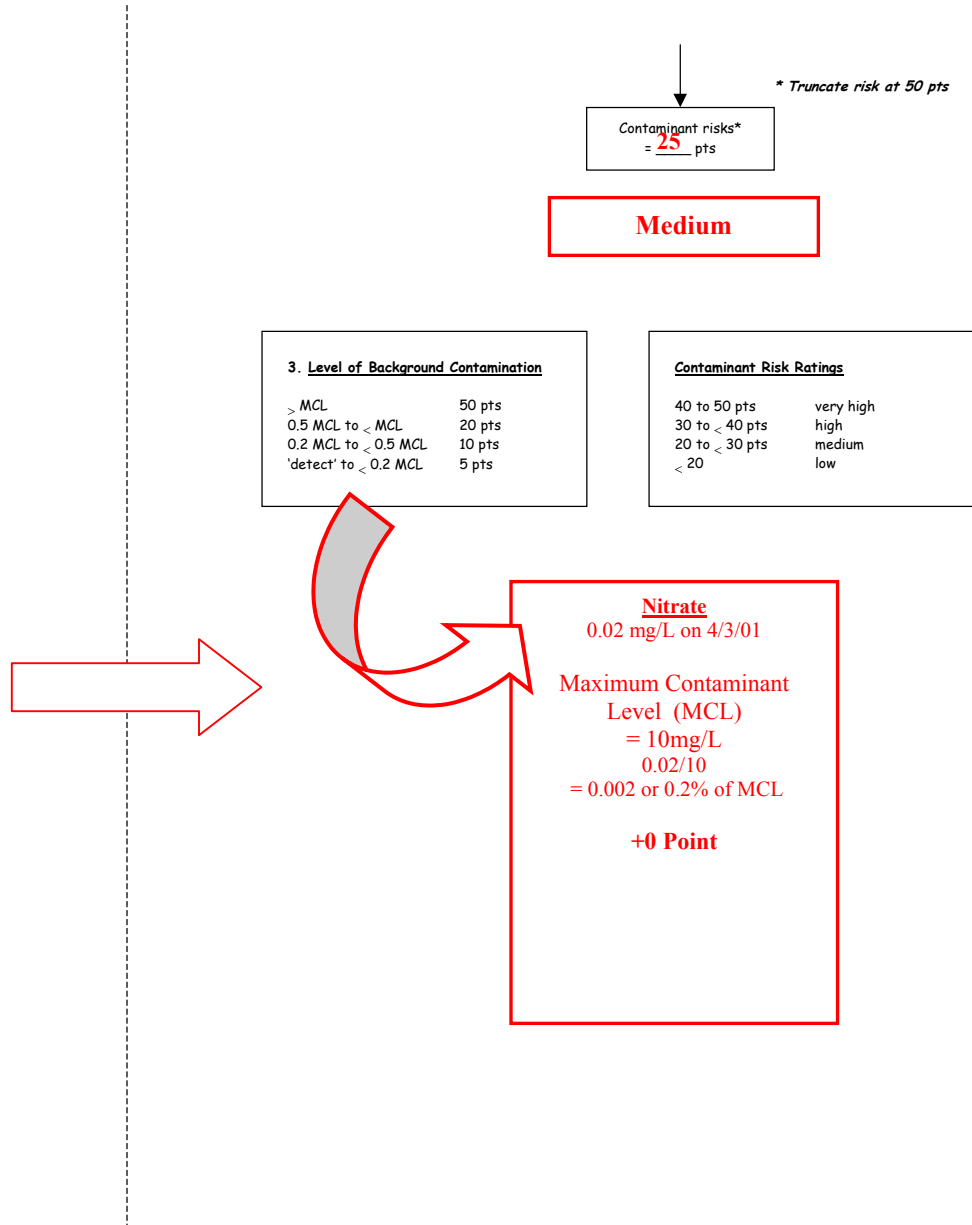
Chart 5. Contaminant risks for Matanuska Assembly of God – Nitrates and Nitrites

Residential acres, septic systems, roads and sewer lines
+5 Points

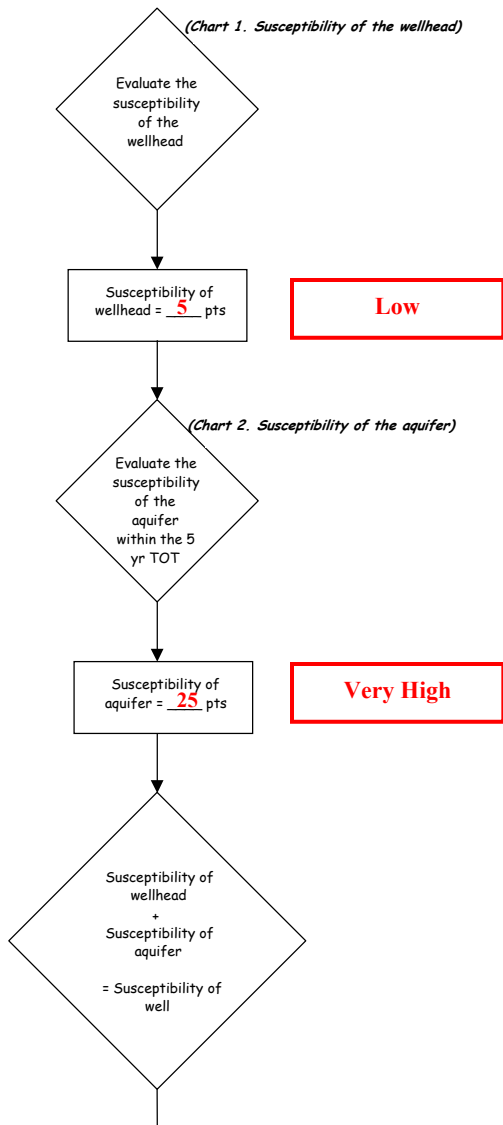
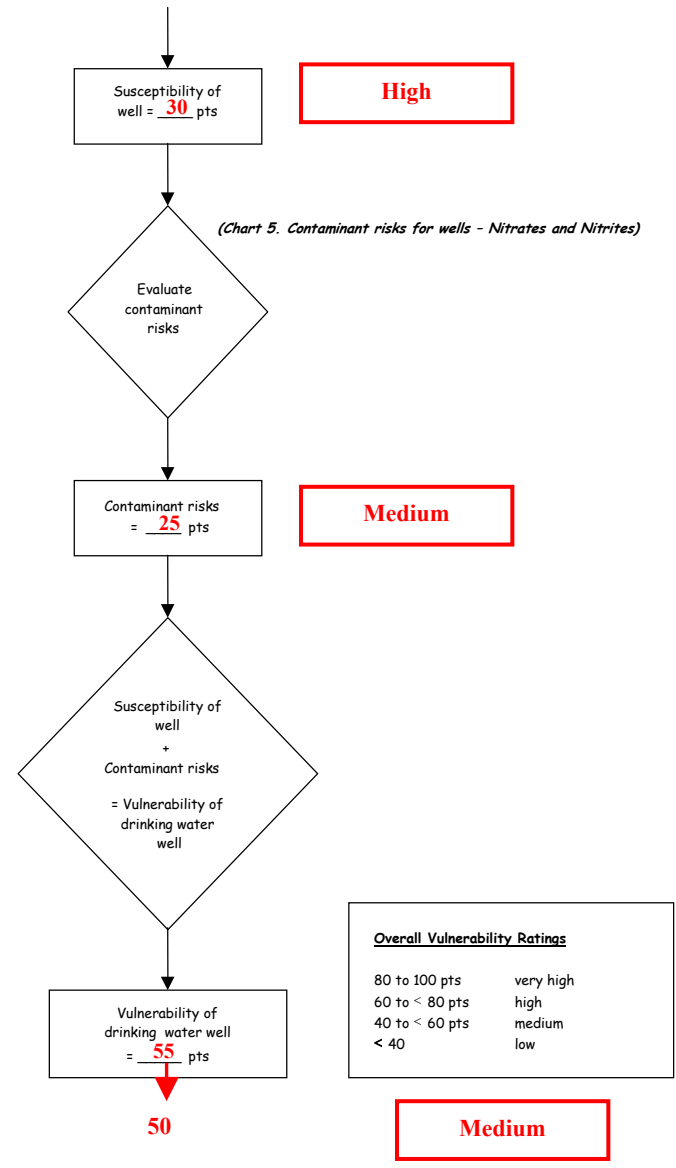
Chart 6. Vulnerability analysis for Matanuska Assembly of God – Nitrates and Nitrites

Nitrates and/or nitrites are found in natural background concentrations at the site, as elsewhere in the Alaska. Sampling history of Matanuska Assembly of God source waters indicate low concentrations of nitrate (See Chart 6 – Contaminant Risks for Nitrates/Nitrites in Appendix D). Existing nitrate contamination is approximately 0.2% of the allowable limit (MCL) for this contaminant. Due to the high solubility and weak retention by soil, nitrates are very mobile in soil, moving at approximately the same rate as water. Nevertheless, the current nitrate concentration in Matanuska Assembly of God remains at safe levels with respect to human health.

Overall, contaminant risks for the nitrate/nitrite category is medium with the residential lawns and gardens, sewer lines and roads driving the score. Combining this potential nitrates and/or nitrites contamination risk with the susceptibility of the well yields an overall vulnerability to contamination of medium for this source of public drinking water.

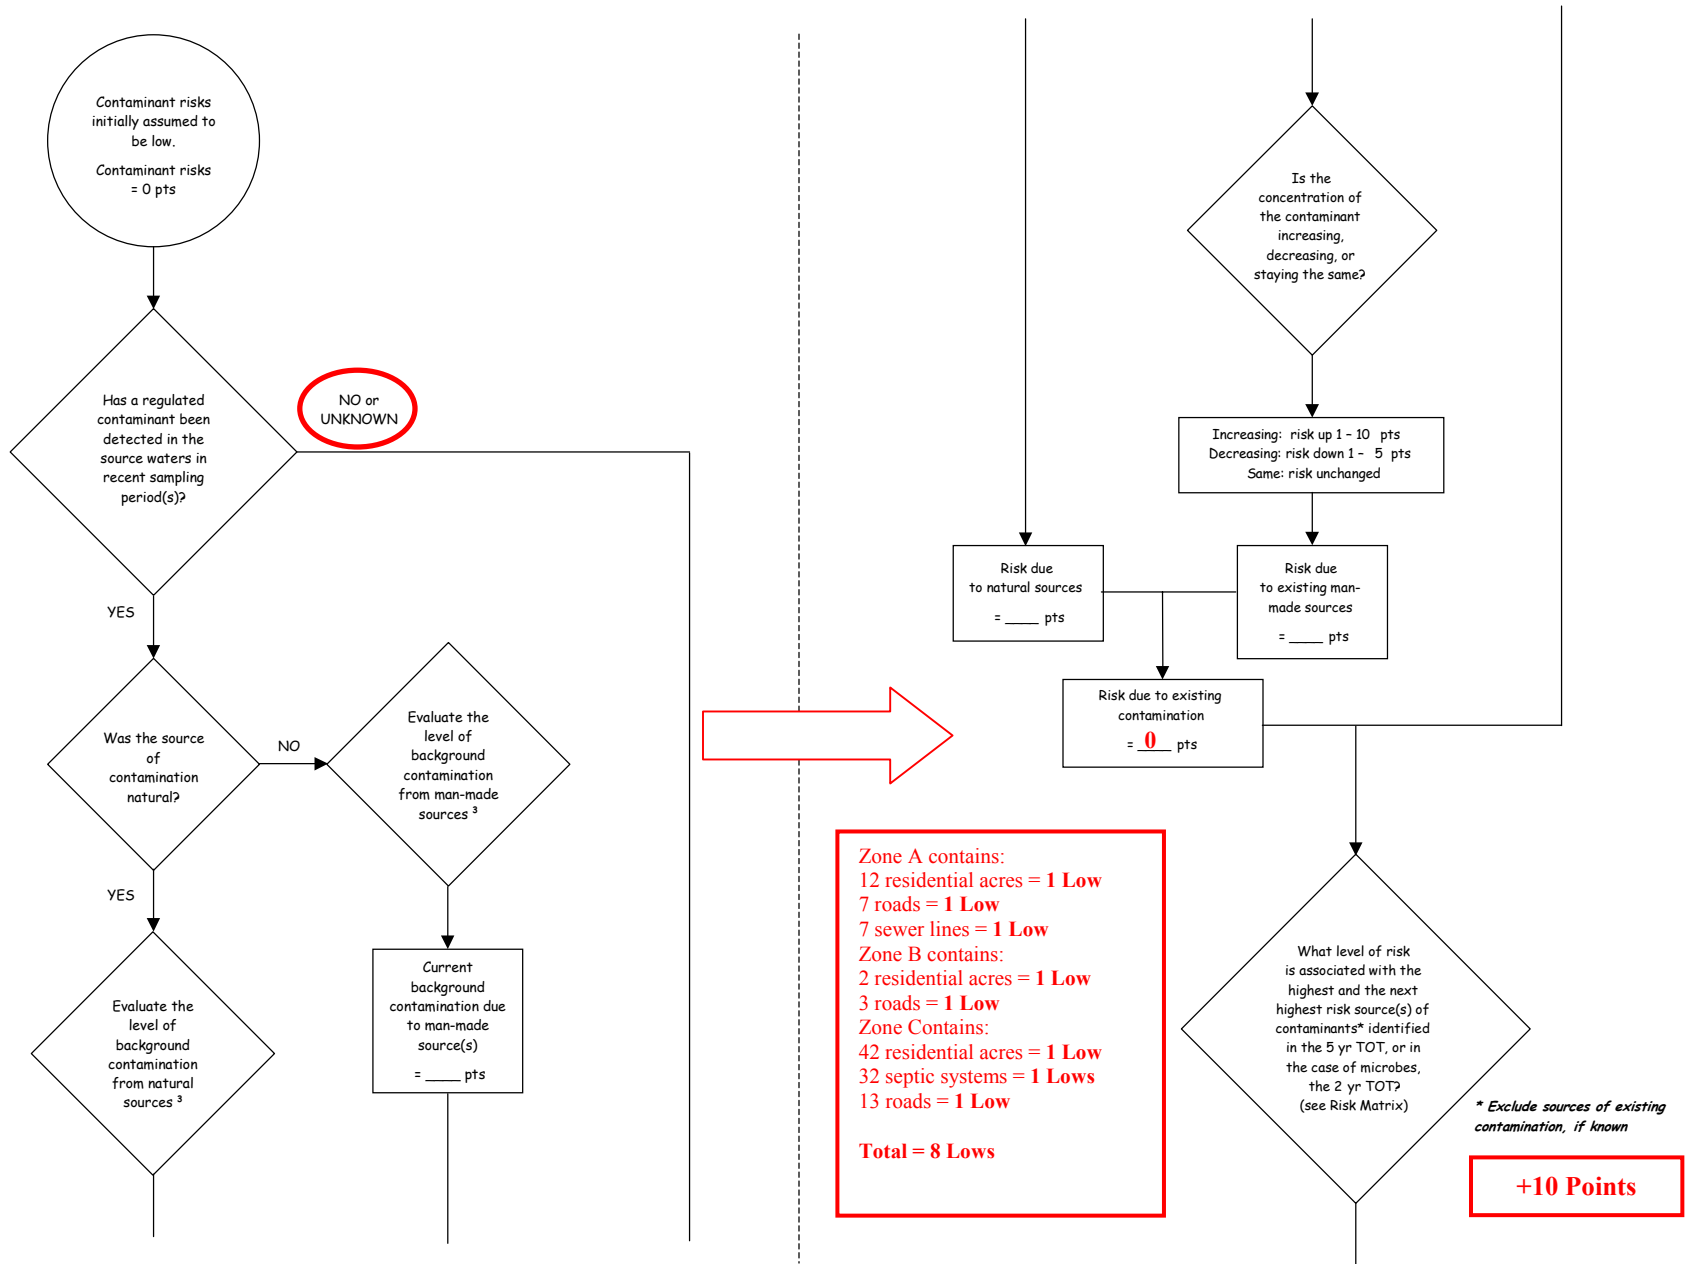
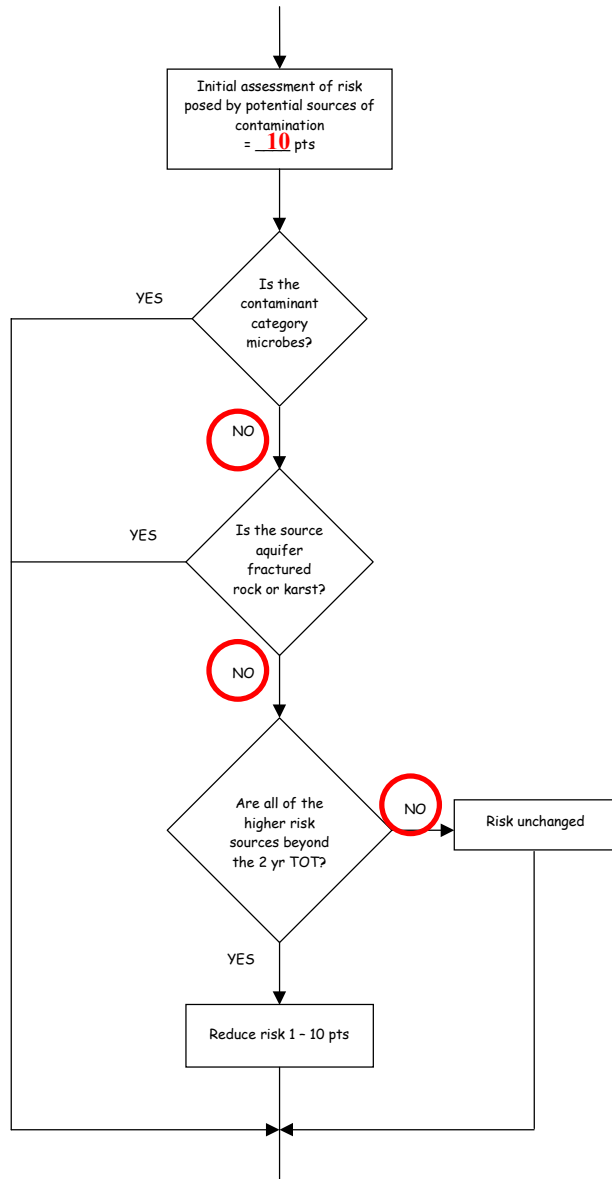
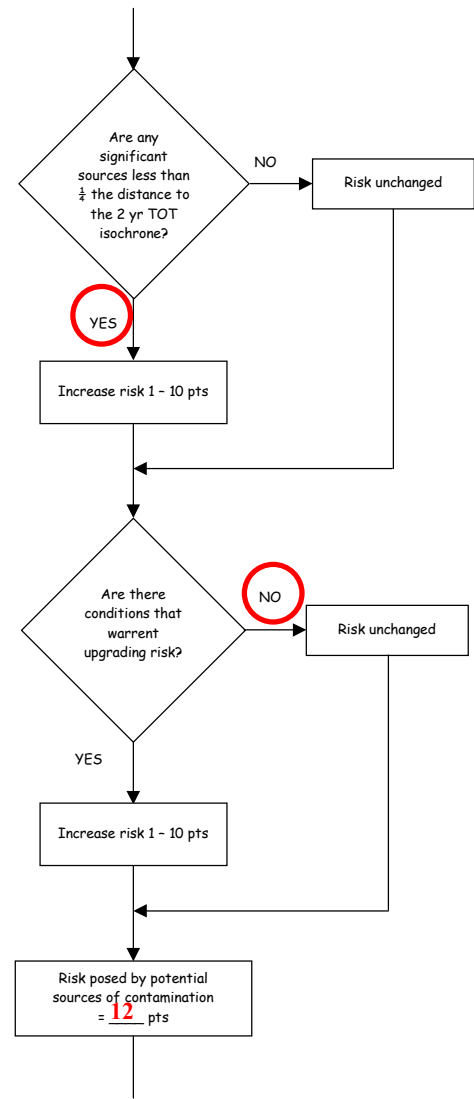
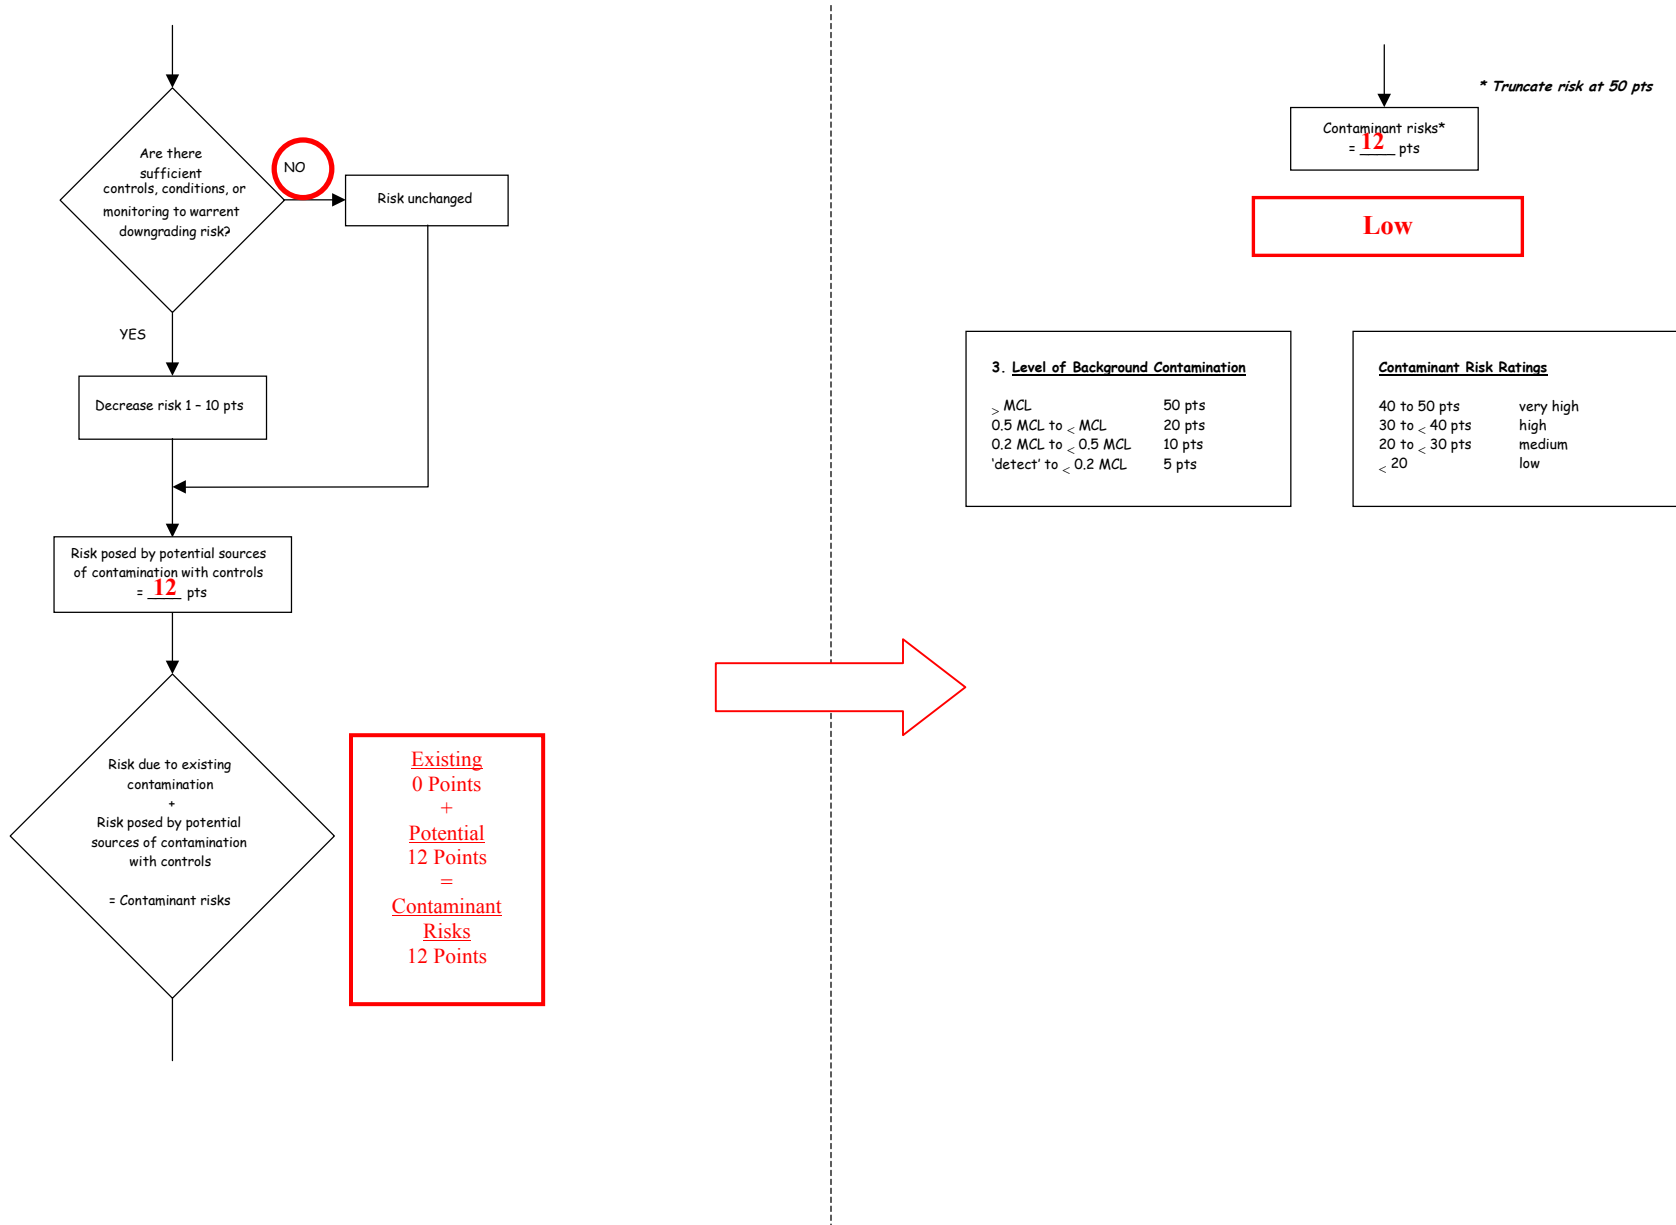
Chart 7. Contaminant risks for Matanuska Assembly of God – Volatile Organic Chemicals

Residential acres, septic systems, roads and sewer lines
+2 Points

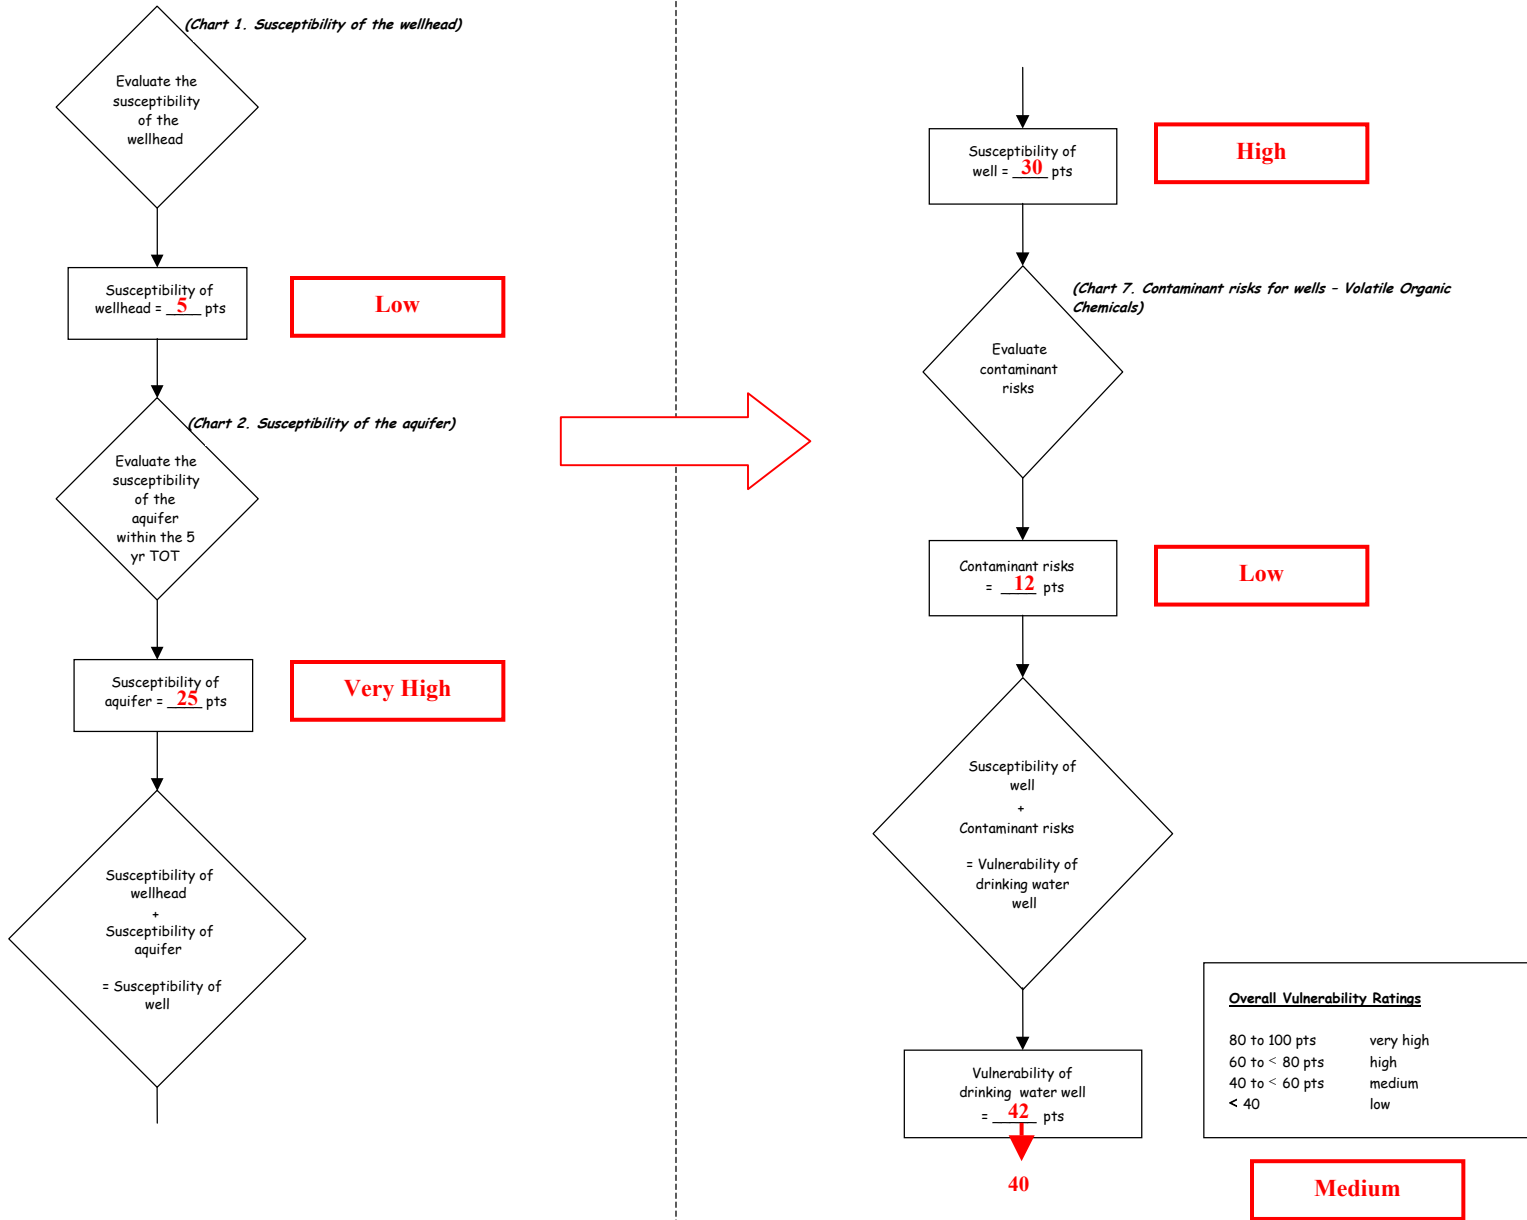
Chart 8. Vulnerability analysis for Matanuska Assembly of God – Volatile Organic Chemicals

Volatile Organic Chemicals were not detected in the source waters of Matanuska Assembly of God. Overall, a contaminant risk for the volatile organic chemicals category is low due to the roads, lawns and gardens and septic systems present up gradient from the well. Combining the contaminate risk with the susceptibility of the well yields an overall medium vulnerability to contamination for Volatile Organic Chemicals.
