# Source Water Assessment

A Hydrogeologic Susceptibility and Vulnerability Assessment for Peter's Creek Baptist Church Drinking Water System, Peter's Creek, Alaska Peter's Creek Baptist Church #218425

DRINKING WATER PROTECTION PROGRAM REPORT # 220 Alaska Department of Environmental Conservation

AUGUST 2002

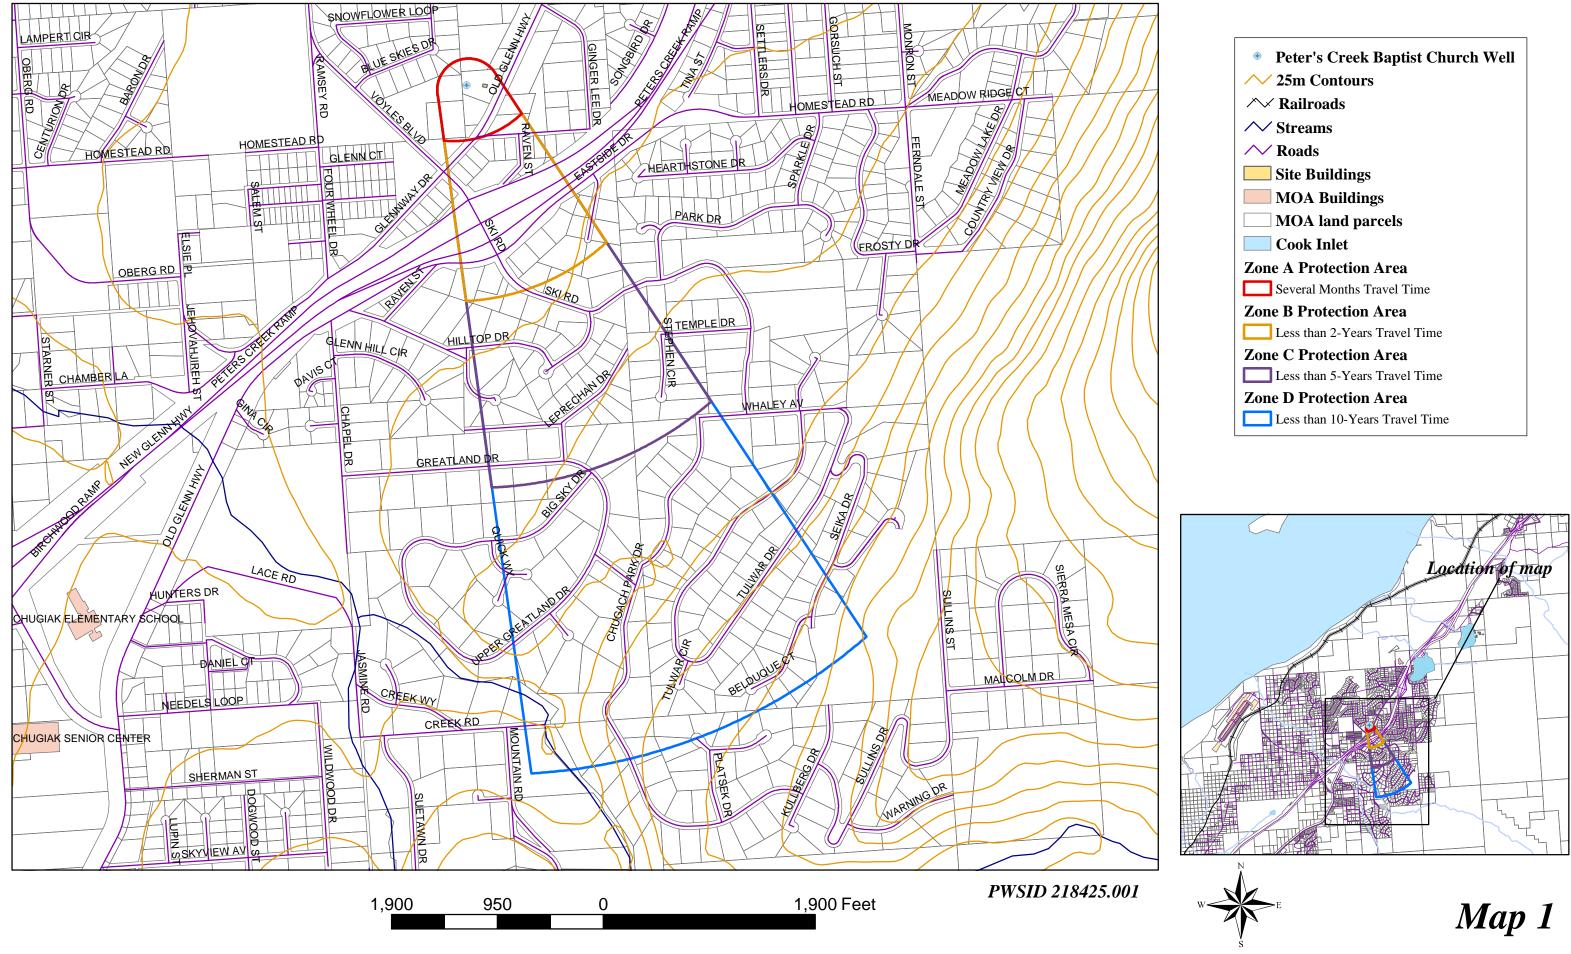
## Drinking Water Protection Areas for Peter's Creek Baptist Church

Peter's Creek Baptist Church Drinking Water Protection Area (Map 1)

The most probable area for contamination to reach the drinking water well is the area that contributes water to the well, the groundwater recharge area. This area is designated as the Drinking Water Protection Area (DWPA). Because a release of contaminants within the DWPA are most likely to impact the drinking water well, this area will serve as the focus for voluntary protection efforts.

An analytical calculation was used to determine the size and shape of the DWPA. The input parameters describing the attributes of the aquifer in this calculation were adopted from the U.S. Geological Survey (*Patrick, Brabets, and Glass, 1989*), and State of Alaska Department of Water Resources. Additional methods were also used to take into account any uncertainties in groundwater flow and aquifer characteristics to arrive at a meaningful DWPA (Please refer to the Guidance Manual for Class B Public Water Systems for additional information).

The DWPAs established for wells by the ADEC are separated into four zones. These zones correspond to differences in the time-of-travel (TOT) of the water moving through the aquifer to the well. The TOT for contaminants within the water varies and is dependent on the physical and chemical characteristics of each contaminant. The following is a summary of the four DWPA zones and the calculated TOT for each:

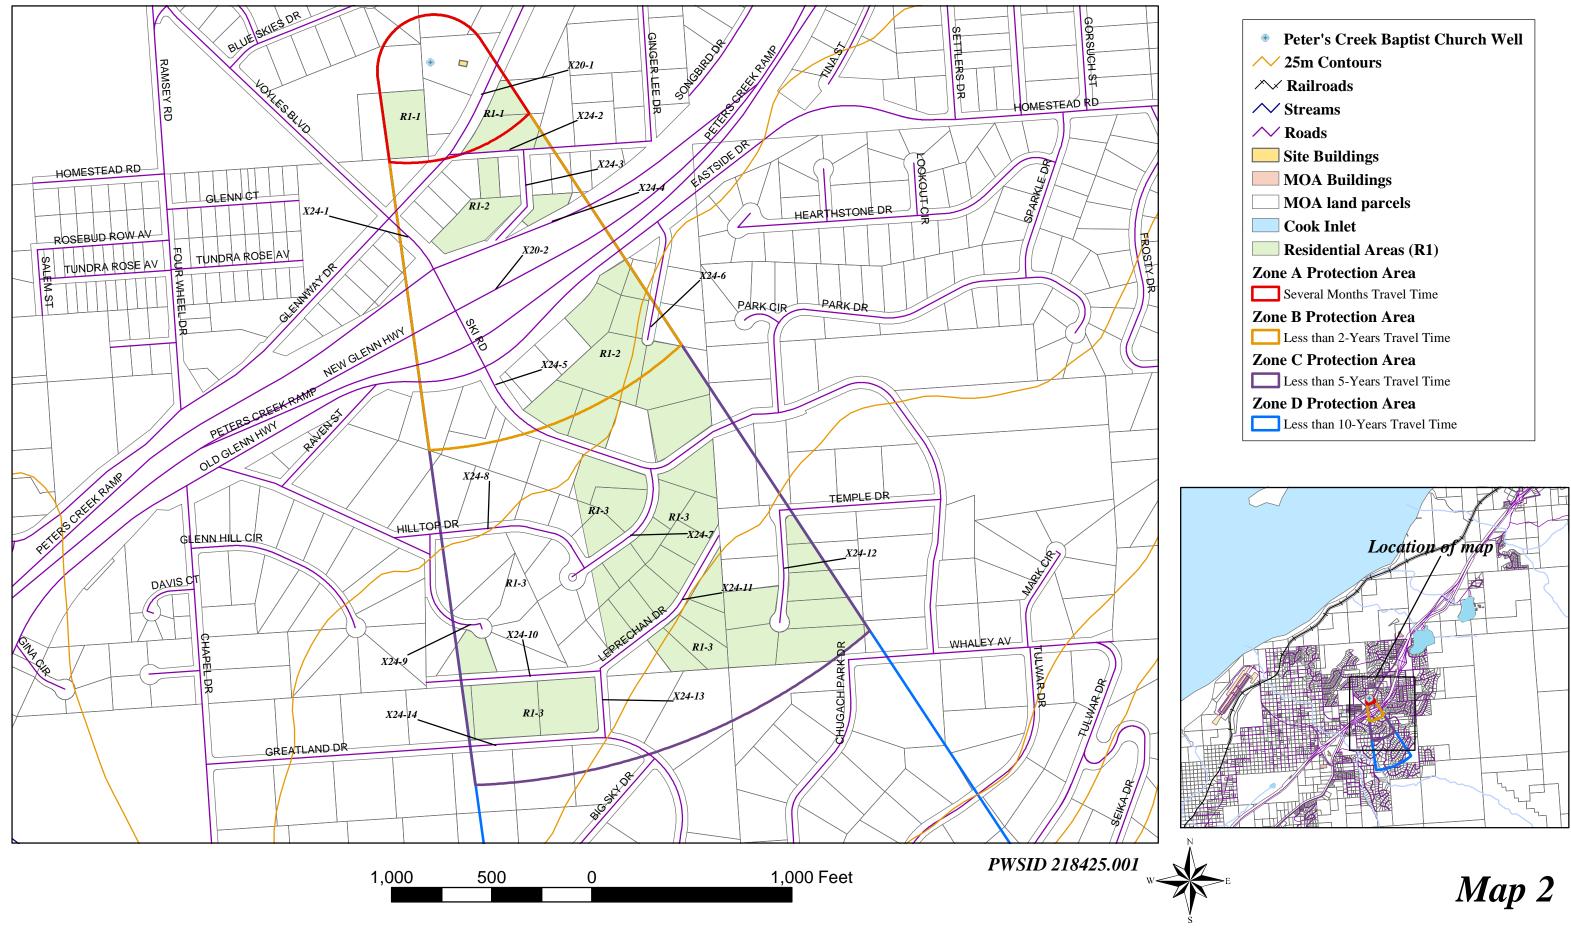
# Drinking Water Protection Areas for Peter's Creek Baptist Church and **Potential and Exisiting Sources of Contamination**

Peter's Creek Baptist Church Drinking Water Protection Area and Potential and Existing Contaminant Sources (Maps 2-3)

Inventoried potential sources of contamination within Zones A through Zone D were associated with residential and light industrial type activities. The sources are summarized in the tables in Appendix B.
