A Hydrogeologic Susceptibility and
Vulnerability Assessment for
Begich Boggs Visitor Center Well No. 2
Drinking Water System,
Portage Valley, Alaska
PWSID # 213718.002

By URS Corporation

DRINKING WATER PROTECTION PROGRAM REPORT # 332

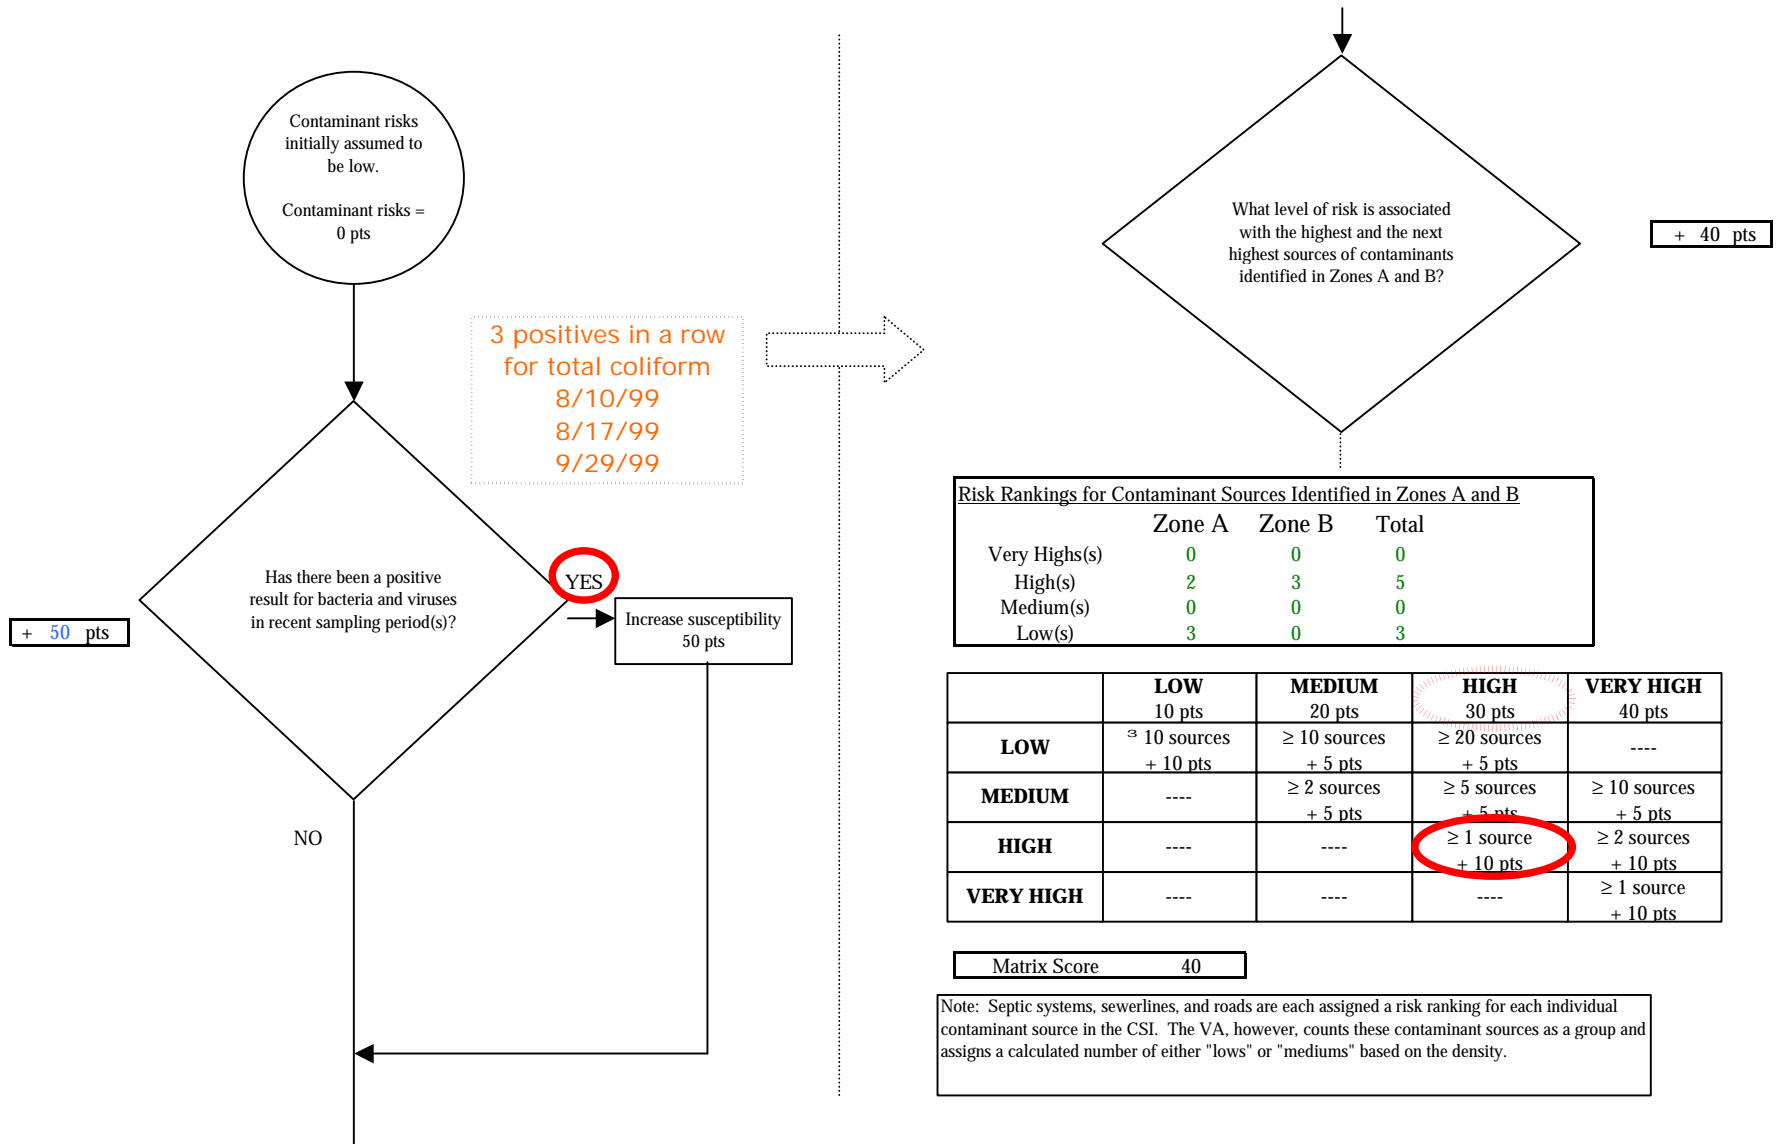
Chart 3. Contaminant risks for Begich Boggs Visitor Center No. 2 (213718.002) - Bacteria & Viruses

Only a small amount of bacteria and viruses are required to endanger public health. Bacteria and viruses (total fecal coliform) were detected during the annual and two subsequent confirmation water sampling events of the system at Begich Boggs Visitor Center Well No. 1 in 1999. These positive results automatically increase the risk for this category. The source of the detects is unknown.

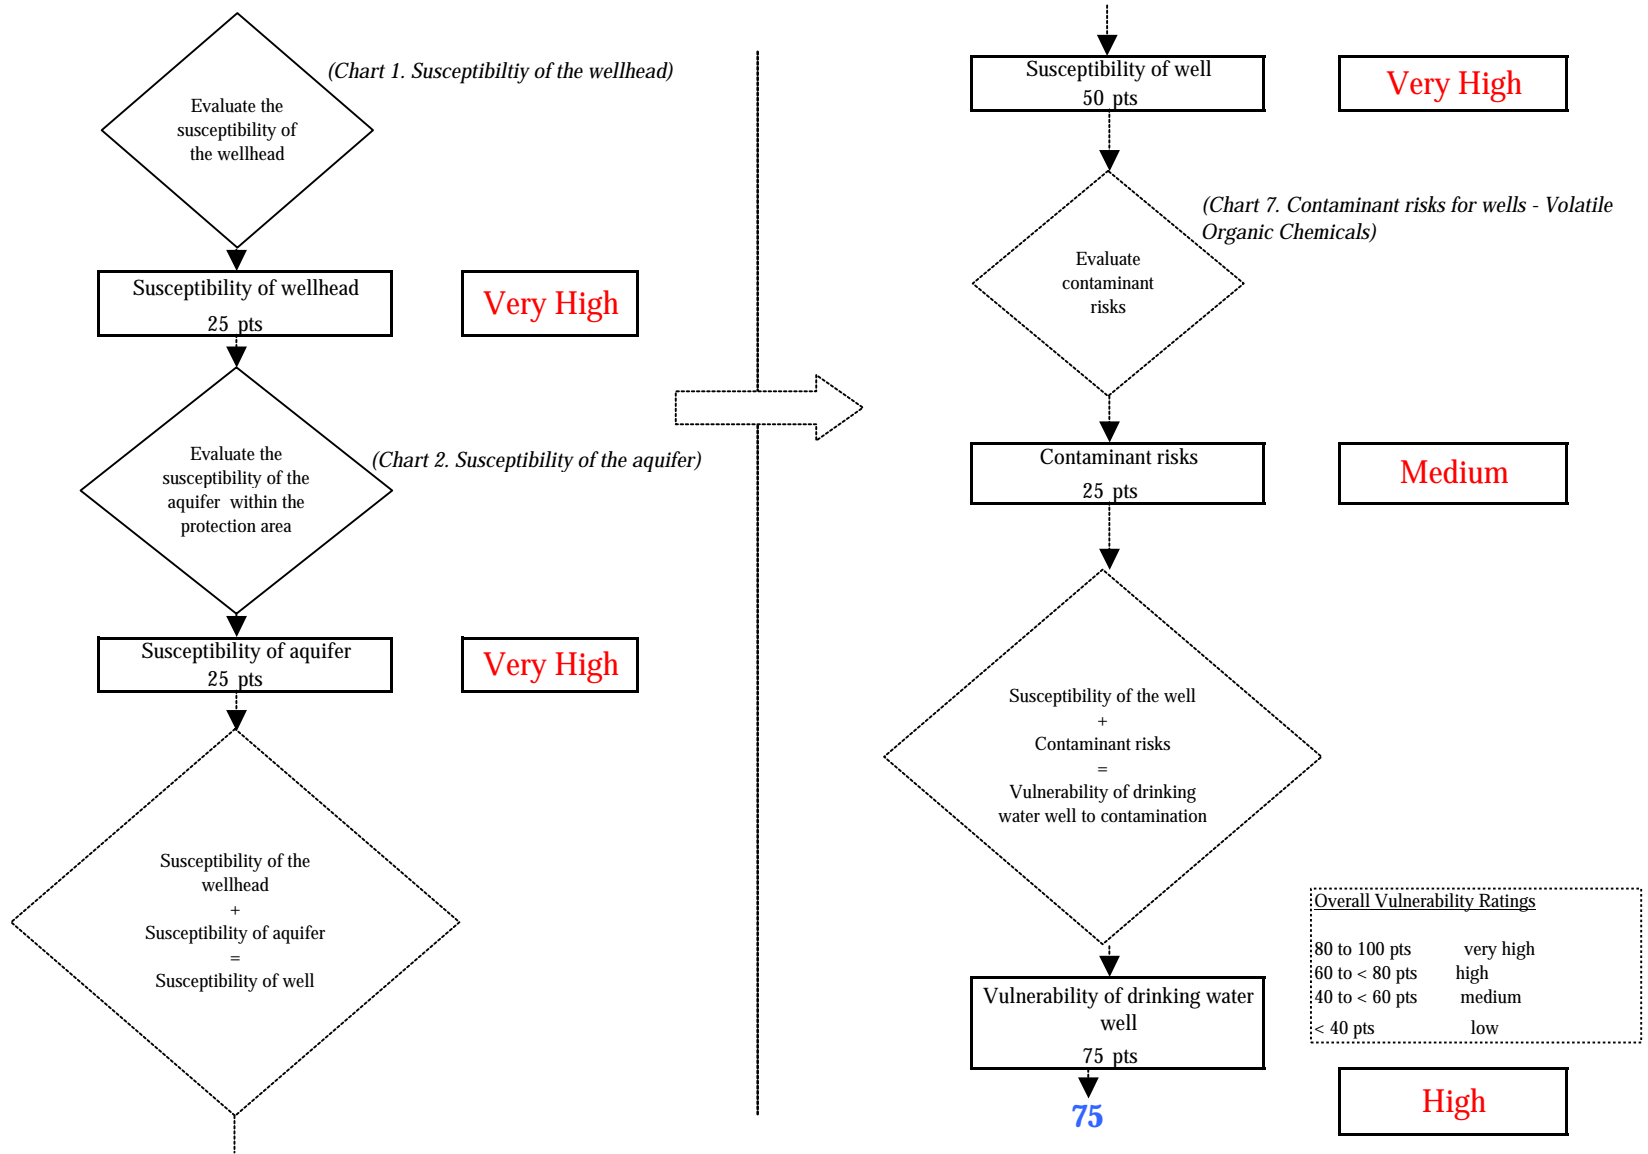
Chart 8. Vulnerability analysis for Begich Boggs Visitor Center No. 2 (213718.002) - Volatile Organic Chemicals
