# Source Water Assessment

A Hydrogeologic Susceptibility and  
Vulnerability Assessment for  
Williwaw Campground No.2  
Drinking Water System,  
Portage Valley, Alaska  
PWSID # 215370.001

By URS Corporation

DRINKING WATER PROTECTION PROGRAM REPORT # 335

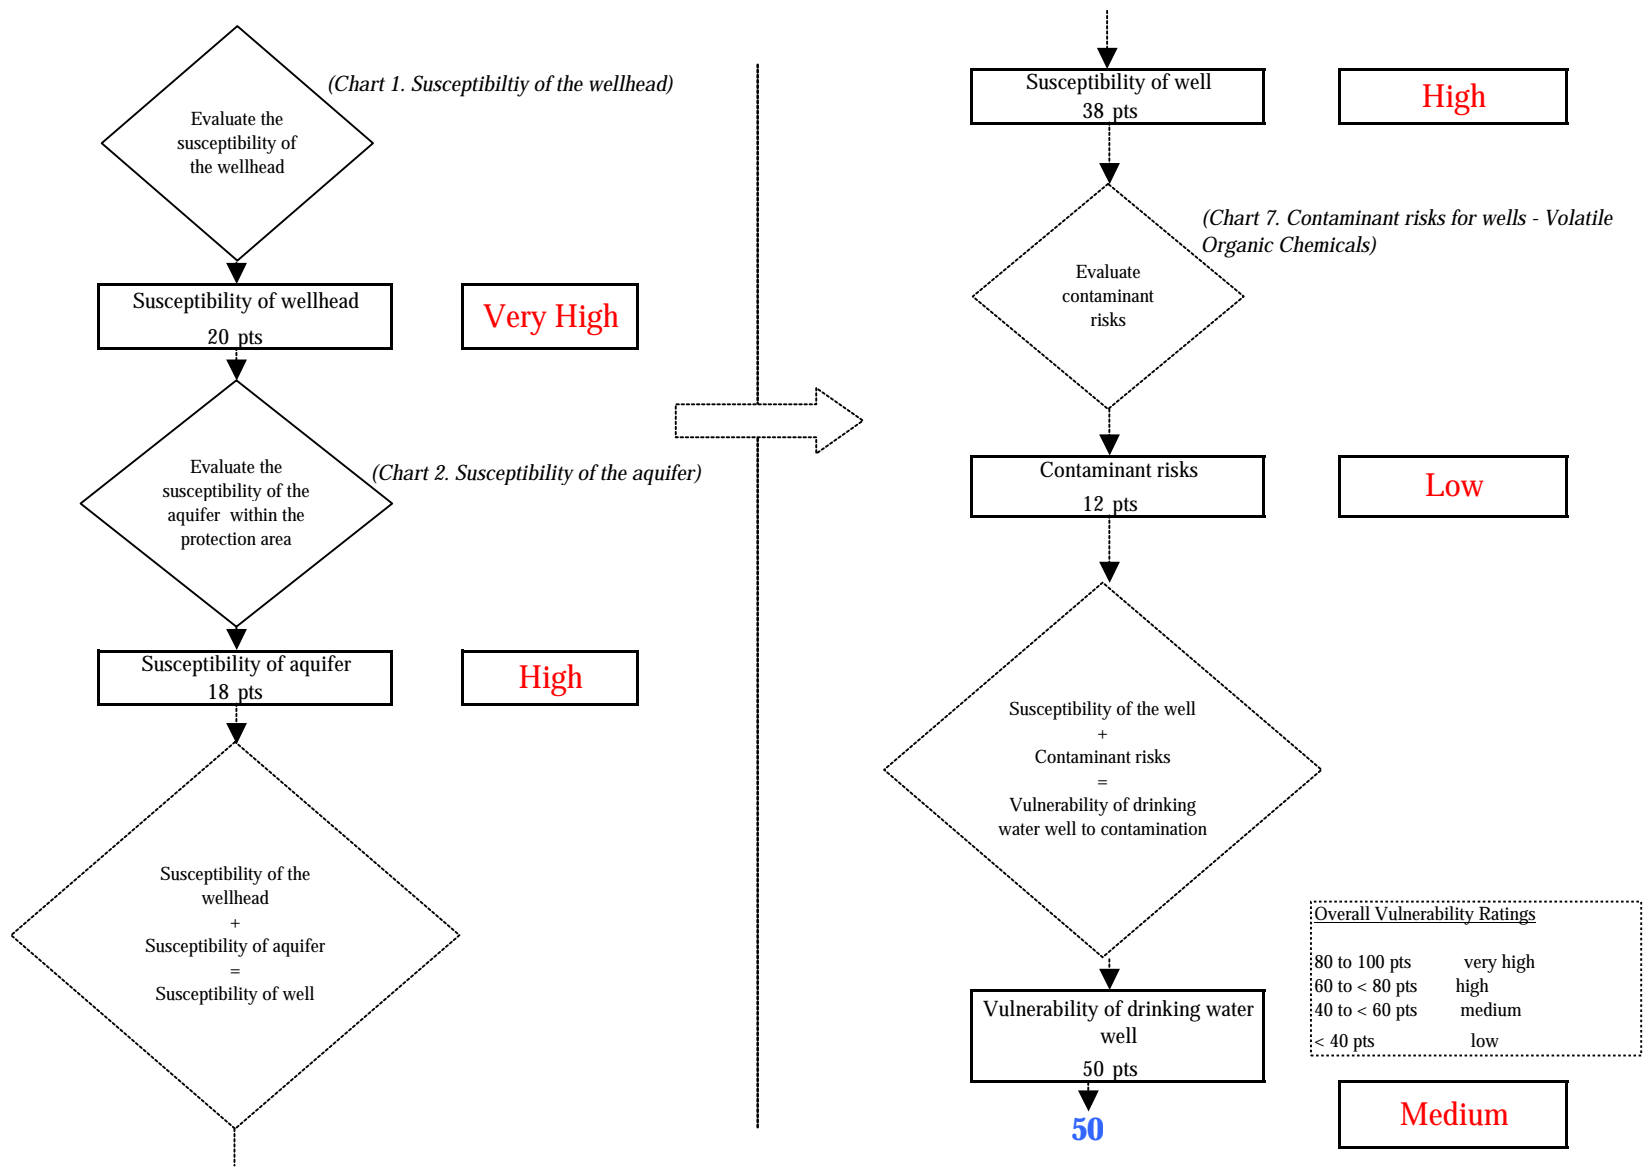
**Chart 8. Vulnerability analysis for USFS Williwaw #2 (215370.001) - Volatile Organic Chemicals**
