A Hydrogeologic Susceptibility and  
Vulnerability Assessment for  
Williwaw Campground No.4  
Drinking Water System,  
Portage Valley, Alaska  
PWSID # 218551.001

By URS Corporation

DRINKING WATER PROTECTION PROGRAM REPORT # 388

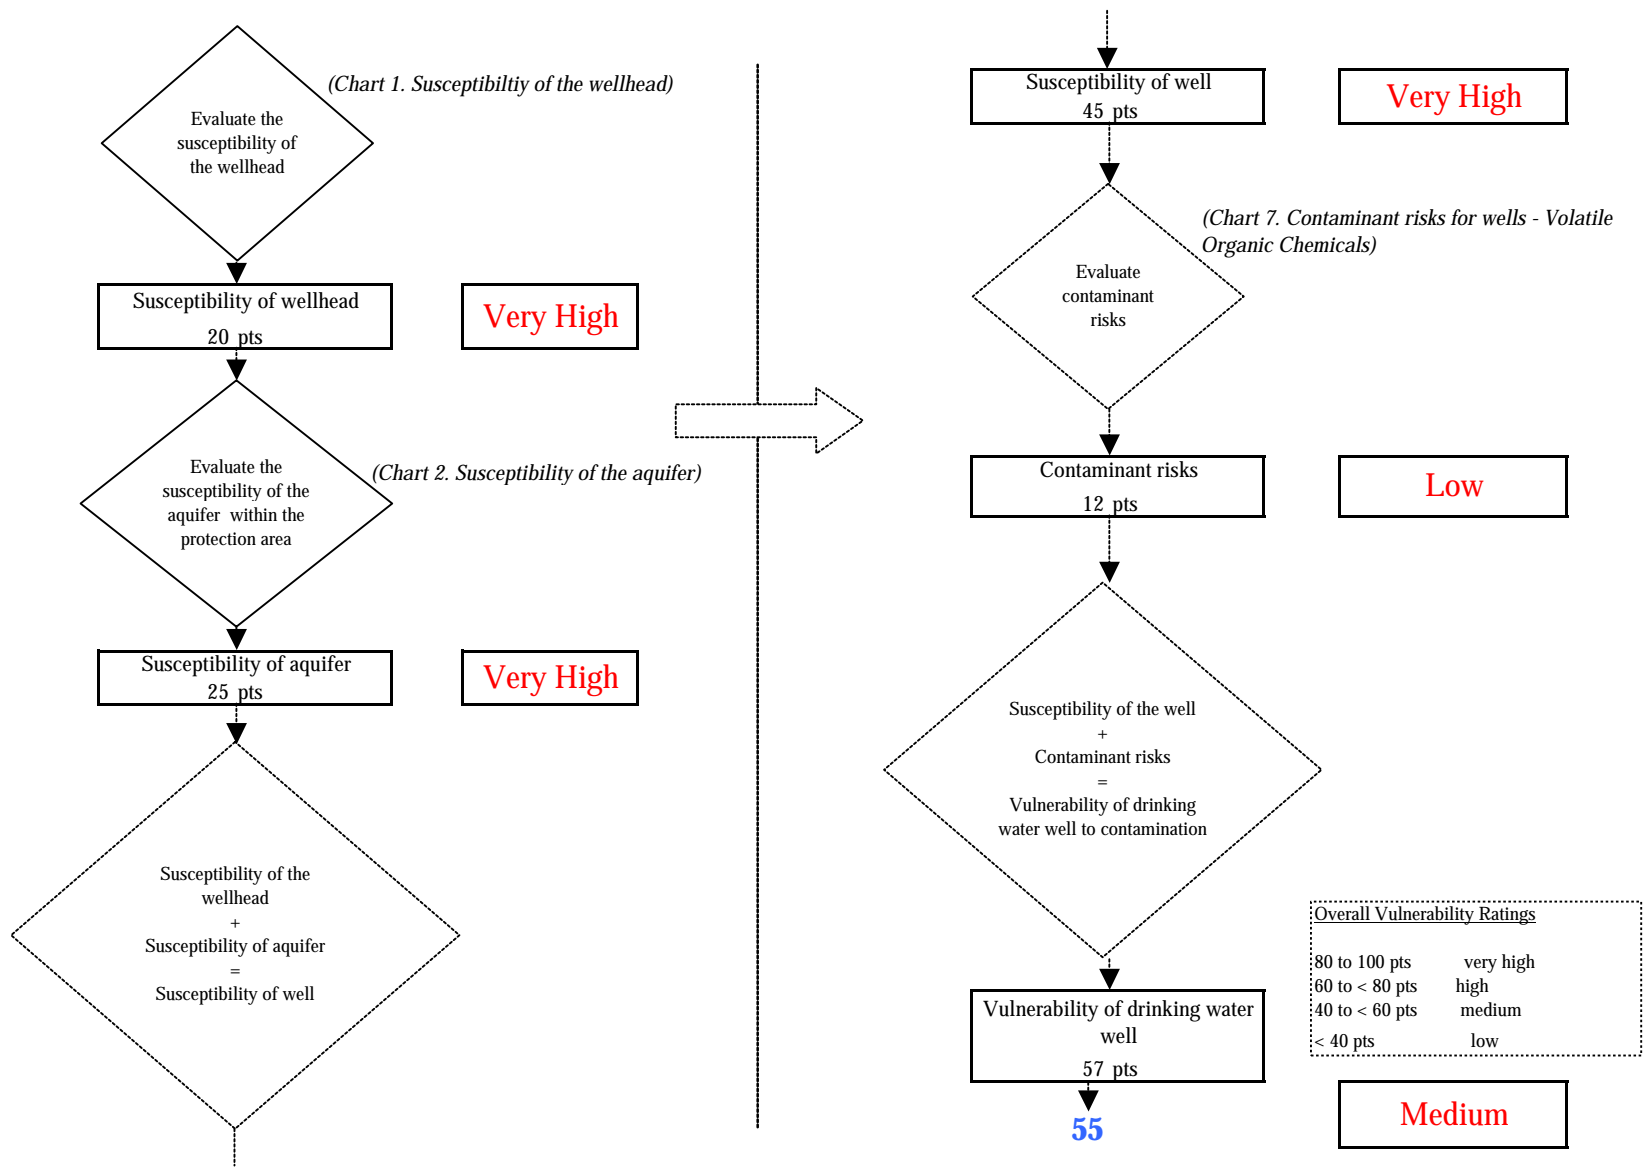
**Chart 8. Vulnerability analysis for USFS Williwaw #4 (218551.001) - Volatile Organic Chemicals**
