A Hydrogeologic Susceptibility and Vulnerability Assessment for YMCA Peggy Lake Camp Drinking Water System, Talkeetna, Alaska YMCA Peggy Lake Camp #222092

DRINKING WATER PROTECTION PROGRAM REPORT 229 Alaska Department of Environmental Conservation

**AUGUST 2002**

By Shannon & Wilson, Inc.

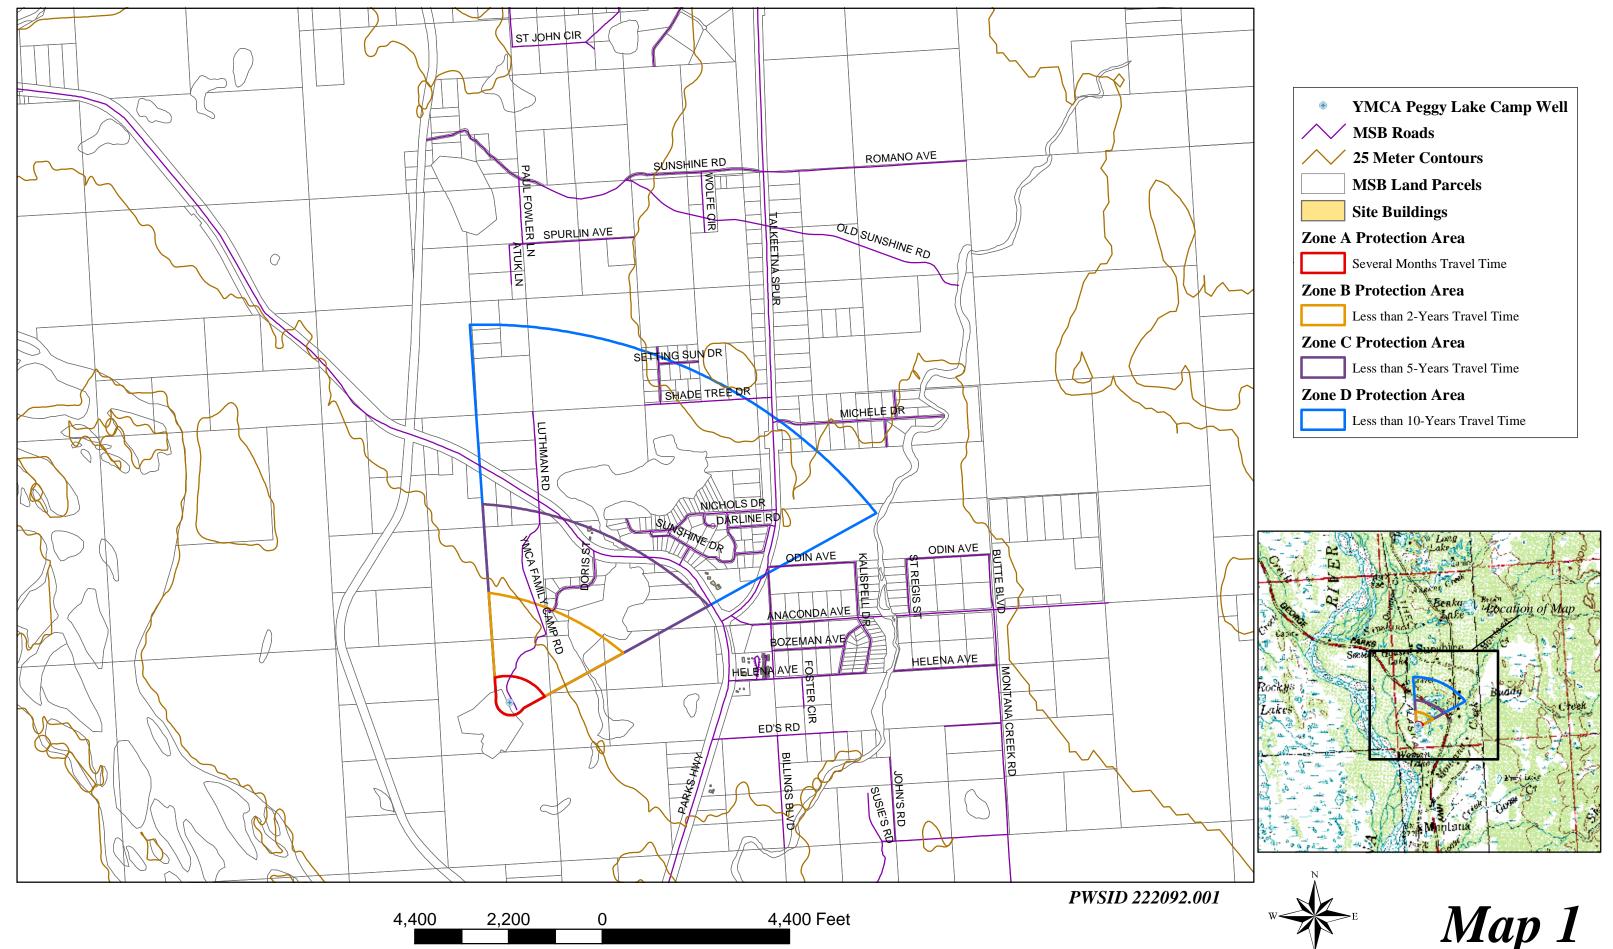
YMCA Peggy Lake Camp Drinking Water Protection Area (Map 1)

### Drinking Water Protection Areas for YMCA Peggy Lake Camp

The most probable area for contamination to reach the drinking water well is the area that contributes water to the well, the groundwater recharge area. This area is designated as the Drinking Water Protection Area (DWPA). Because a release of contaminants within the DWPA are most likely to impact the drinking water well, this area will serve as the focus for voluntary protection efforts.

The DWPAs established for wells by the ADEC are separated into four zones. These zones correspond to differences in the time-of-travel (TOT) of the water moving through the aquifer to the well. The time of travel for contaminants within the water varies and is dependent on the physical and chemical characteristics of each contaminant. The following is a summary of the four DWPA zones and the calculated TOT for each:

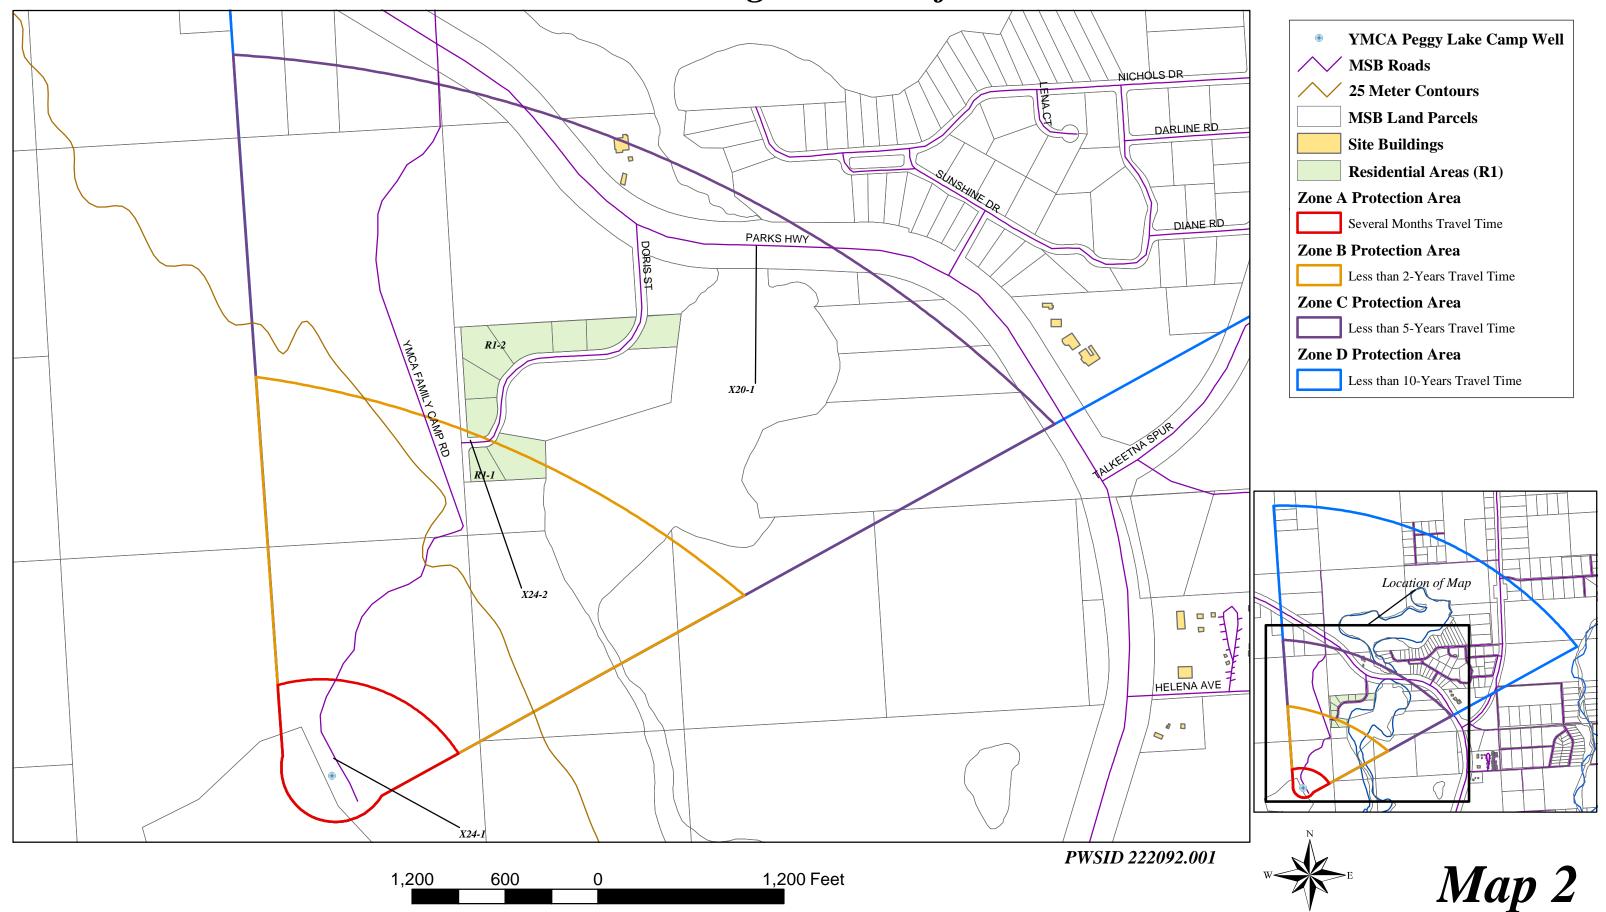
YMCA Peggy Lake Camp Drinking Water Protection Area and Potential and Existing Contaminant Sources (Maps 2-3)

## Drinking Water Protection Areas for YMCA Peggy Lake Camp and Potential and Existing Sources of Contamination

Contaminant Source Type	Contaminant Source ID	CS ID tag	Zone	Location	Map Number	Comments
Highways and roads, dirt/gravel	X24	X24-1	A	YMCA Family Camp Road	2	
Shooting ranges (outdoor, commercial or community)	C40	C40-1	В	West of YMCA Family Camp Road	3	
Residential Areas	R01	R1-1	В	Residence along Doris Street	2	2 acres of residential area in Zone B
Laundromats without dry cleaning	C22	C22-1	C	North of corner of Park and Doris Street	3	
Residential Areas	R01	R1-2	C	Residence along Doris Street	2	7 acres of residential area in Zone C
Closed tanks, gasoline (above ground)	T11	T11-1	C	North of corner of Park and Doris Street	3	
Closed tanks, gasoline (above ground)	T11	T11-2	C	North of corner of Park and Doris Street	3	
Closed tanks, diesel (above ground)	T07	T7-1	C	North of corner of Park and Doris Street	3	
Contaminated sites, DEC recognized, non-Superfund, non-RCRA	U04	U4-1	C	North of corner of Park and Doris Street	3

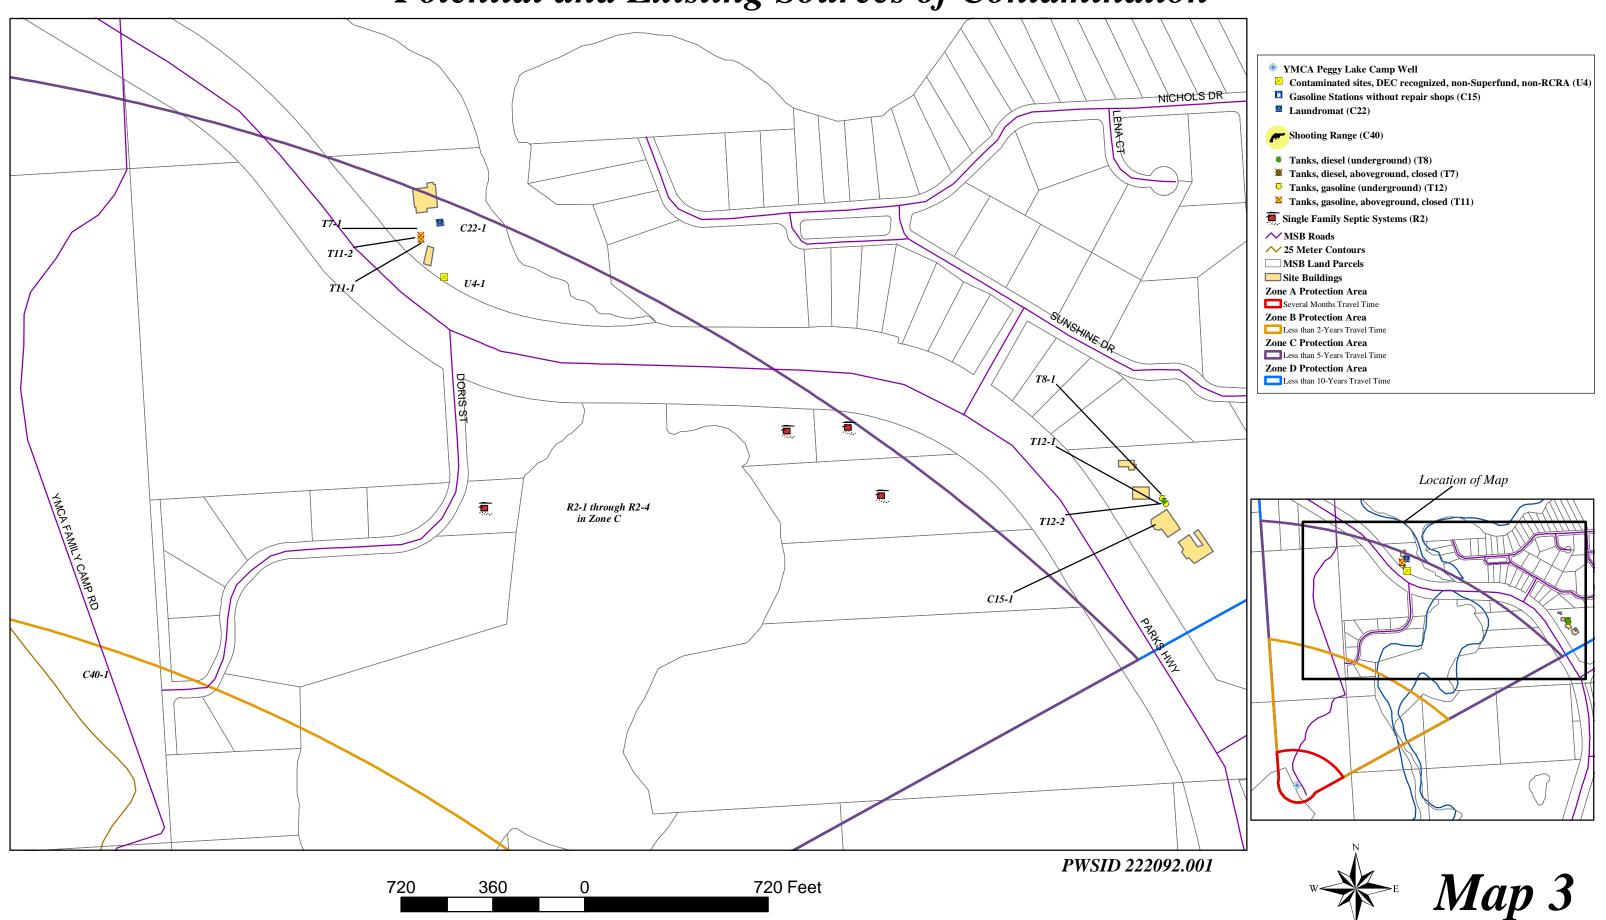
# Drinking Water Protection Areas for YMCA Peggy Lake Camp and Potential and Existing Sources of Contamination

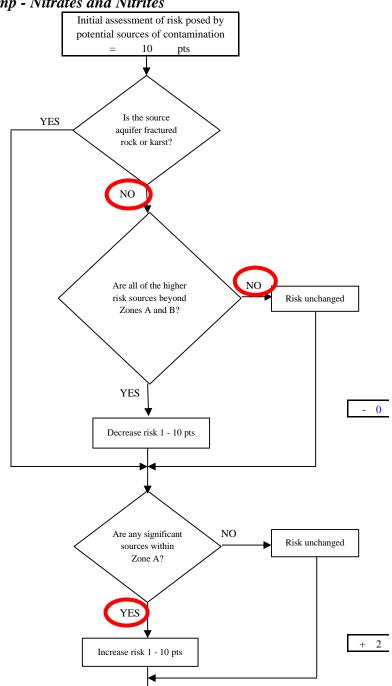
Chart 5. Contaminant Risks for YMCA Peggy Lake Camp - Nitrates and Nitrites

Risk Levels for Contaminant Sources identified in Zones A, B and C					
	Zone A	Zones B&C	Total		
Very Highs(s)	0	0	0		
High(s)	0	0	0		
Medium(s)	0	0	0		
Low(s)	1	4	5

LOW 10 pts	MEDIUM 20 pts	HIGH 30 pts	VERY HIGH 40 pts
LOW	3 10 sources + 10 pts	≥ 10 sources + 5 pts	≥ 20 sources + 5 pts	
MEDIUM		≥ 2 sources + 5 pts	≥ 5 sources + 5 pts	≥ 10 sources + 5 pts
HIGH			≥ 1 source + 10 pts	≥ 2 sources + 10 pts
VERY HIGH				≥ 1 source + 10 pts

Matrix Score	10

Note: Septic systems, sewerlines, and roads are each assigned a risk ranking for each individual contaminant source in the CSI. The VA, however, counts these contaminant sources as a group and assigns a calculated number of either "lows" or "mediums" based on the density.

Sampling history for YMCA Peggy Lake Camp well indicates that low concentrations of nitrate have been detected (see Chart 5 - Contaminant Risks for Nitrates and/or Nitrites in Appendix D). The maximum reported existing nitrate concentration is approximately 0.08 mg/L or 1% of the Maximum Contaminant Level (MCL) of 10 mg/L. The MCL is the maximum level of contaminant that is allowed to exist in drinking water and still be consumed by humans without harmful health effects. Due to the high solubility and weak retention by soil, nitrates are very mobile, moving at approximately the same rate as water. Though existing nitrate contamination was detected at the site, concentrations remain at very safe levels with respect to human health.

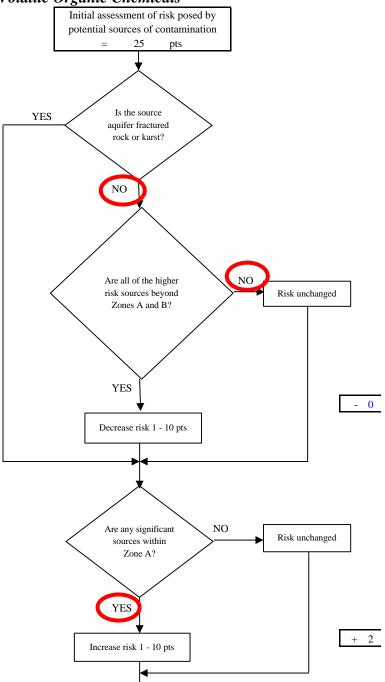
Chart 7. Contaminant Risks for YMCA Peggy Lake Camp - Volatile Organic Chemicals

Risk Levels for Contaminant Sources identified in Zones A, B and C					
	Zone A	Zones B&C	Total		
Very Highs(s)	0	0	0		
High(s)	0	0	0		
Medium(s)	0	3	3		
Low(s)	1	3	4

LOW 10 pts	MEDIUM 20 pts	HIGH 30 pts	VERY HIGH 40 pts
LOW	* 10 sources + 10 pts	≥ 10 sources + 5 pts	≥ 20 sources + 5 pts	
MEDIUM		≥ 2 sources + 5 pts	≥ 5 sources + 5 pts	≥ 10 sources + 5 pts
HIGH			≥ 1 source + 10 pts	≥ 2 sources + 10 pts
VERY HIGH				≥ 1 source + 10 pts

Matrix Score 25

Note: Septic systems, sewerlines, and roads are each assigned a risk ranking for each individual contaminant source in the CSI. The VA, however, counts these contaminant sources as a group and assigns a calculated number of either "lows" or "mediums" based on the density.

Roads, a shooting range, residential areas, a laundromat, aboveground closed gasoline and diesel tanks, a contaminated site, a gasoline station, single-family septic systems, and underground gasoline and diesel tanks form the greatest risks for volatile organic chemicals.
