# Source Water Assessment

A Hydrogeologic Susceptibility and  
Vulnerability Assessment for  
Birch Harbor Baptist Church  
Public Drinking Water System,  
Wasilla, Alaska

PWSID # 220026.001

DRINKING WATER PROTECTION REPORT 1626

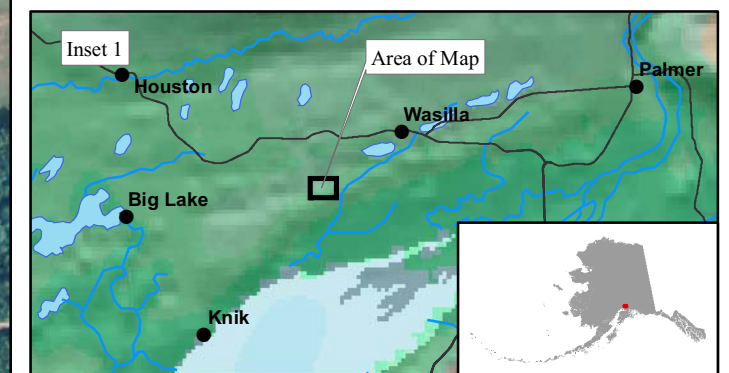
**Appendix C Map C**

Birch Harbor Baptist Church  
PWS 220026.001

- APPENDIX
- A. Birch Harbor Baptist Church Drinking Water Protection Area (Map A)
  - B. Contaminant Source Inventory for Birch Harbor Baptist Church (Table 1)  
 Contaminant Source Inventory and Risk Ranking for Birch Harbor Baptist Church – Bacteria and Viruses (Table 2)  
 Contaminant Source Inventory and Risk Ranking for Birch Harbor Baptist Church – Nitrates/Nitrites (Table 3)  
 Contaminant Source Inventory and Risk Ranking for Birch Harbor Baptist Church – Volatile Organic Chemicals (Table 4)
  - C. Birch Harbor Baptist Church Drinking Water Protection Area and Potential and Existing Contaminant Sources (Map C)
