Hydrogeologic Susceptibility and Vulnerability Assessment for
Char Dees Drinking Water Well, Wasilla, Alaska

DRINKING WATER PROTECTION PROGRAM REPORT 87

October 2001

By Shannon & Wilson, Inc.

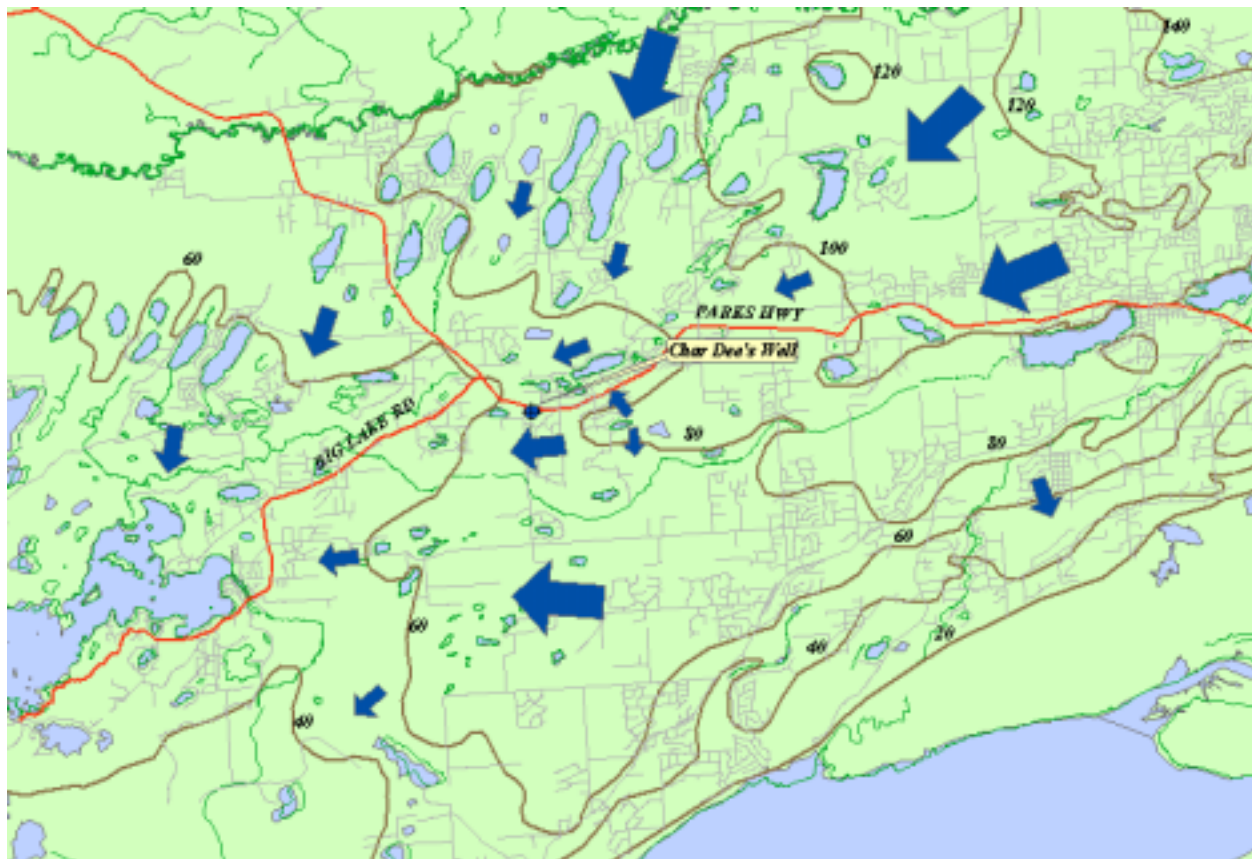
Figure 2. Map showing regional ground-water flow in Matanuska-Susitna Valley. (Jokela, Munter and Evans, 1991)

In the Mat-Su Valley, the groundwater is primarily recharged by snowmelt and precipitation infiltrating into the foothill slopes of the Talkeetna or Chugach Mountains and by direct precipitation and snowmelt throughout the study area.

Groundwater flow in the confined aquifer is generally, north to south in the central region of the valley, toward the Matanuska River in the eastern region and the slope is predominantly northeast to northwest in the western region. The direction of groundwater flow in the upper unconfined aquifer's are more variable due to the influence from surficial topography as well as its close connection with surface water bodies. (*Jokela, Munter and Evans, 1991*) (Figure 2).

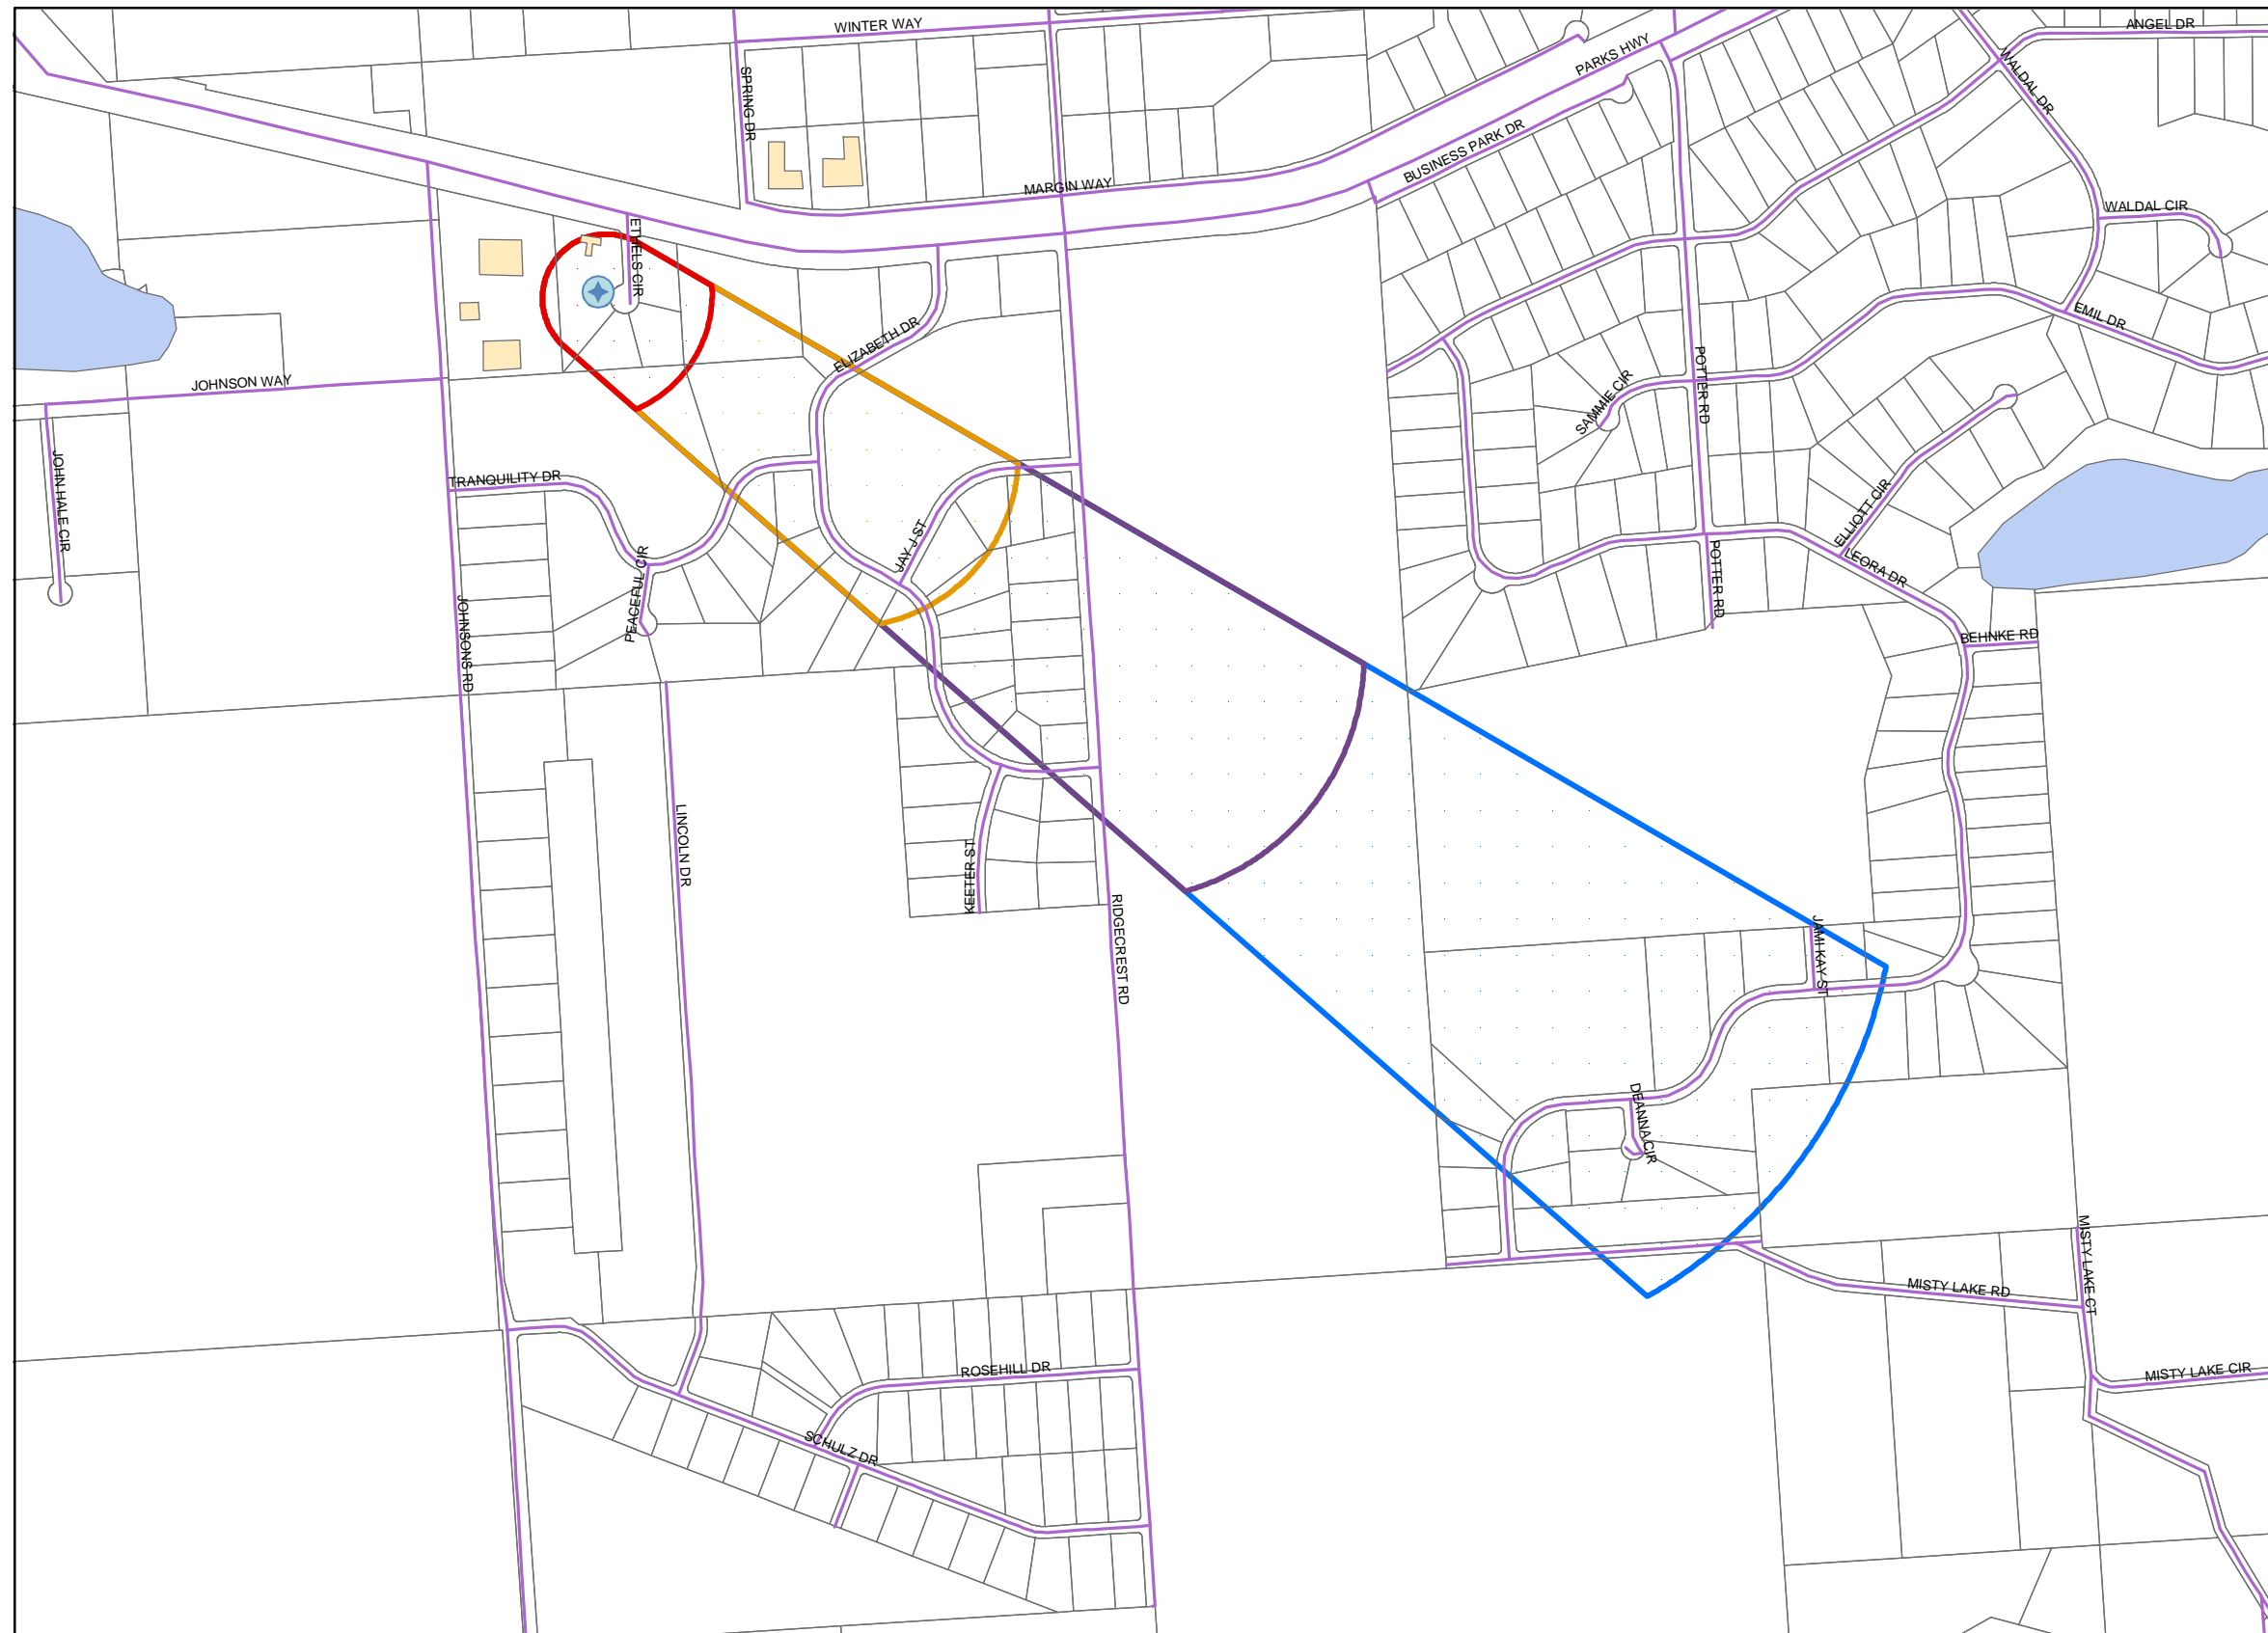
Drinking Water Protection Areas for Char Dees

- Char Dees Well
- MSB roads
- MSB parcel core
- Buildings
- Lakes
- Zone A Protection Area**
- Several Months Travel Time
- Zone B Protection Area**
- Less Than 2-Years Travel Time
- Zone D Protection Area**
- Less Than 10-Years Travel Time
- Zone C Protection Area**
- Less Than 5-Years Travel Time

The Drinking Water Protection Areas established for wells by the Alaska Department of Environmental Conservation are separated into zones. These zones correspond to a time-of-travel. Time-of-travel is the time required for water to move in the saturated zone of the ground from a specific point to the well. The Drinking Water Protection Areas for Char Dees contain four zones, Zone A, Zone B, Zone C and Zone D (See Map 1 in Appendix A). Zone A corresponds to the area between the well and the distance equal to $\frac{1}{4}$ of the distance of the 2-year time-of-travel. Depending on where a contaminant source is located within Zone A, travel time for a contaminant to the well may be on the order of several days to several hours. Zone A also extends downgradient from the well to take into account the area of the aquifer that is influenced by pumping of the well.

The Zone B protection area for Char Dees corresponds to a time-of-travel of less than two years and extends eastward. The Zone C protection area extends from the 2-year time of travel to the 5-year time of travel. Lastly, Zone D extends from Zone C to the end of the protection area, roughly 1.2 miles from the Char Dees well.

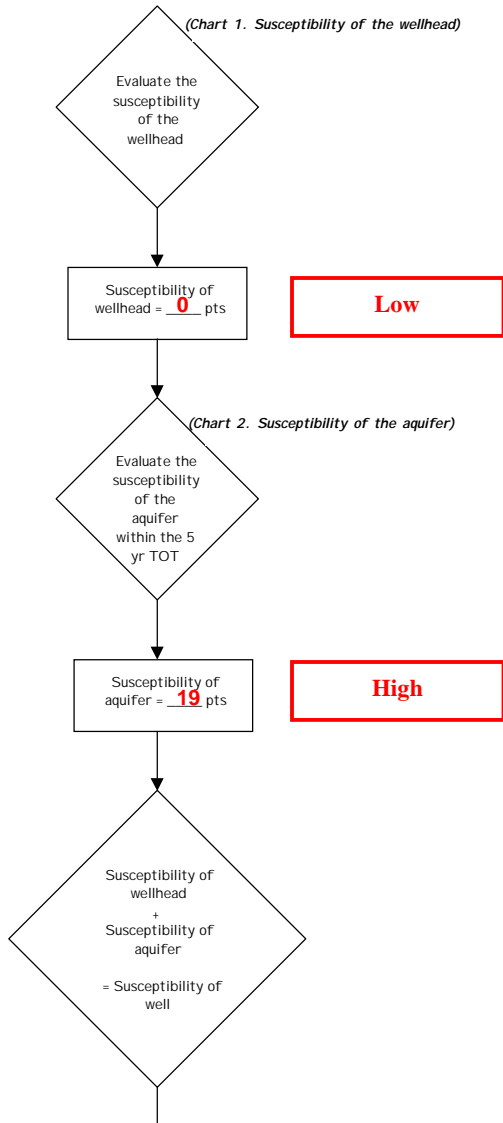
Chart 6. Vulnerability analysis for Char Dees – Nitrates and Nitrites

Nitrates and/or nitrites are found in natural background concentrations at the site, as elsewhere in Alaska. The sampling history of the Char Dees source water has not reported the presence of nitrate. (See Chart 6-Contaminant Risks for Nitrates/Nitrites in Appendix D). Due to high solubility and weak retention by soil, nitrates are very mobile in soil, moving approximately the same rate as water. Nevertheless, nitrate concentrations in the Char Dees water source have not been detected.

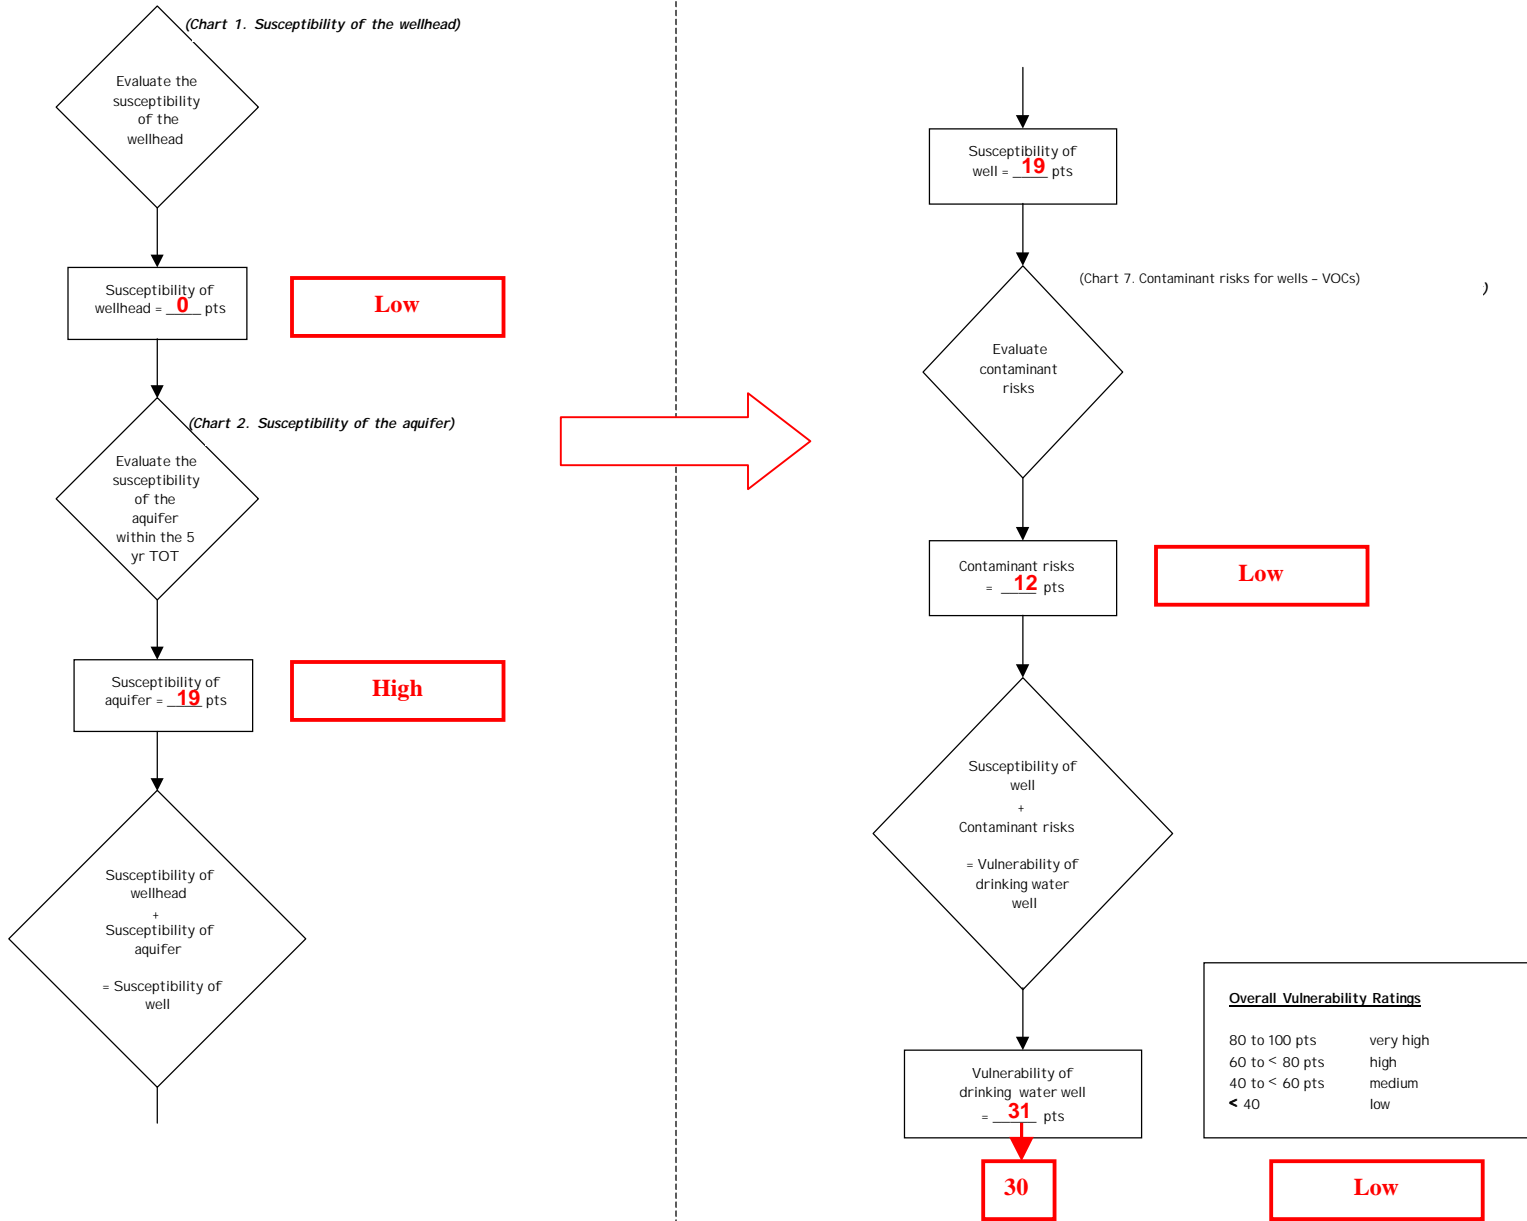
Chart 8. Vulnerability analysis for Char Dees – Volatile Organic Chemicals

Vulnerability of the drinking water source to contamination is the combination of susceptibility of the aquifer and the well with contaminant risks. Table 3 contains the overall vulnerability scores (0 – 100) and ratings for each of the three categories of drinking water contaminants (See Appendix D). Note: scores are rounded off to the nearest five.
