Source Water Assessment

A Hydrogeologic Susceptibility and Vulnerability Assessment for Matanuska Creamery Public Drinking Water System, Wasilla Area, Alaska PWSID # 220064.001

DRINKING WATER PROTECTION REPORT 1630

December, 2008

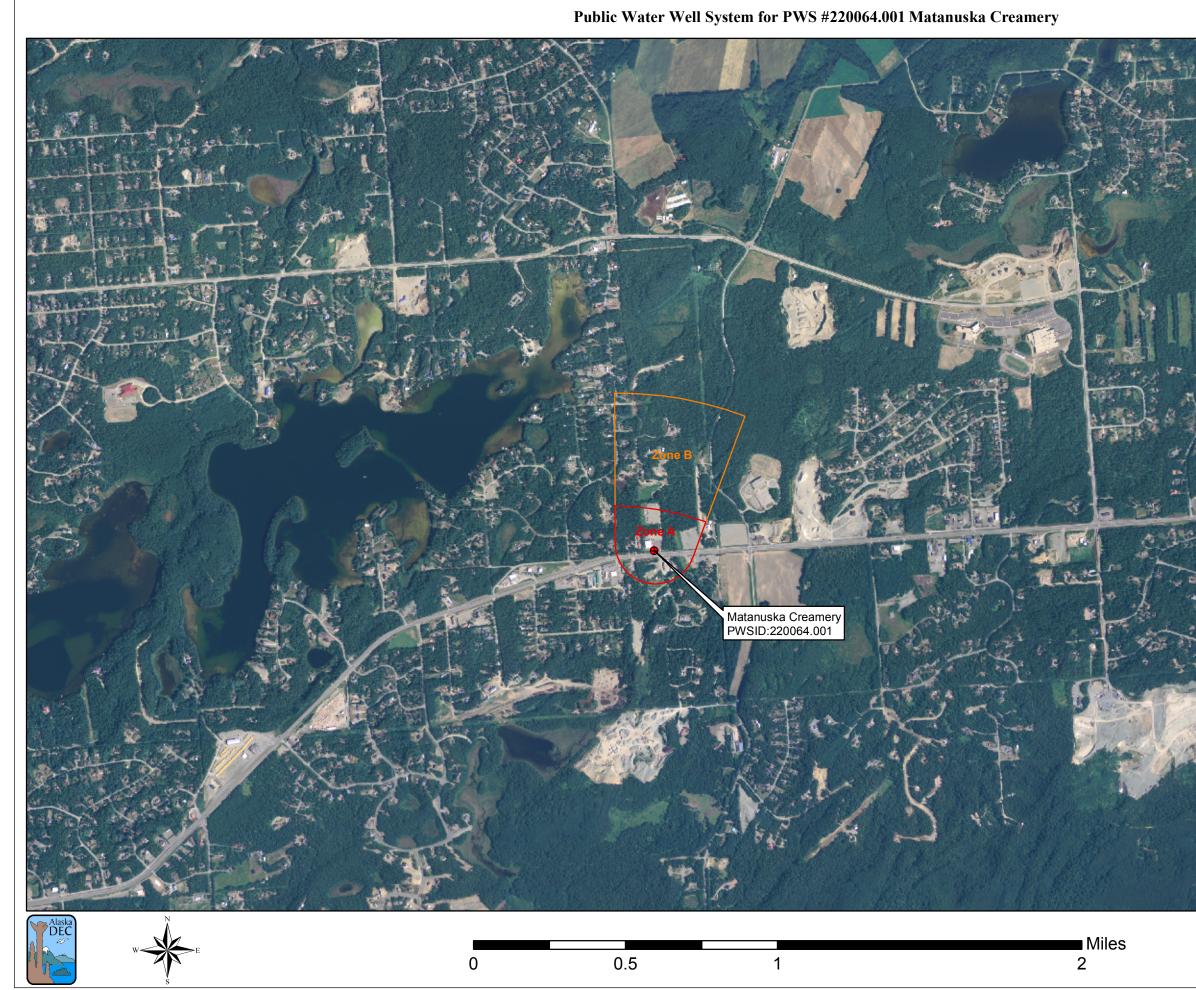
Appendix A Map A

The drinking water protection area for Matanuska Creamery was determined using an analytical calculation and includes Zones A and B (See Map A of Appendix A).

Matanuska Creamery Drinking Water Protection Area Location Map (Map A)

Matanuska Creamery public water system is a Class B (transient/non-community) water system. The system consists of one well located at mile 4.5 of the Palmer-Wasilla Highway, approximately 5.5 miles east of Wasilla, Alaska (see Map A in Appendix A). Wasilla has a population of 7,028 and lies about 12 miles north of the Knik Arm of Cook Inlet along the George Parks Highway (ADCED, 2008).

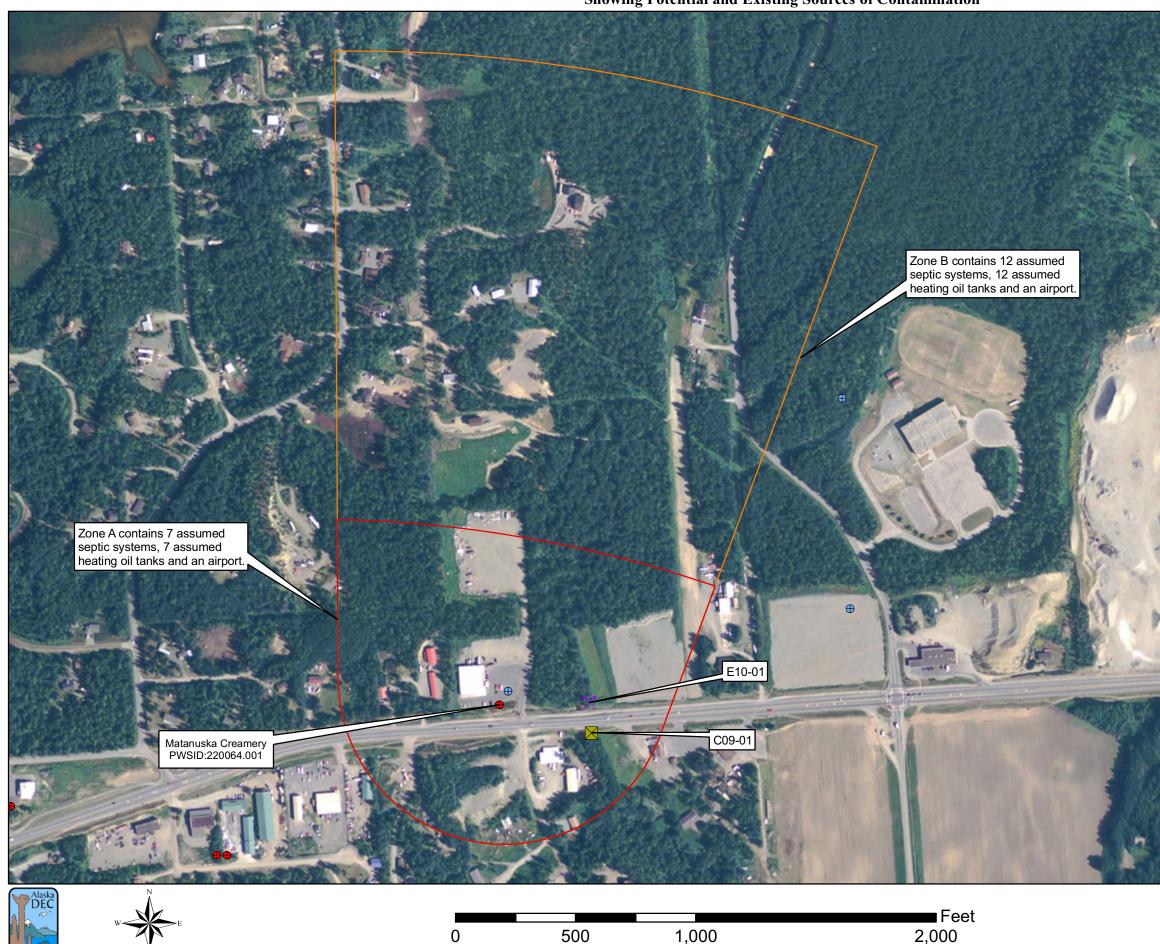
Appendix C Map C

Matanuska Creamery Drinking Water Protection Area and Potential and Existing Contaminant Sources (Map C)

Public Water Well System for PWS #220064.001 Matanuska Creamery Showing Potential and Existing Sources of Contamination

The sources are displayed on Map C of Appendix C and summarized in Table 1 of Appendix B.
