Hydrogeologic Susceptibility and Vulnerability Assessment for Pizza Pro - Overlook, Wasilla, Alaska

DRINKING WATER PROTECTION PROGRAM REPORT *140*

By URS

ALASKA DEPARTMENT OF ENVIRONMENTAL CONSERVATION: 2001

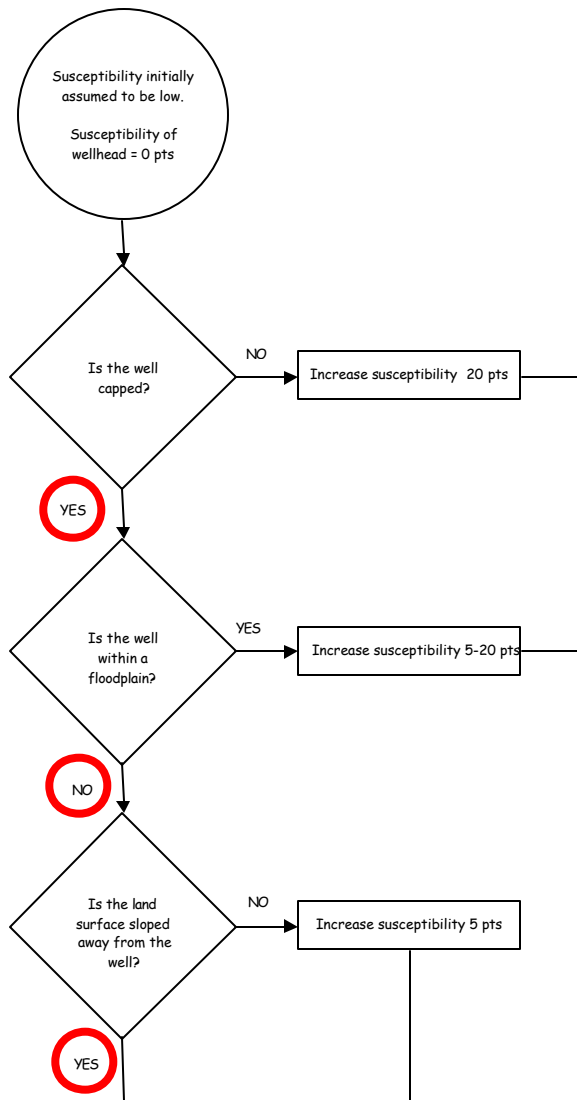
Chart 1. Susceptibility of the wellhead – Pizza Pro

Appendix D contains eight charts, which together form the ‘Vulnerability Analysis’ for a source water assessment for a public drinking water source. Chart 1 analyzes the ‘Susceptibility of the Wellhead’ to contamination by looking at the construction of the well and its surrounding area. Chart 2 analyzes the ‘Susceptibility of the Aquifer’ to contamination by looking at the naturally occurring attributes of the water source and influences on the groundwater system that might lead to contamination. Chart 3 analyzes ‘Contaminant Risks’ for the drinking water source with respect to bacteria and viruses. The ‘Contaminant Risks’ portion of the analysis considers potential sources of contaminants as well as a review of contamination that has or may have occurred, but has not arrived or been detected at the well. Lastly, Chart 4 contains the ‘Vulnerability Analysis for Bacteria and Viruses’. Charts 5 through 8 contain the Contaminant Risks and Vulnerability Analyses for nitrates and nitrites and volatile organic chemicals, respectively.

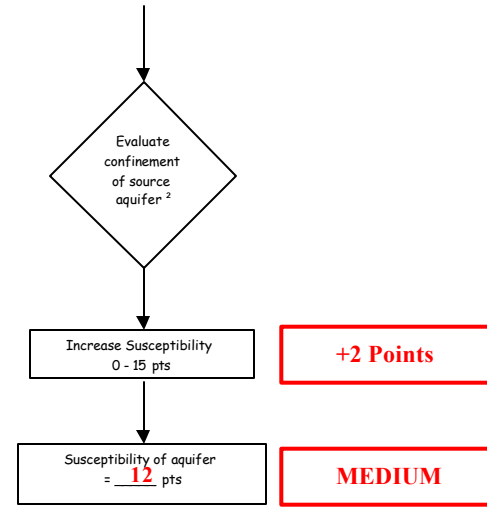
Chart 2. Susceptibility of the aquifer - Pizza Pro

The well for Pizza Pro - Overlook was completed in a confined or semi-confined aquifer setting. The aquifer that is utilized by the well is protected from surface contamination by approximately 120 feet of relatively impermeable clay. Combining the susceptibility of the wellhead and the aquifer to contamination leads to a score (0 – 50 points) and rating of Overall Susceptibility (see Appendix D). Table 1 shows the Overall Susceptibility score and rating for Pizza Pro - Overlook.

Septic system injection well in Zone C.
