Source Water Assessment

A Hydrogeologic Susceptibility and Vulnerability
Assessment for
St. David's Episcopal Church Drinking Water
System, Wasilla, Alaska
St. David's Episcopal Church PWSID #
224426.001

DRINKING WATER PROTECTION PROGRAM REPORT 830

Alaska Department of Environmental Conservation

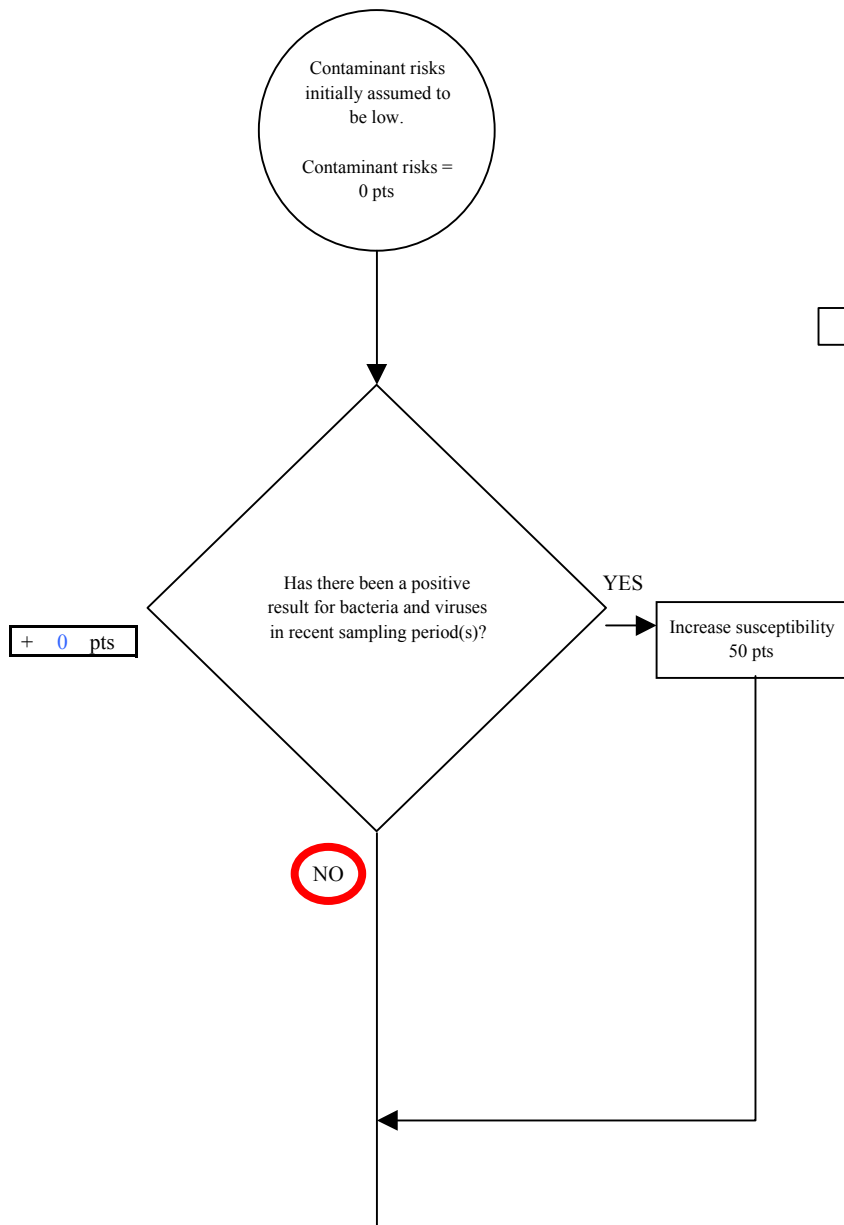
Chart 3. Contaminant risks for St. David's Episcopal Church - Bacteria & Viruses

The contaminant risk for bacteria and viruses is very high with large capacity septic systems in Zones A and B posing the most significant risk to the drinking water well (See Chart 3 – Contaminant Risks for Bacteria and Viruses in Appendix D). Recent sampling of St. David’s Episcopal Church shows no detection of Bacteria and Viruses. After combining the contaminant risk for bacteria and viruses with the natural susceptibility of the well, the overall vulnerability of the well to contamination is high.

Risk Rankings for Contaminant Sources Identified in Zones A and B

Zone A	Zone B	Total
Very High(s)	0	0	0
High(s)	1	2	3
Medium(s)	0	0	0
Low(s)	1	6	7

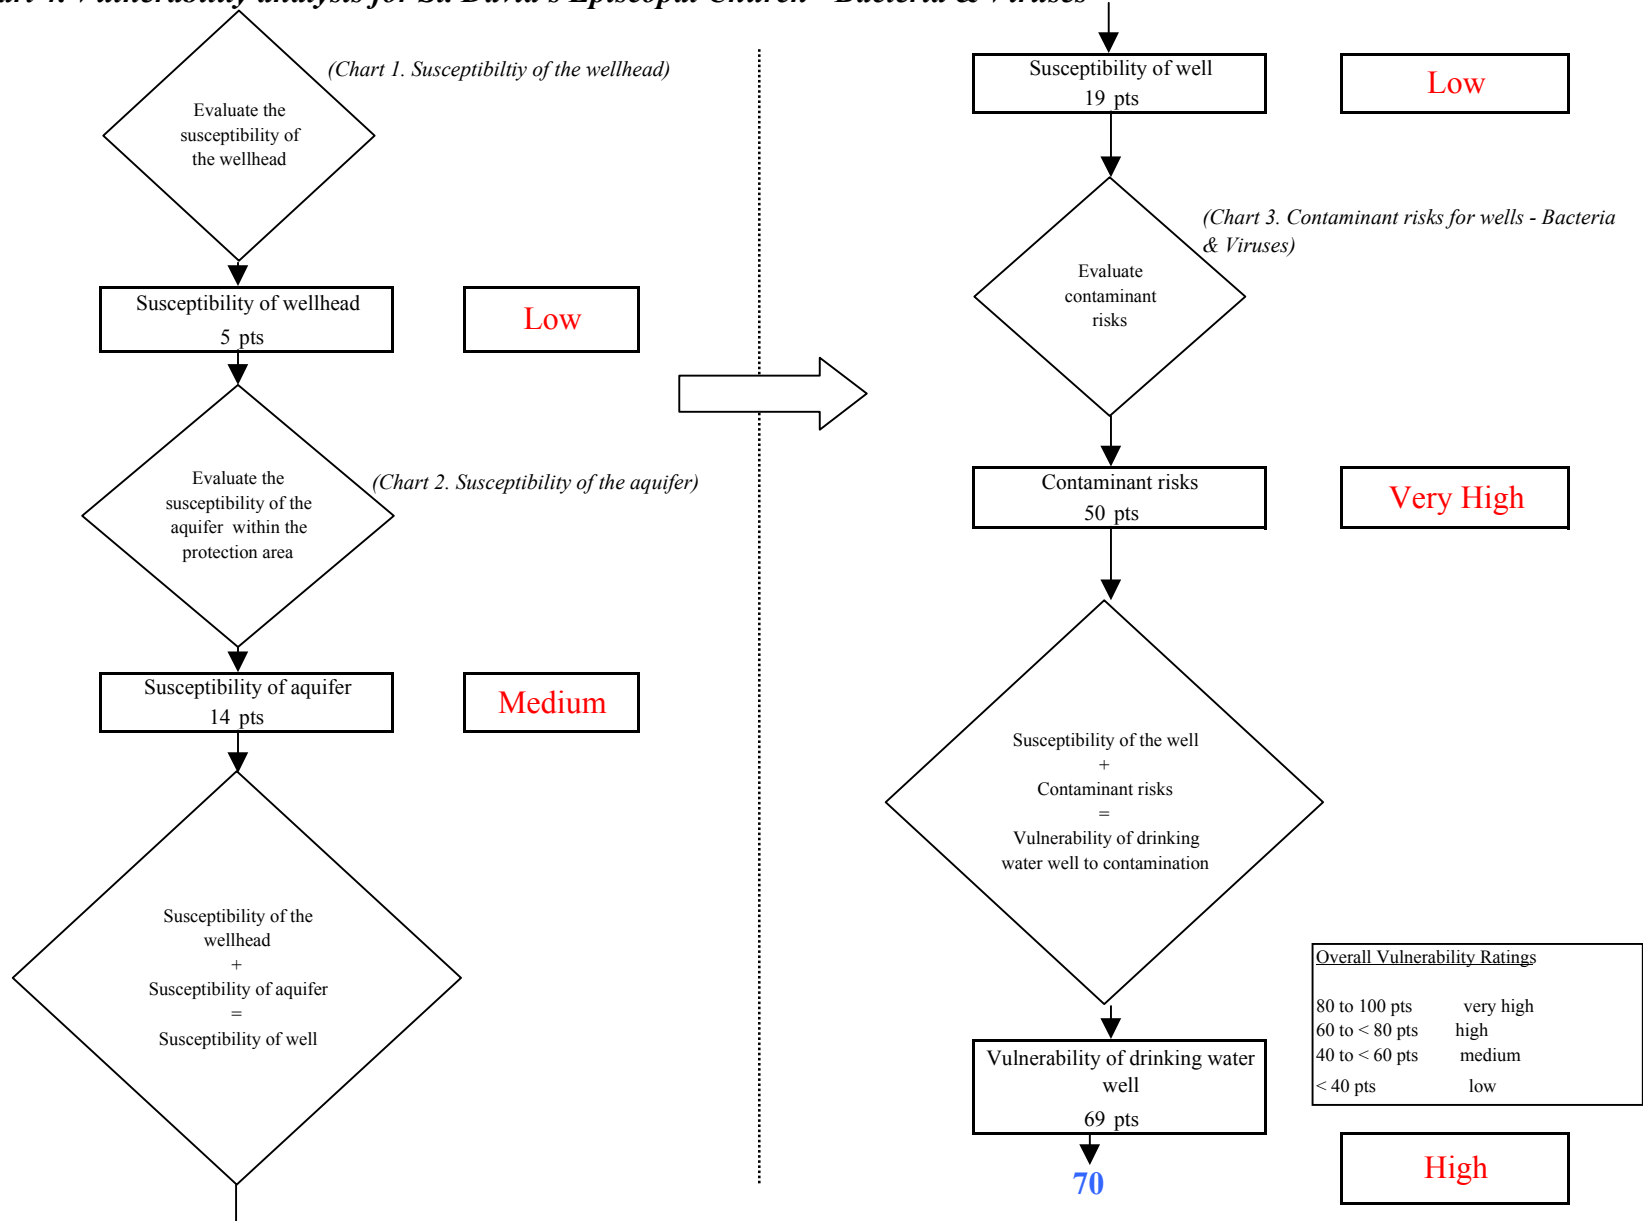
Chart 4. Vulnerability analysis for St. David's Episcopal Church - Bacteria & Viruses

Category	Score	Rating
Bacteria and Viruses	70	High
Nitrates and Nitrites	70	High
Volatile Organic Chemicals	60	High
