Source Water Assessment

A Hydrogeologic Susceptibility and
Vulnerability Assessment for
Glacier View Alliance Church
Public Drinking Water System,
Wasilla Area, Alaska
PWSID # 220088.001

DRINKING WATER PROTECTION REPORT 1627

December, 2008

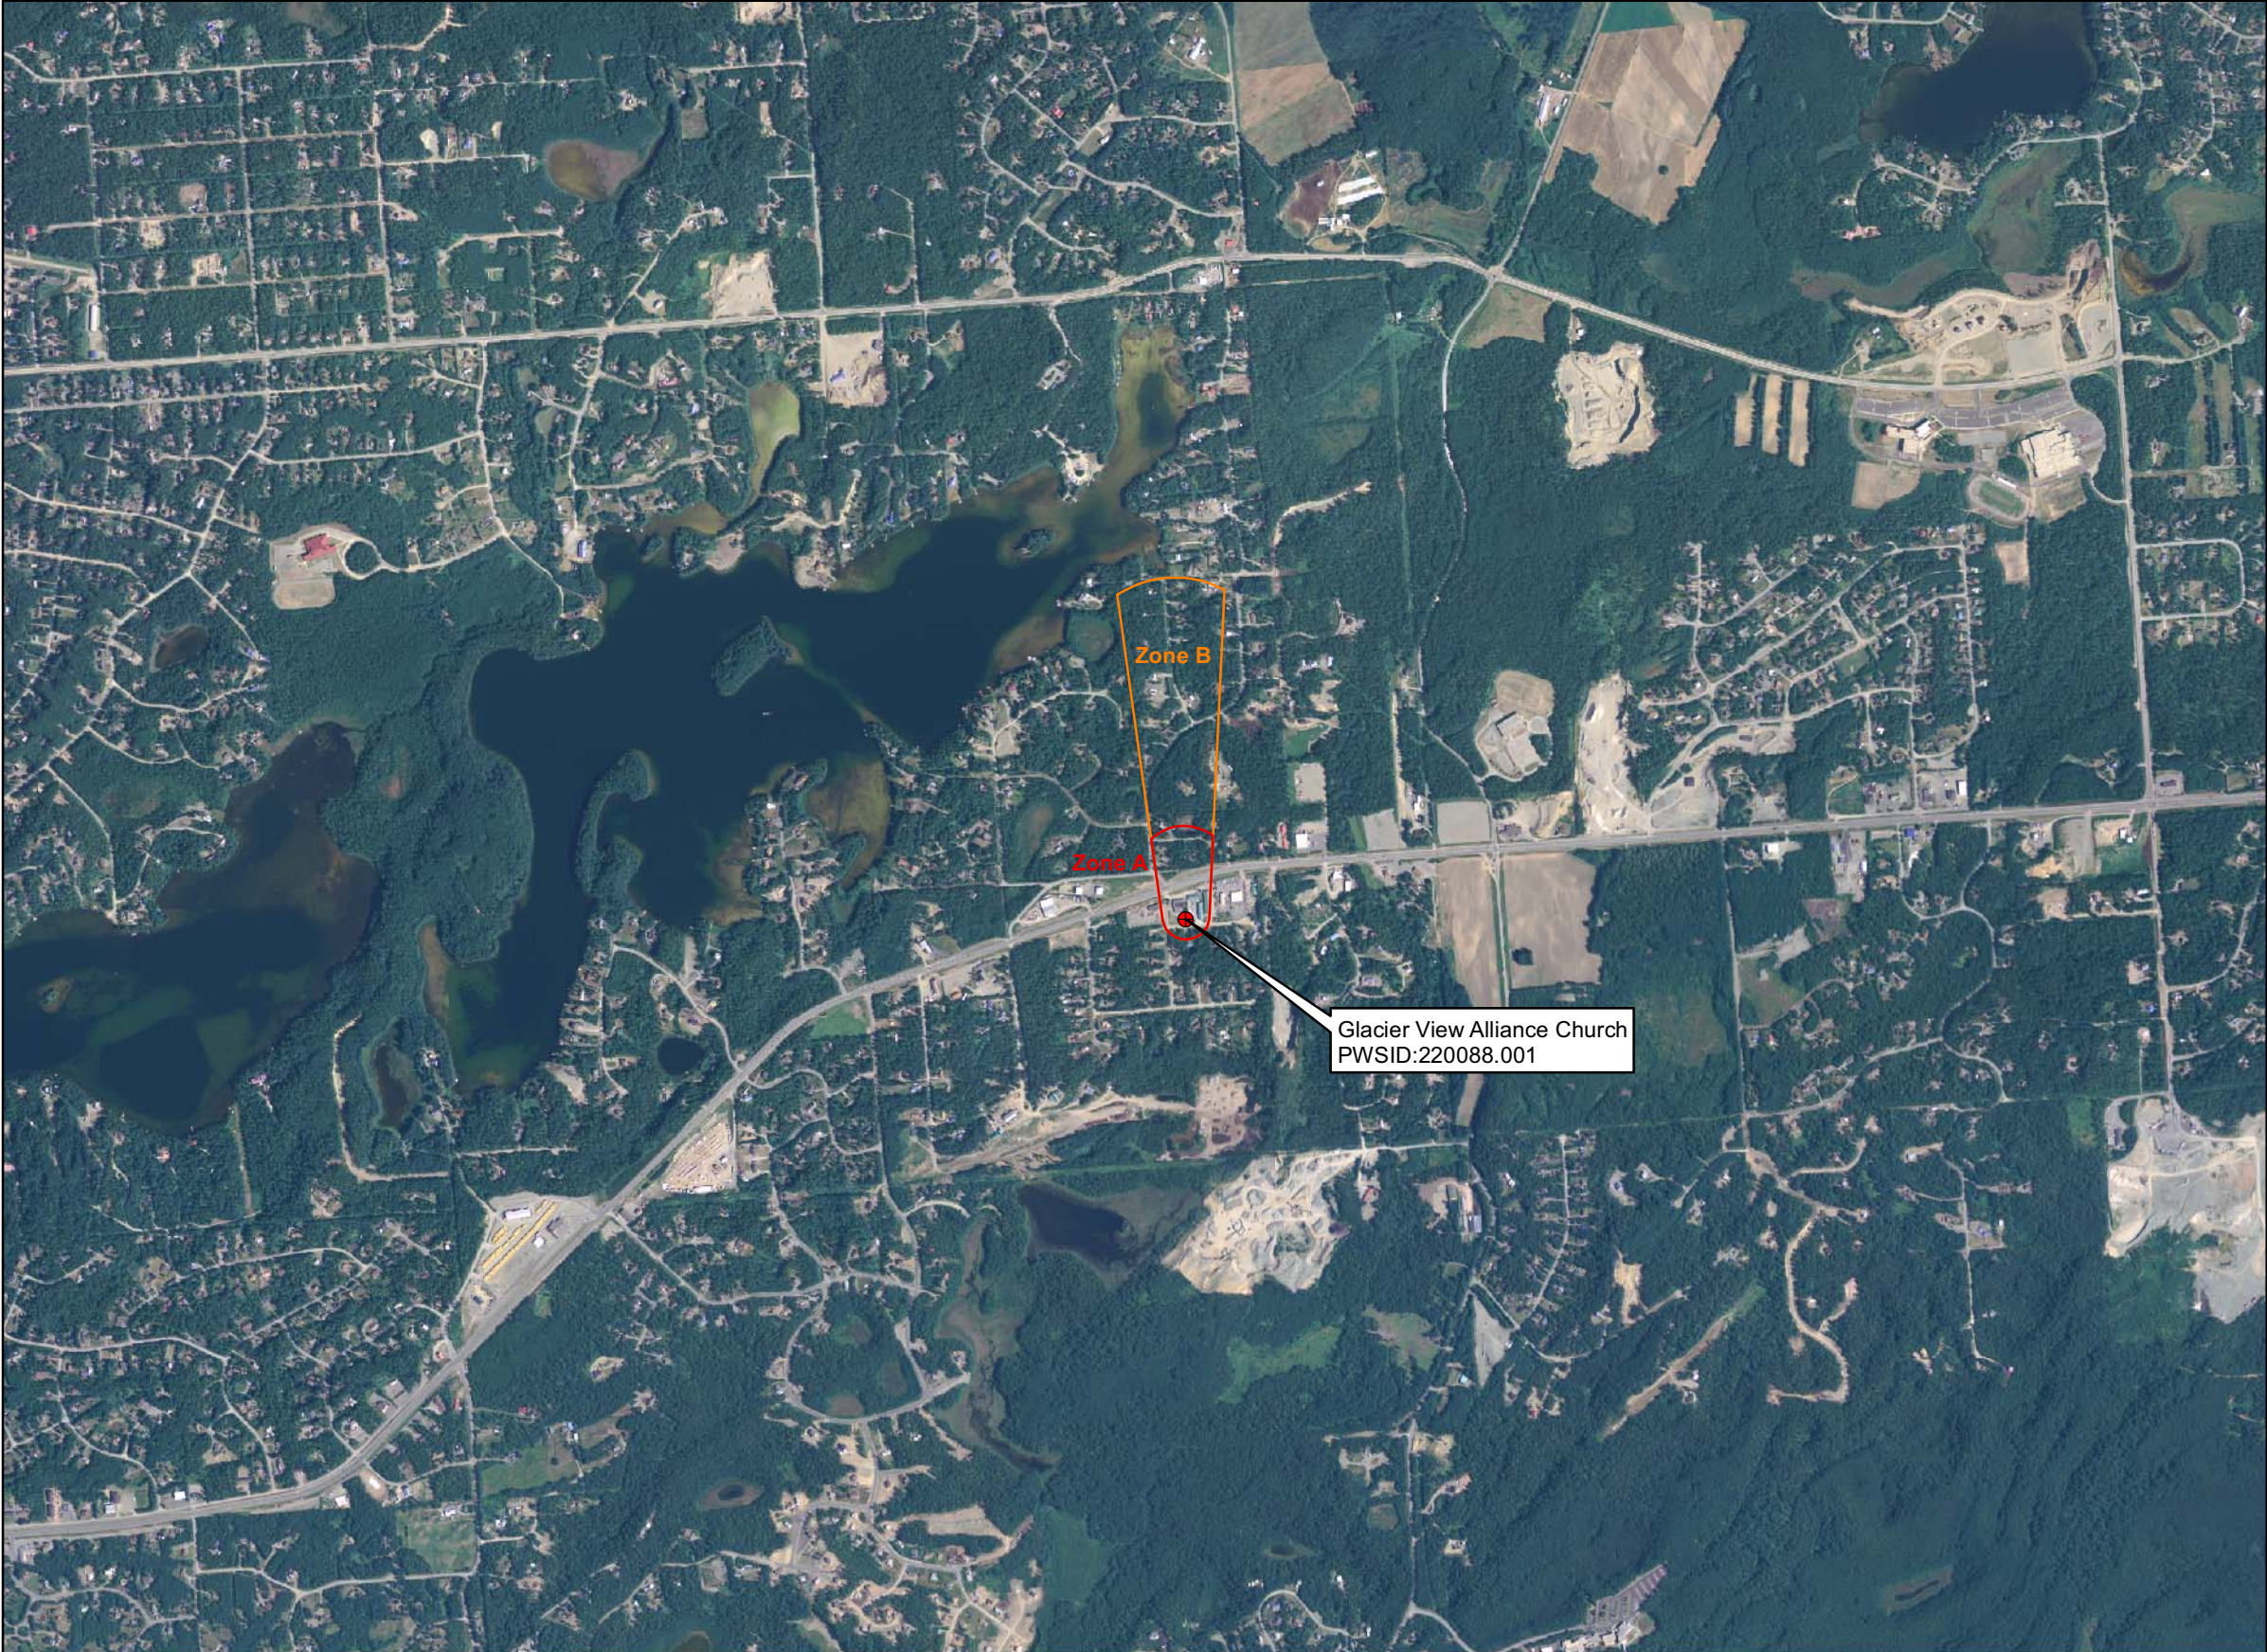
Glacier View Alliance Church
 PWS 220088.001
Appendix A Map A

The drinking water protection area for Glacier View Alliance Church was determined using an analytical calculation and includes Zones A and B (see Map A of Appendix A).

Public Water Well System for PWS #220088.001 Glacier View Alliance Church

The Glacier View Alliance Church public water system is a Class B (transient/non-community) water system. The system consists of one well located at the corner of Wagon Road and the Palmer-Wasilla Highway, approximately 5 miles east of Wasilla, Alaska (see Map A in Appendix A). Wasilla has a population of 7,028 and lies about 12 miles north of the Knik Arm of Cook Inlet along the George Parks Highway (ADCCED, 2008).

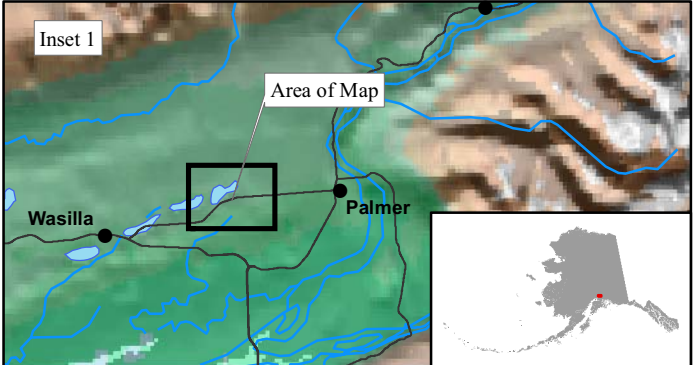
Drinking Water Protection Areas based on "Alaska Drinking Water Protection Program - Guidance Manual for Class B Public Water Systems" published by ADEC

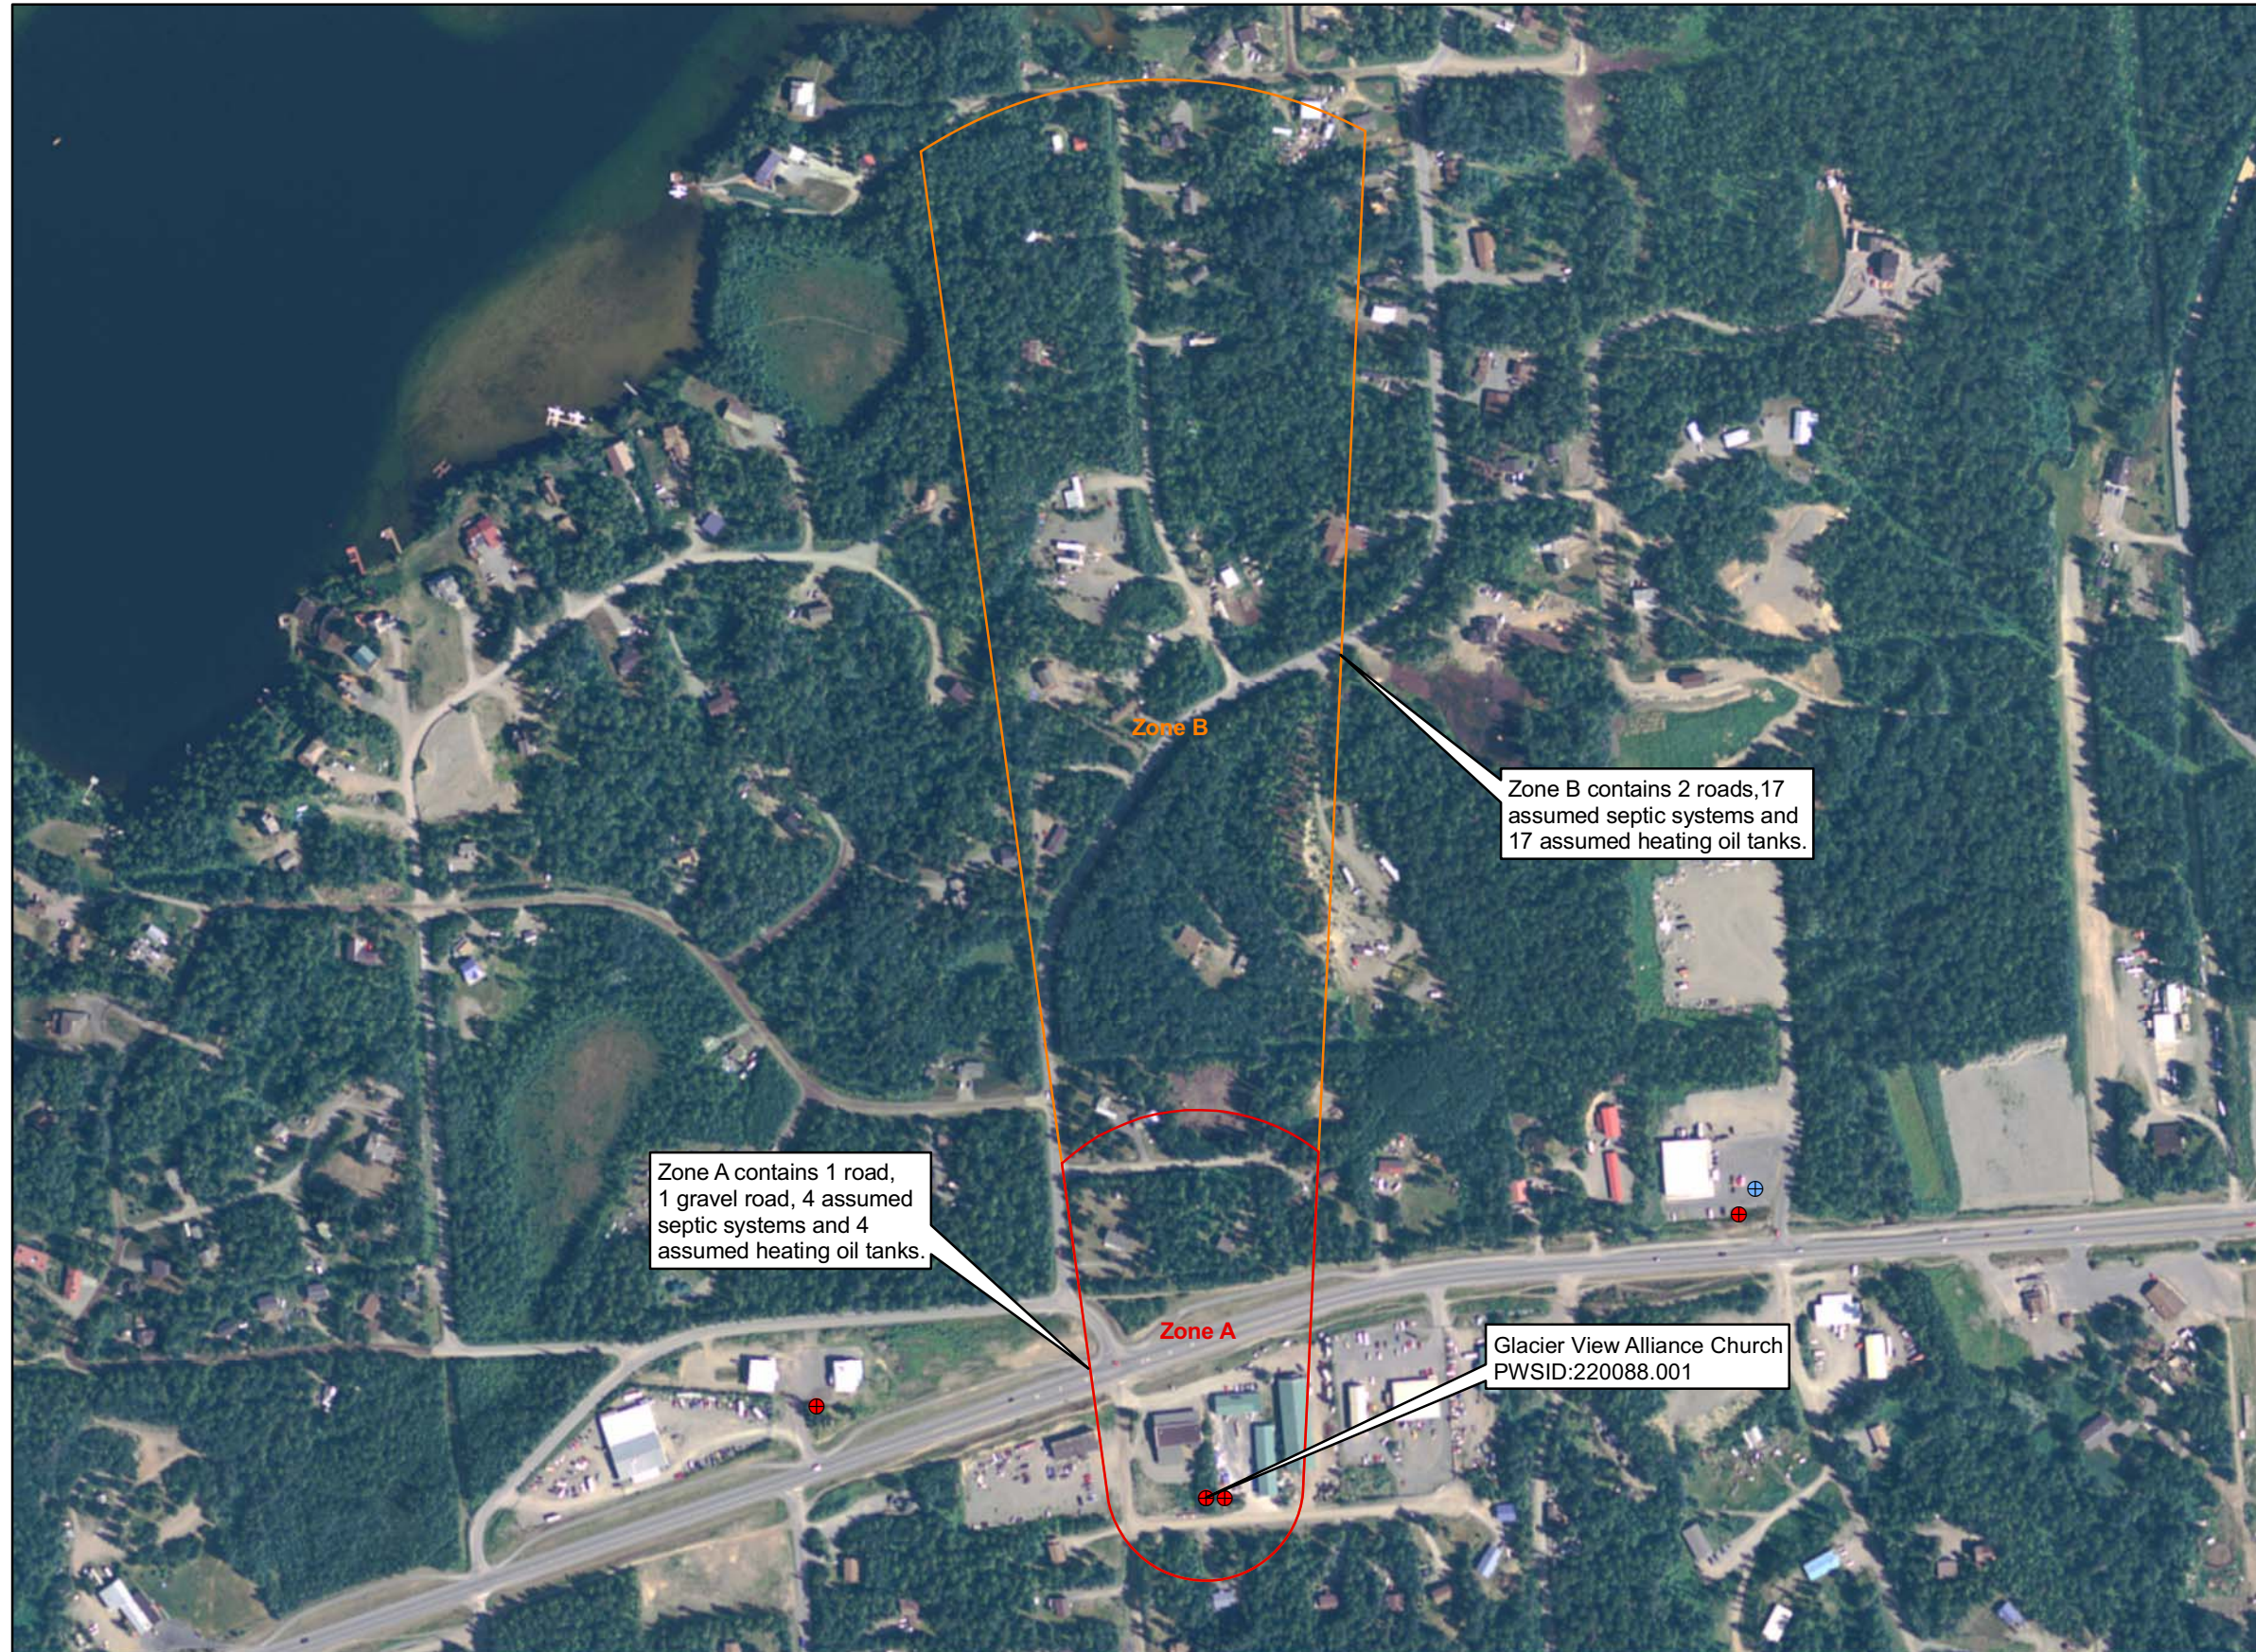
Appendix C Map C

**Public Water Well System for PWS #220088.001 Glacier View Alliance Church
Showing Potential and Existing Sources of Contamination**

Zone A contains 1 road, 1 gravel road, 4 assumed septic systems and 4 assumed heating oil tanks.

Zone B contains 2 roads, 17 assumed septic systems and 17 assumed heating oil tanks.

The sources are displayed on Map C of Appendix C and summarized in Table 1 of Appendix B.

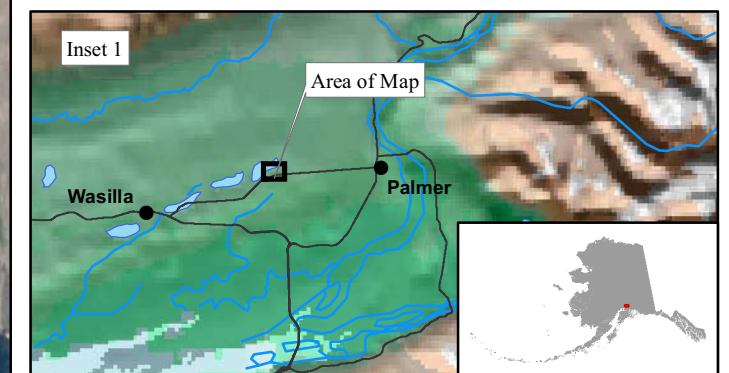
Drinking Water Protection Areas based on "Alaska Drinking Water Protection Program - Guidance Manual for Class B Public Water Systems" published by ADEC
