# **Source Water Assessment**

A Hydrogeologic Susceptibility and Vulnerability Assessment for First Baptist Church of Willow Public Drinking Water System, Willow, Alaska PWSID # 220073.001

DRINKING WATER PROTECTION REPORT 1631

Alaska Department of Environmental Conservation

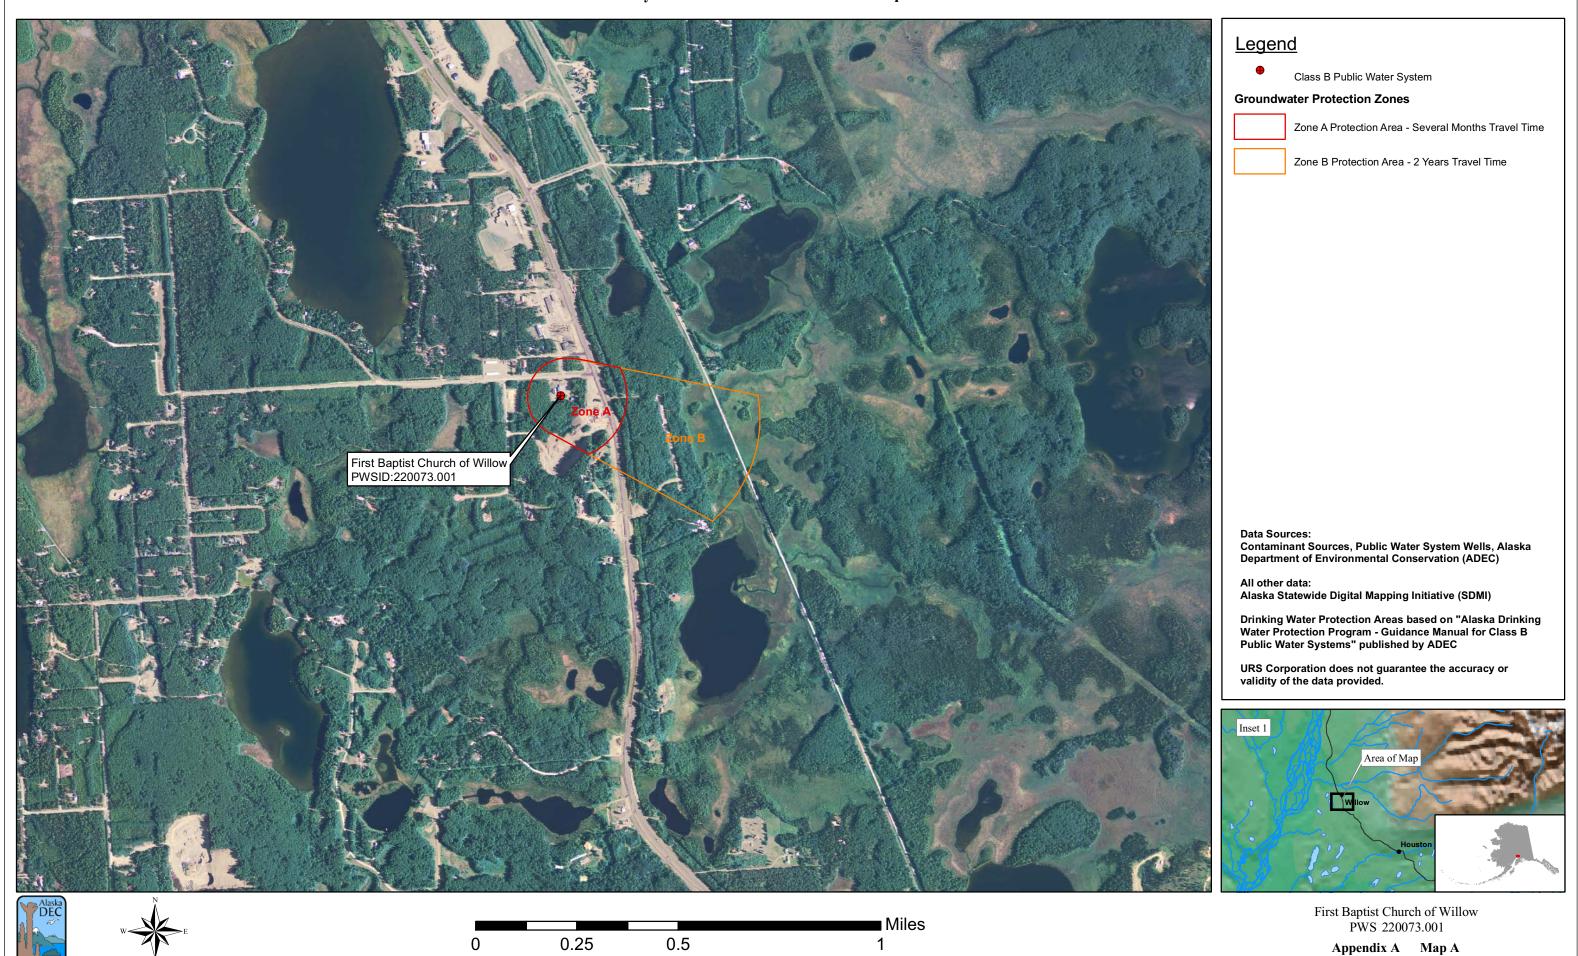
First Baptist Church of Willow Drinking Water Protection Area Location Map (Map A)

The drinking water protection area for First Baptist Church of Willow was determined using an analytical calculation and includes Zones A and B (See Map A of Appendix A).

### Public Water Well System for PWS #220073.001 First Baptist Church of Willow

First Baptist Church of Willow public water system is a Class B (transient/non-community) water system. The system consists of one well located on the west side of the Parks Highway in Willow, Alaska, approximately 70 road miles northwest of Anchorage (see Map A in Appendix A). Willow lies between miles 60 and 80.7 of the Parks Highway and is part of the Matanuska-Susitna Borough. Temperatures in January can range from -33 to 33 degrees Fahrenheit, while in July temperatures can range from 42 to 83 degrees Fahrenheit. Willow receives between 16 and 27 inches of precipitation per year and up to 150 inches of snowfall. The population of Willow is 2,048 and the population of the Matanuska-Susitna Borough as a whole is 80,088 (ADCED, 2008).
