Hydrogeologic Susceptibility and Vulnerability Assessment for Mat Su
RV Park Drinking Water Source, Willow Area, Alaska

DRINKING WATER PROTECTION PROGRAM REPORT 42

September 2001

By Ecology and Environment, Inc.

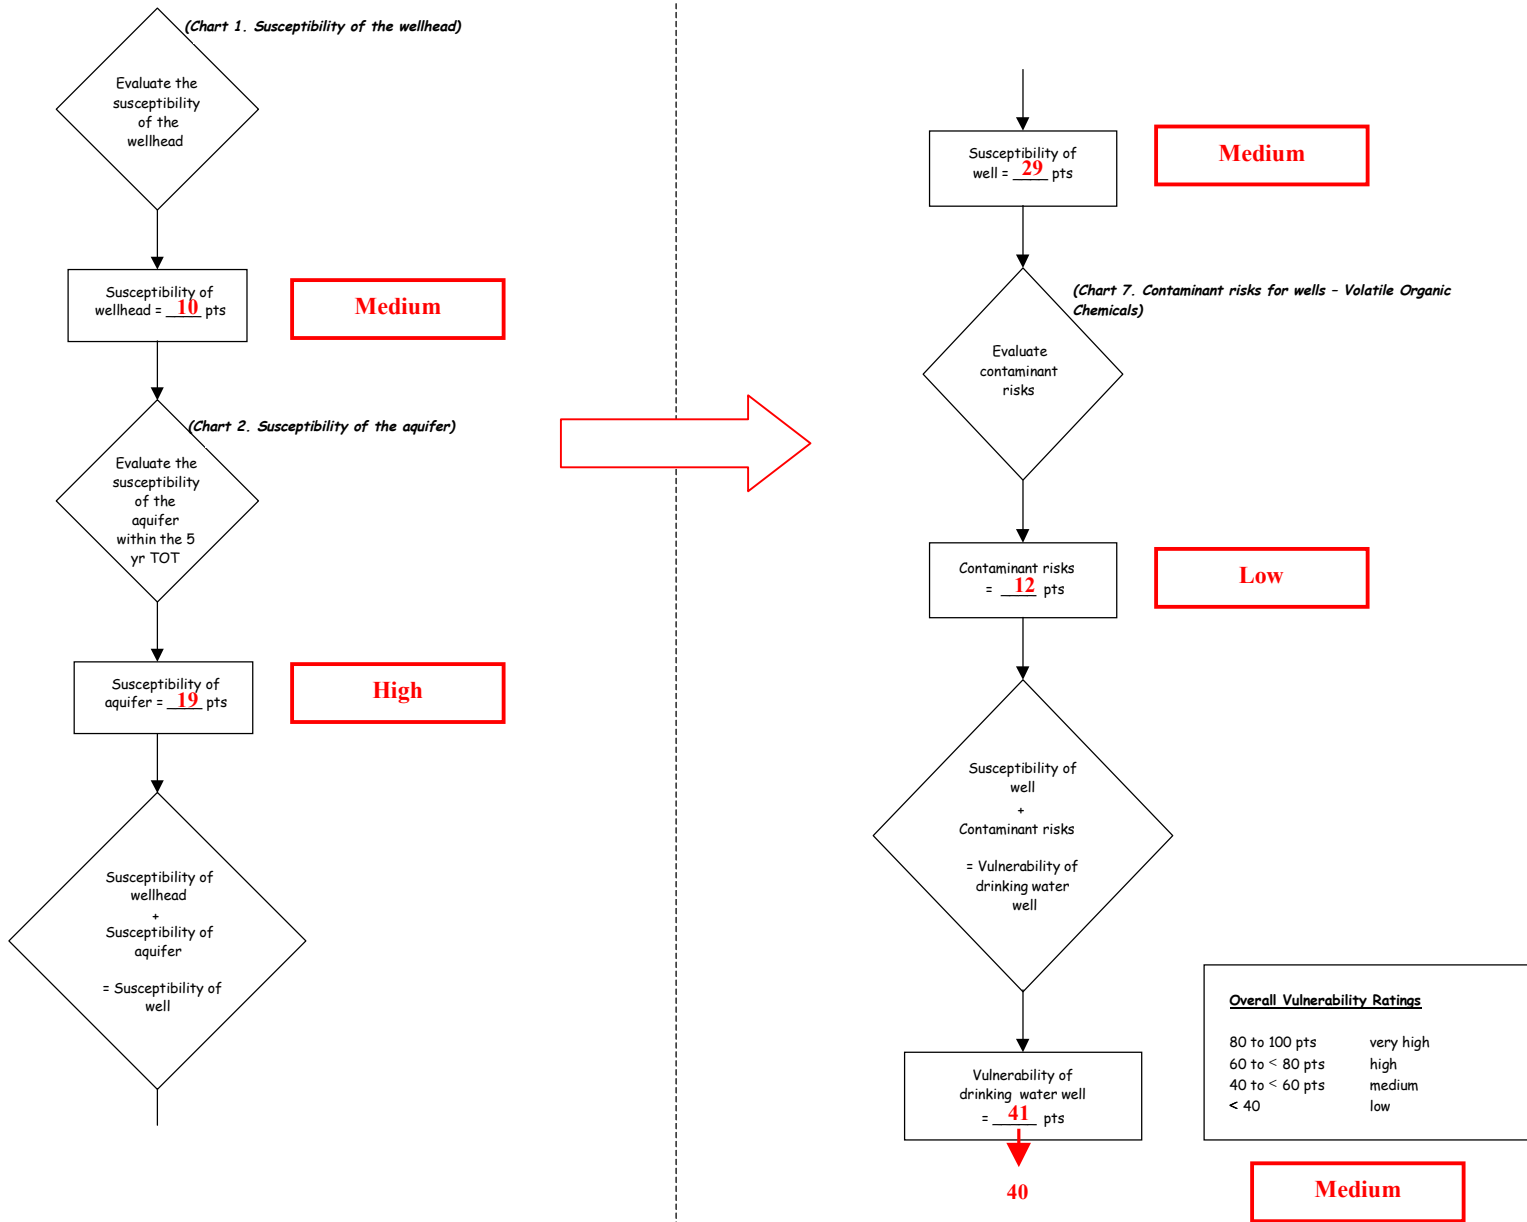
Chart 8. Vulnerability analysis for Mat Su RV Park – Volatile Organic Chemicals
