Channel Changes of the Gila River in Safford Valley, Arizona 1846-1970

GEOLOGICAL SURVEY PROFESSIONAL PAPER 655-G

By D. E. BURKHAM

GILA RIVER PHREATOPHYTE PROJECT

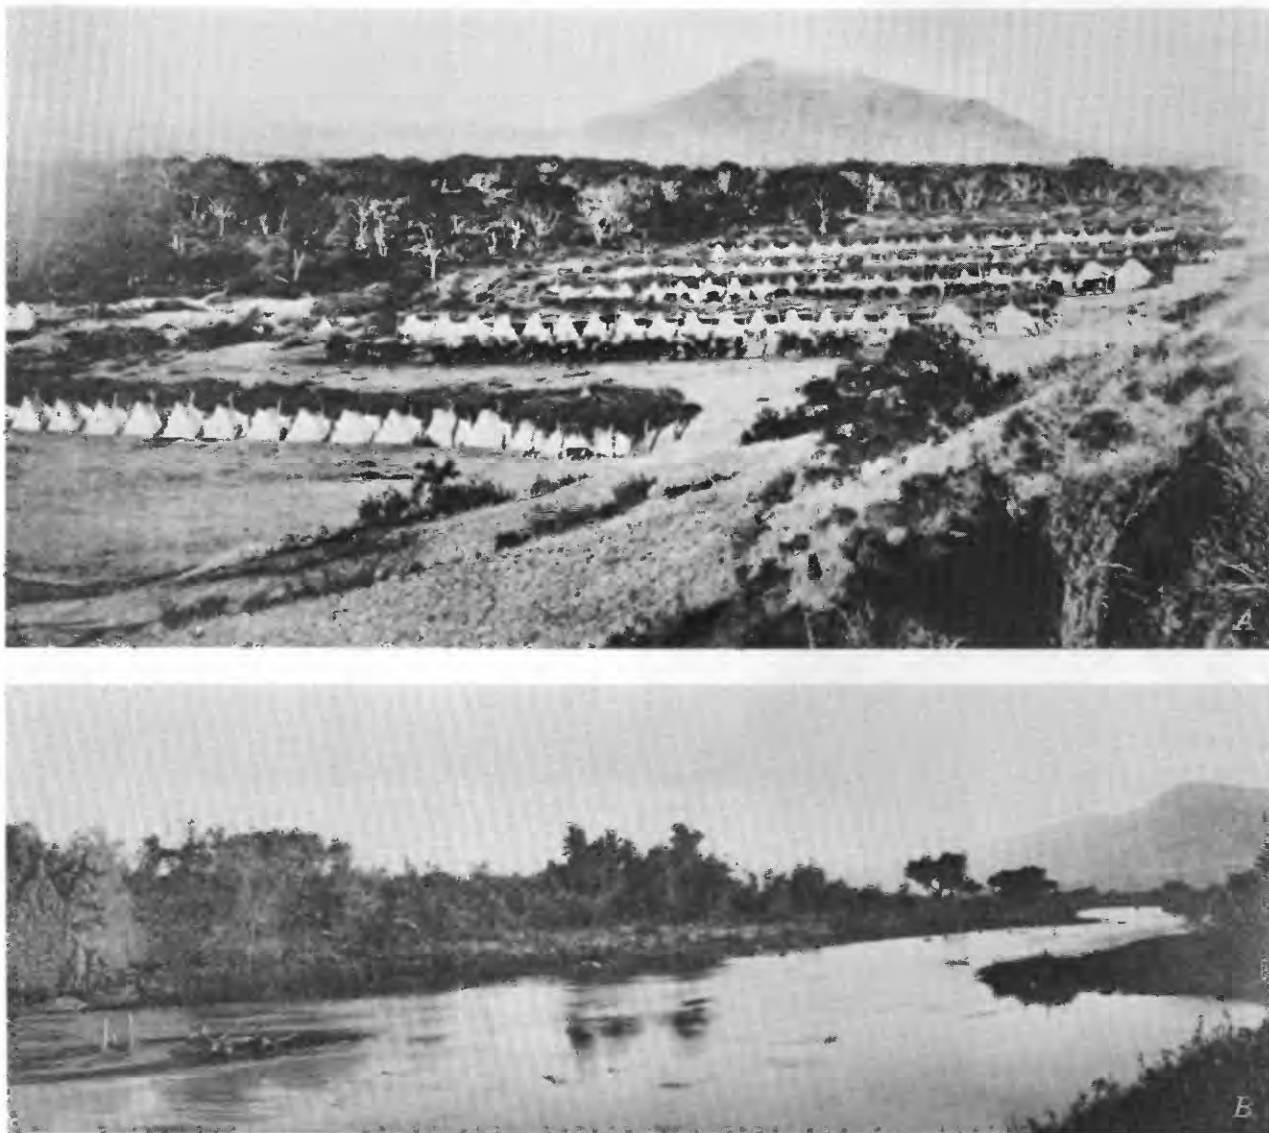
FIGURE 2.—Gila River near Fort Thomas in the 1880's. *A*, Cavalry camp on the flood plain in 1881. *B*, Stream channel in 1885. The trees in the two photographs are mainly willow and cottonwood. Photographs furnished by the Arizona Pioneers' Historical Society.

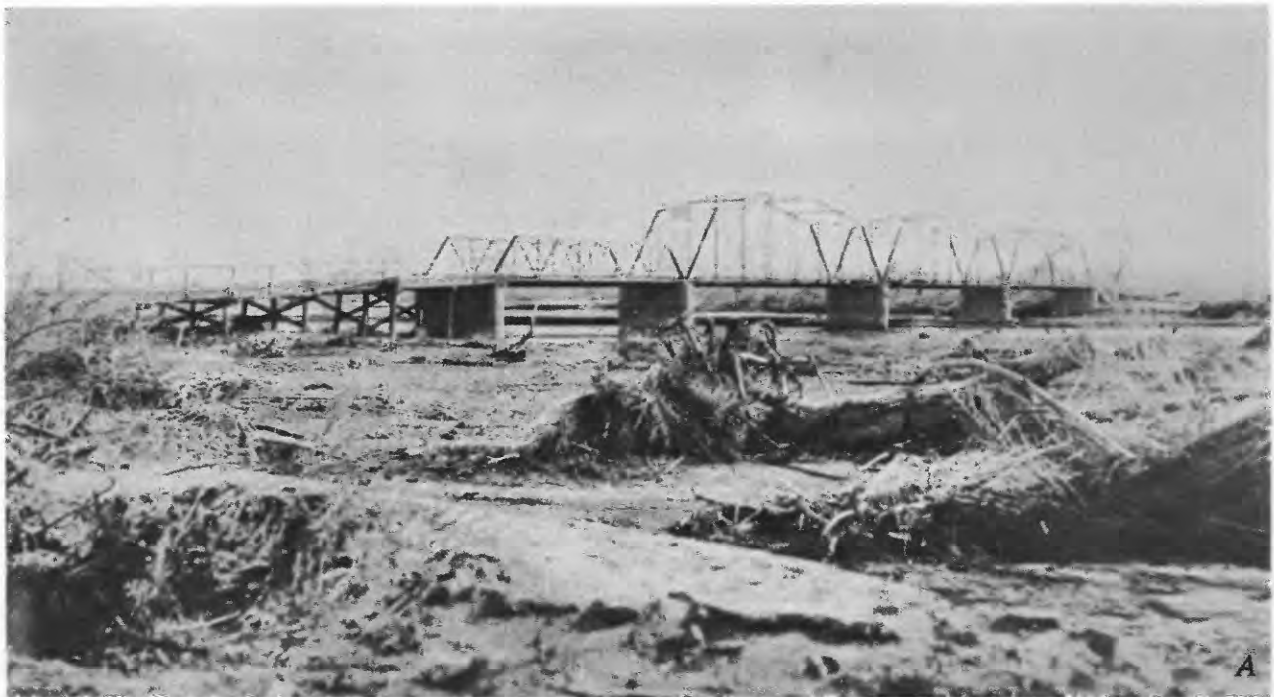
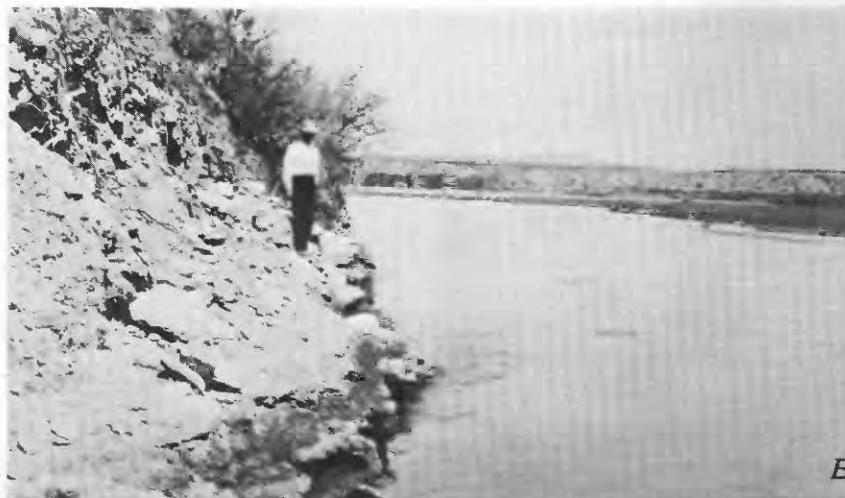
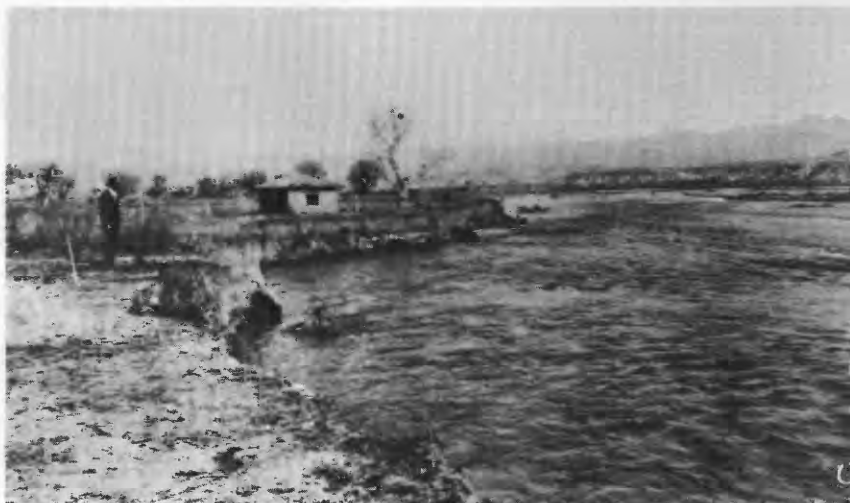
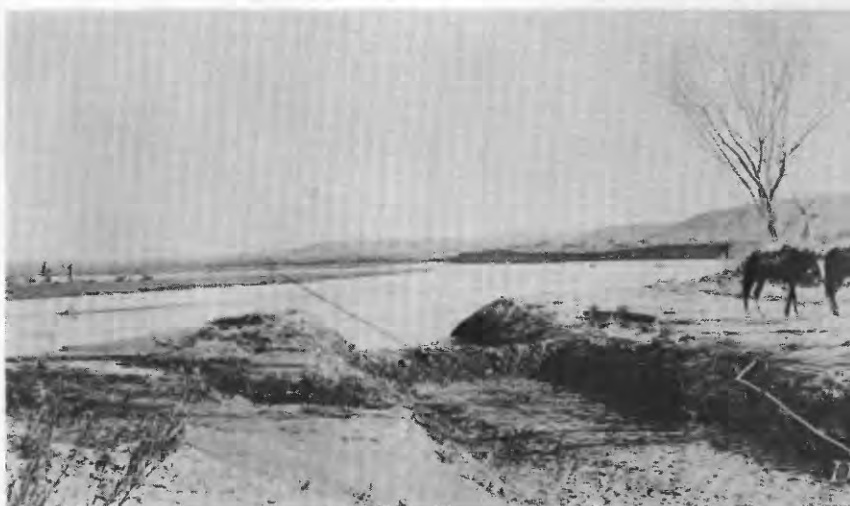
FIGURE 3.—Gila River in 1916. *A*, Looking upstream at the bridge at Pima; the drift in the foreground probably is cottonwood. *B*, Looking downstream at Black Point near Bylas; the trees in the background across the river probably are cottonwood. *C*, Erosion on the left bank of the river at Bylas; the alluvial fan on the right side of the river at the mouth of Salt Creek (not shown in photo-

graph; see pl. 1) is causing a realignment of the river. *D*, Gila River near Bylas; debris in the left background is uprooted cottonwood. Photograph *A* is from Olmstead (1919, pl. 11); photographs *B*, *C*, and *D* furnished by the U.S. Bureau of Indian Affairs, Phoenix, Ariz.

Most of the dense stands of willow and cottonwood that grew along the Gila River prior to 1905 were destroyed during 1905-17 (fig. 3). The stream channel was relatively barren in 1909 (fig. 4); therefore, most of the destruction probably occurred during 1905-9.

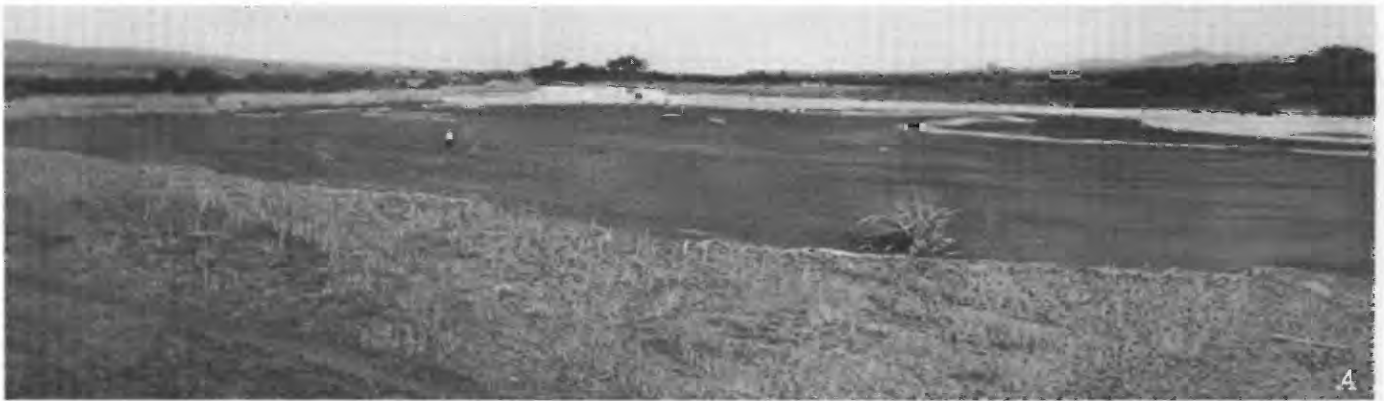
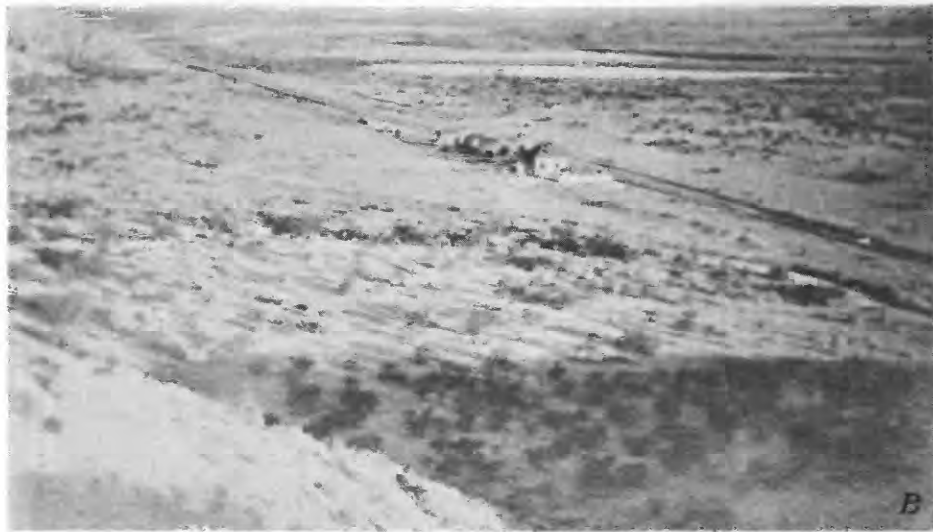
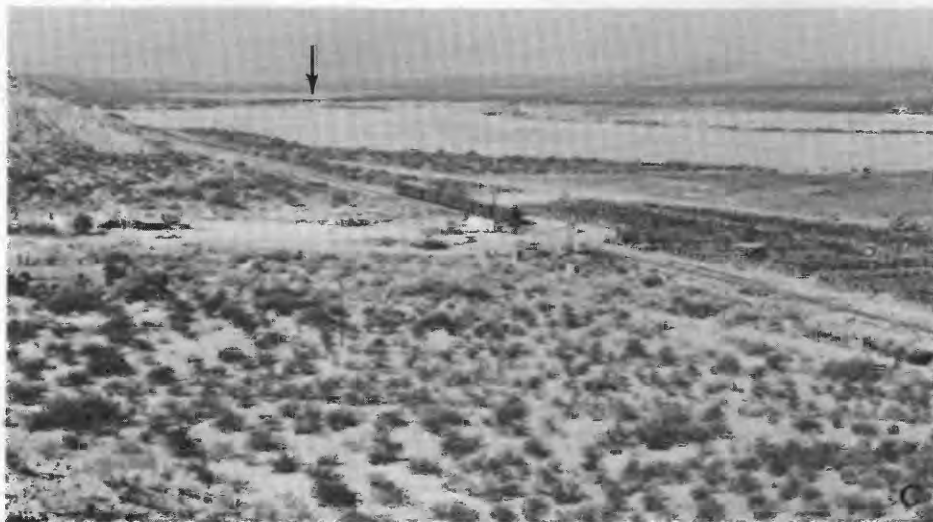
FIGURE 4.—Gila River in 1909 and 1969. *A*, Looking downstream near Geronimo in May 1909. *B*, Looking downstream near the railroad siding at Calva in 1909. *C*, Looking downstream near the railroad siding at Calva in 1969 (arrow indicates location of railroad bridge); the bottom-land vegetation was eradicated in 1966 to control evapotranspiration, and the photograph in figure 6 shows the same area before eradication. Photographs *A* and *B* furnished by the U.S. Bureau of Indian Affairs, Phoenix, Ariz. Photograph *C* furnished by Mr. R. M. Turner, Tucson, Ariz.

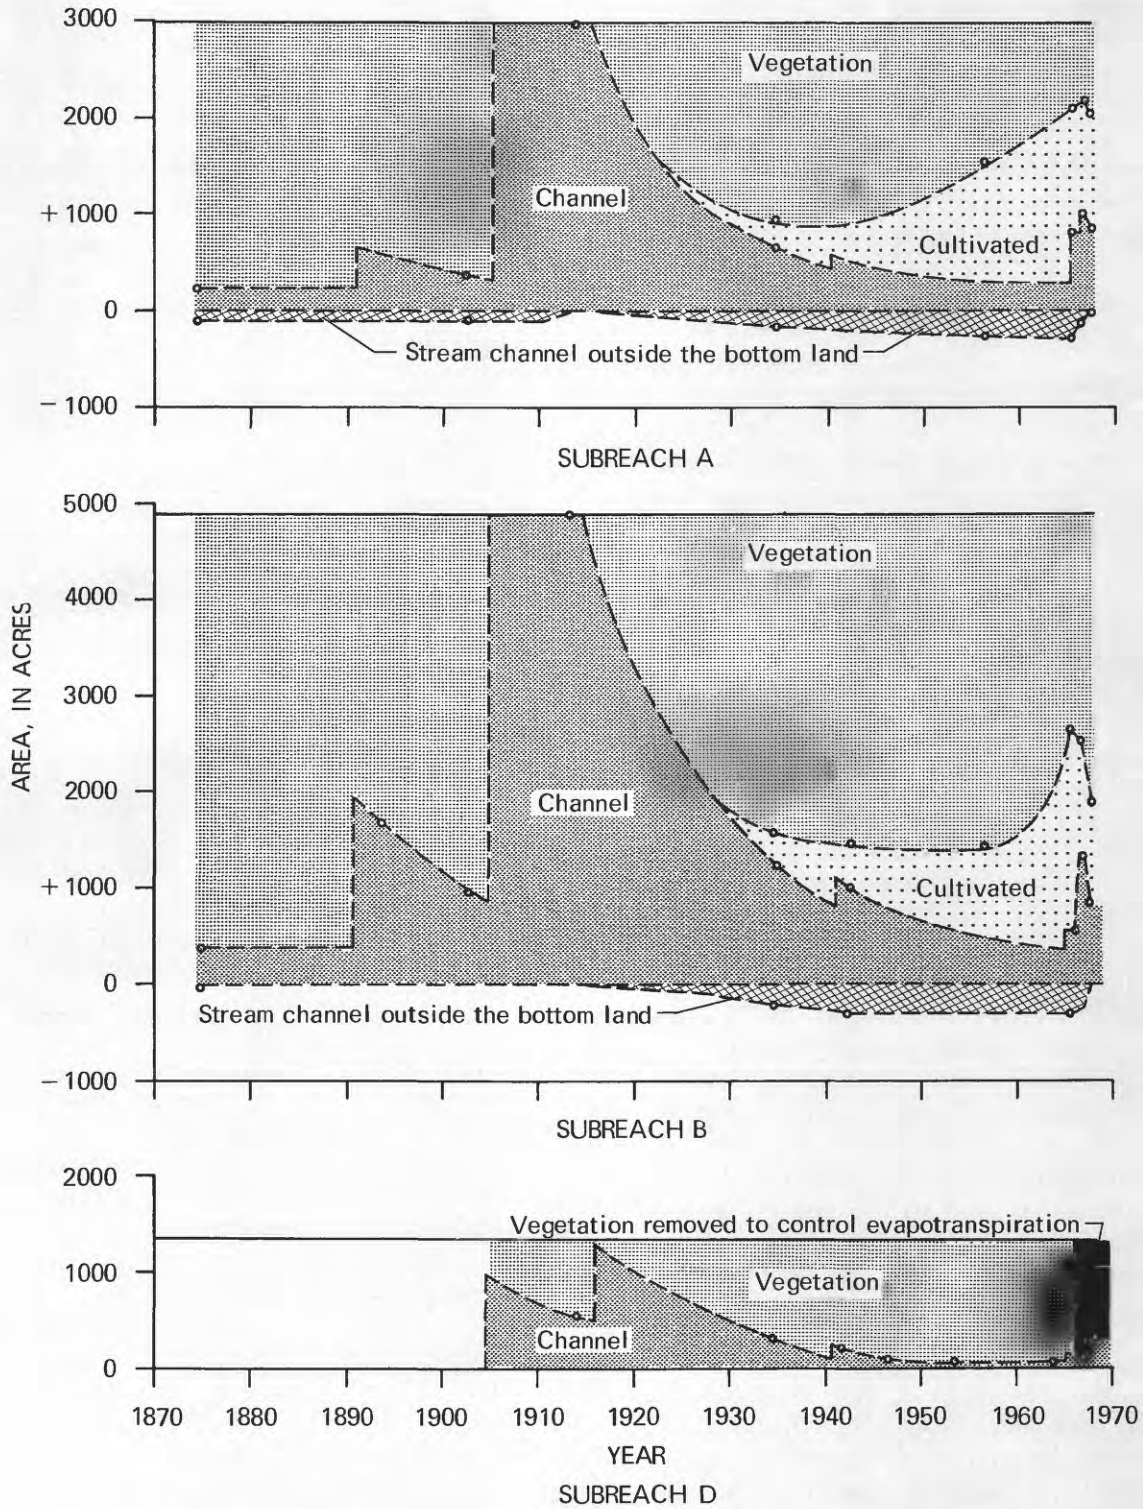
FIGURE 5.—Historical changes in the bottom land in subreaches A, B, and D. The increases in channel width are the result of the major floods in 1891, 1905-17, 1941, 1965, and 1967 (pl. 3). Data plotted from table 1.

Saltcedar became the dominant tree type in the bottom land during 1920-30. The saltcedar, a plant brought into Texas and New Mexico from the Mediterranean region, apparently was introduced into the Safford Valley in the second decade of the 20th century (Gatewood and others, 1950, p. 11). Conditions for the growth of the saltcedar were ideal, and it spread rapidly along the flood plain. The saltcedar, which consumes large amounts of water, reached its maximum areal extent in the study reach during 1945-55; after 1955, farmers began to clear large areas of saltcedar for the cultivation of crops (fig. 5).

during 1945-55 (fig. 5). At present (1970), saltcedar is very dense in most places where the black willow was planted, and most of the mechanical devices are buried under the alluvium.

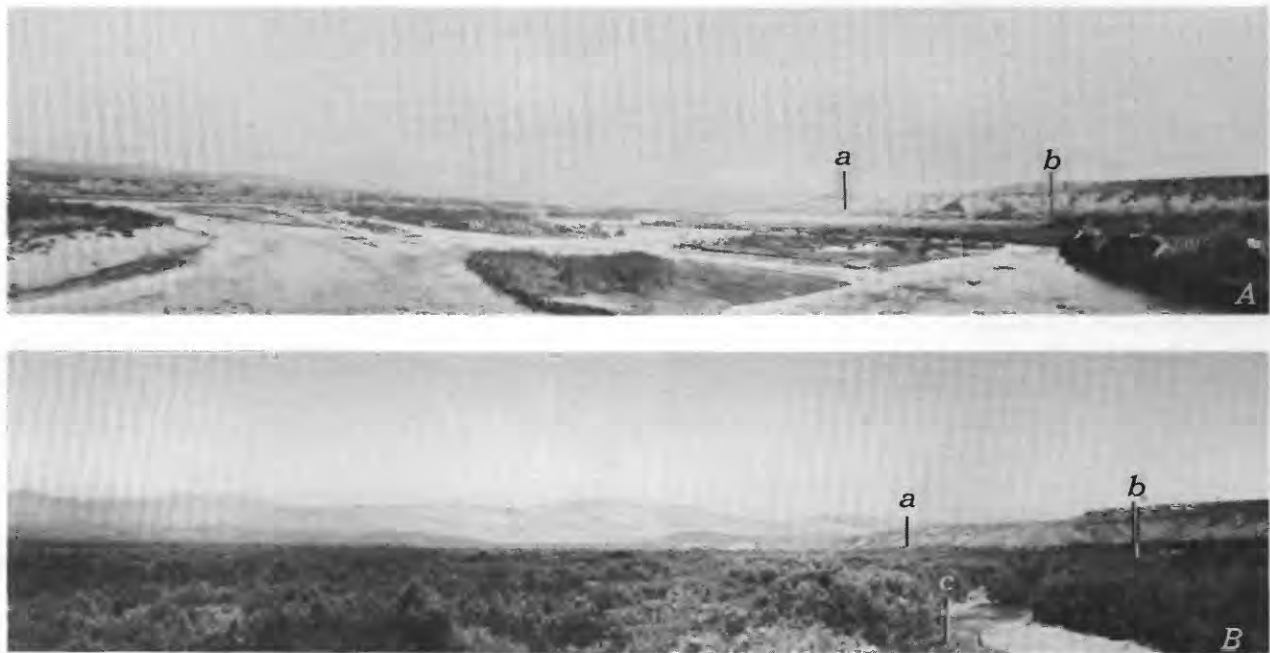
FIGURE 6.—Saltcedar encroachment along the Gila River between 1932 and 1964. *A*, Looking upstream from the railroad bridge near Calva in 1932; the braided stream probably is typical of the Gila River in most of the Safford Valley in the third and early fourth decades of the 20th century. *B*, Looking upstream from the railroad bridge near Calva in 1964. Leaders indicate: *a*, location of railroad siding at Calva (fig. 4*B*, *C*); *b*, location of alluvial fan shown on plate 4; *c*, location of stream channel in 1964.

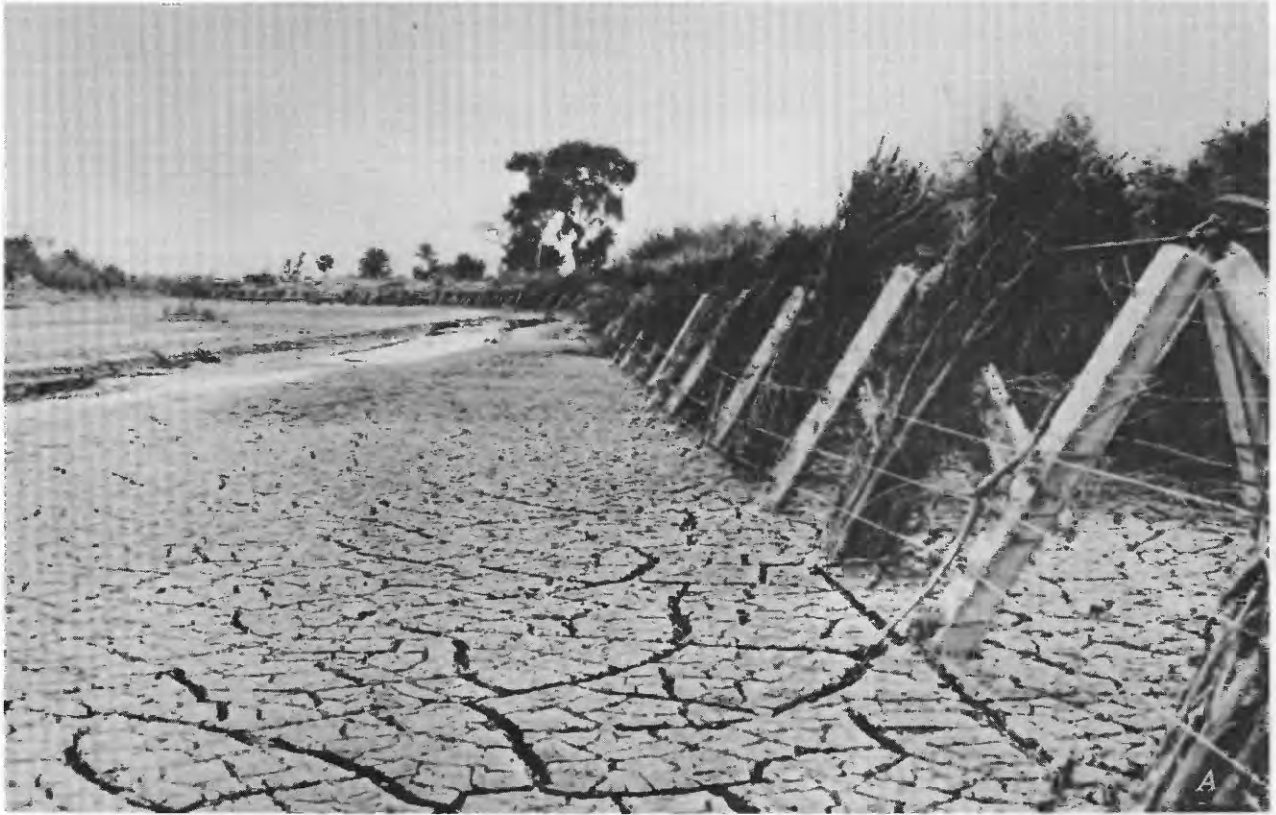
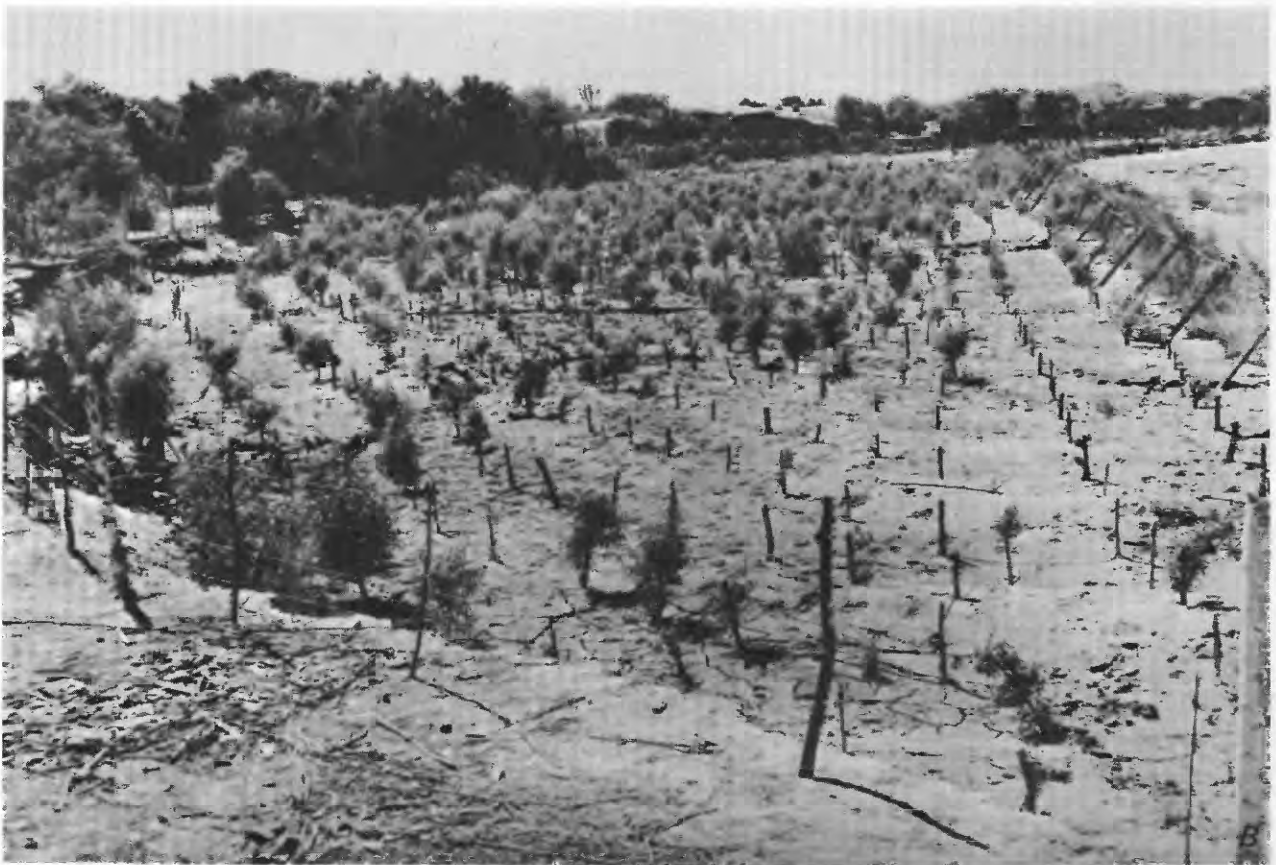
The erosion-control treatment used by the Soil Conservation Service (fig. 8) undoubtedly had some short-term local effects because it was applied during a period having few major floods; however, saltcedar became established naturally, and any reduction in erosion effected by the willow probably would have occurred later as a result of the saltcedar.
