APPENDIX A EXISTING EXPLORATION SITES

Overview

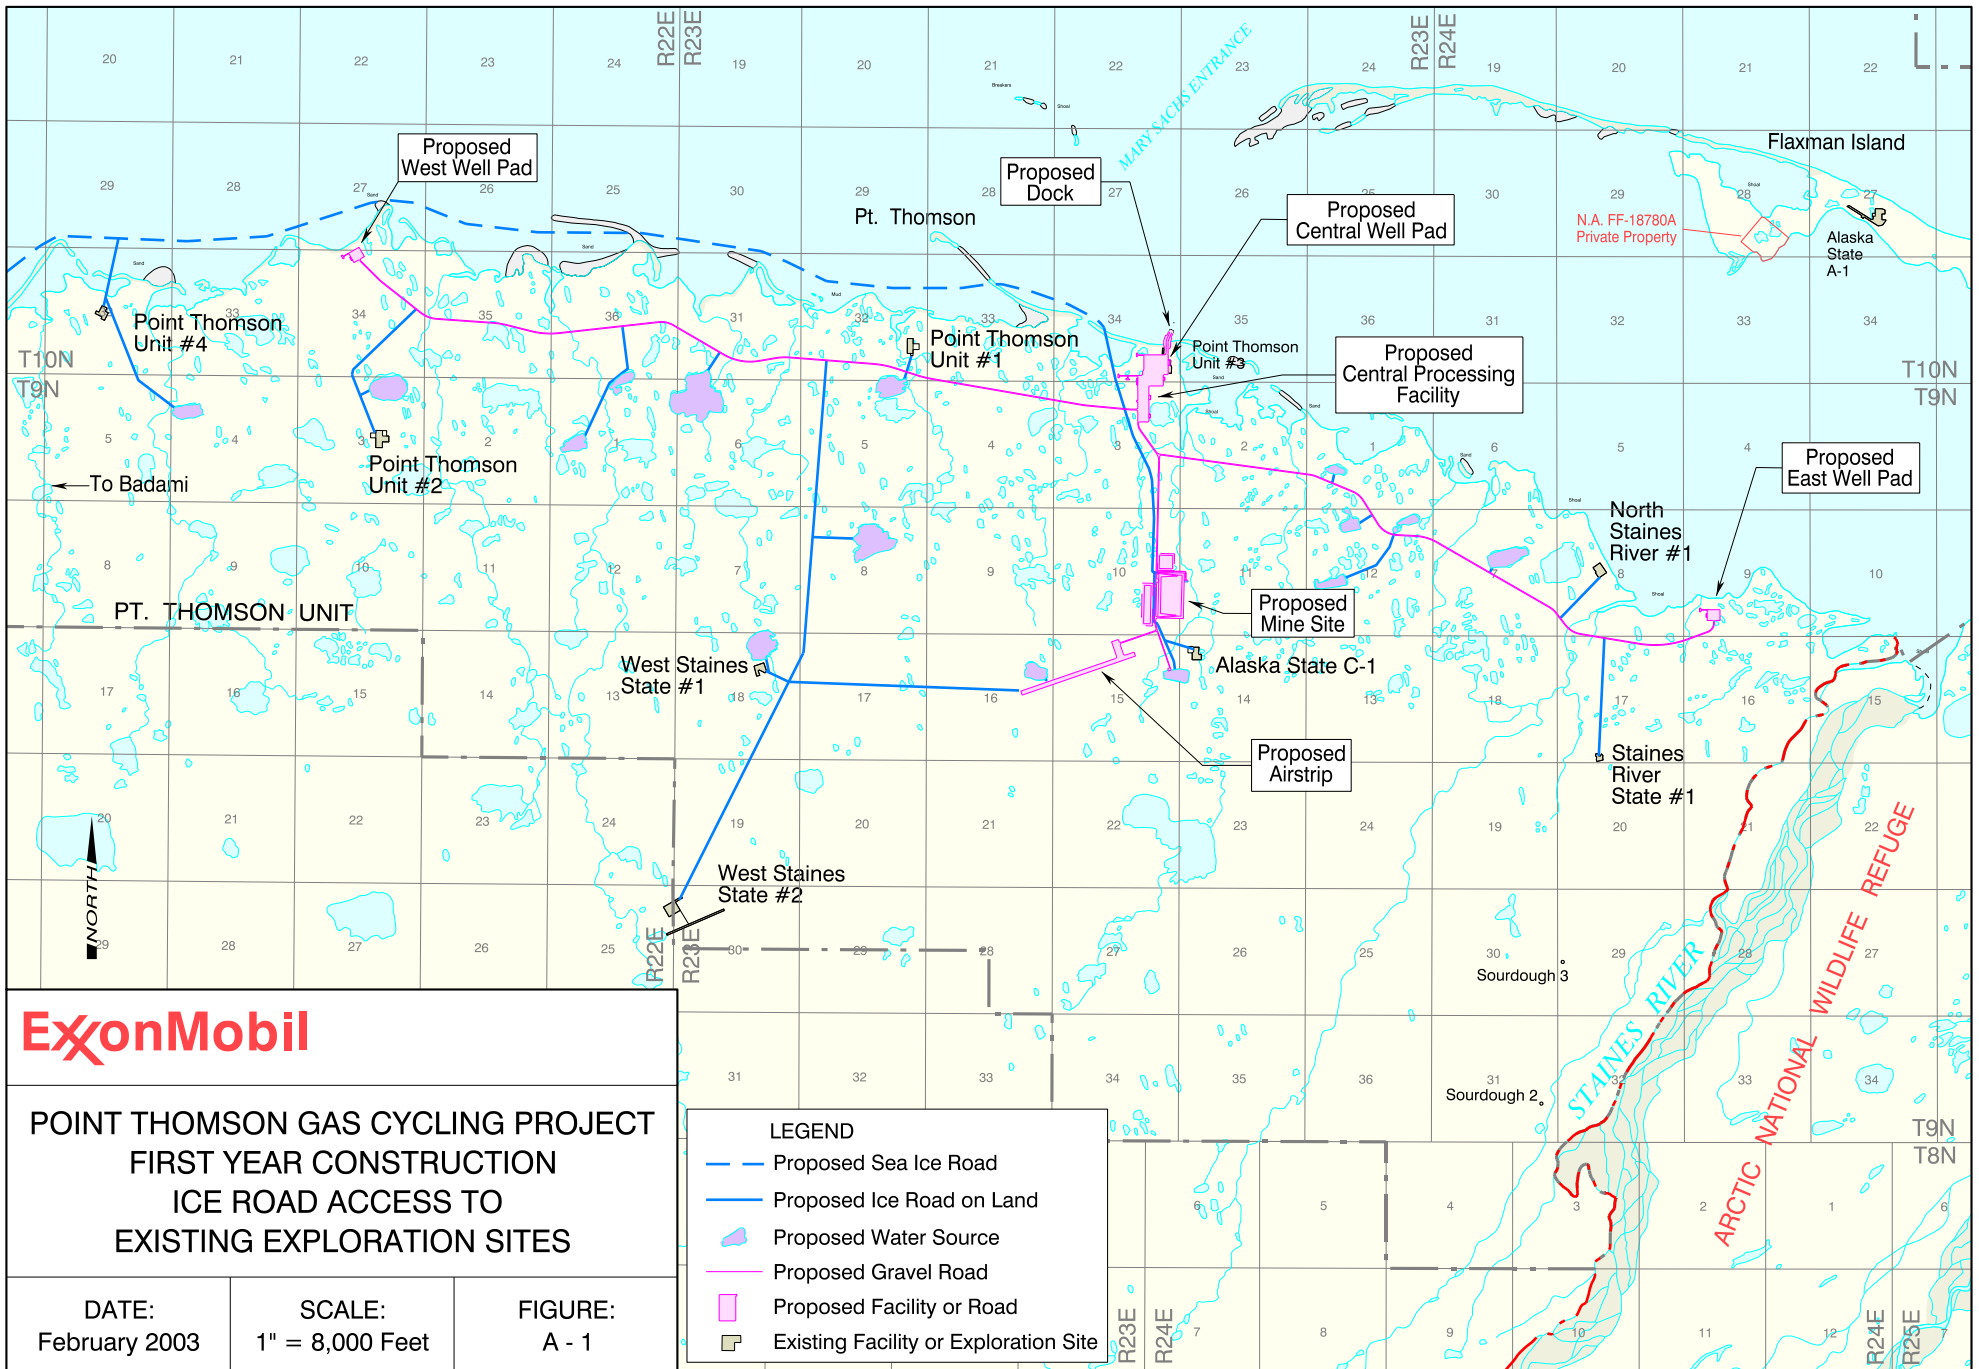
There are 10 onshore gravel pads existing within the PTU as a result of exploration and assessment activities. ExxonMobil was the operator for all but one of these pads. The PTU also includes a former gravel mine used to support some of these exploration activities. These 11 sites are listed in Table A-1 (Figure A-1).
